Displacement Behaviour of the Checkerboard Creek Rock Slope

THOMAS W.G. STEWART AND DENNIS P. MOORE

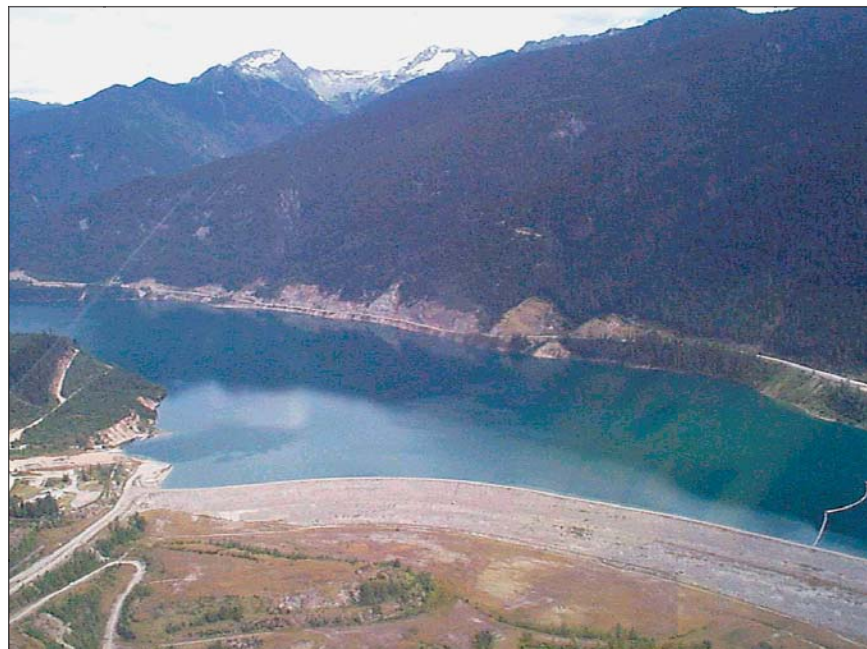
FIGURE 2 Oblique view of slope. Checkerboard Creek enters reservoir at right of main rock cut in centre of photo. Main slope area is to left of creek. Note Revelstoke Dam (earthfill section) in foreground.

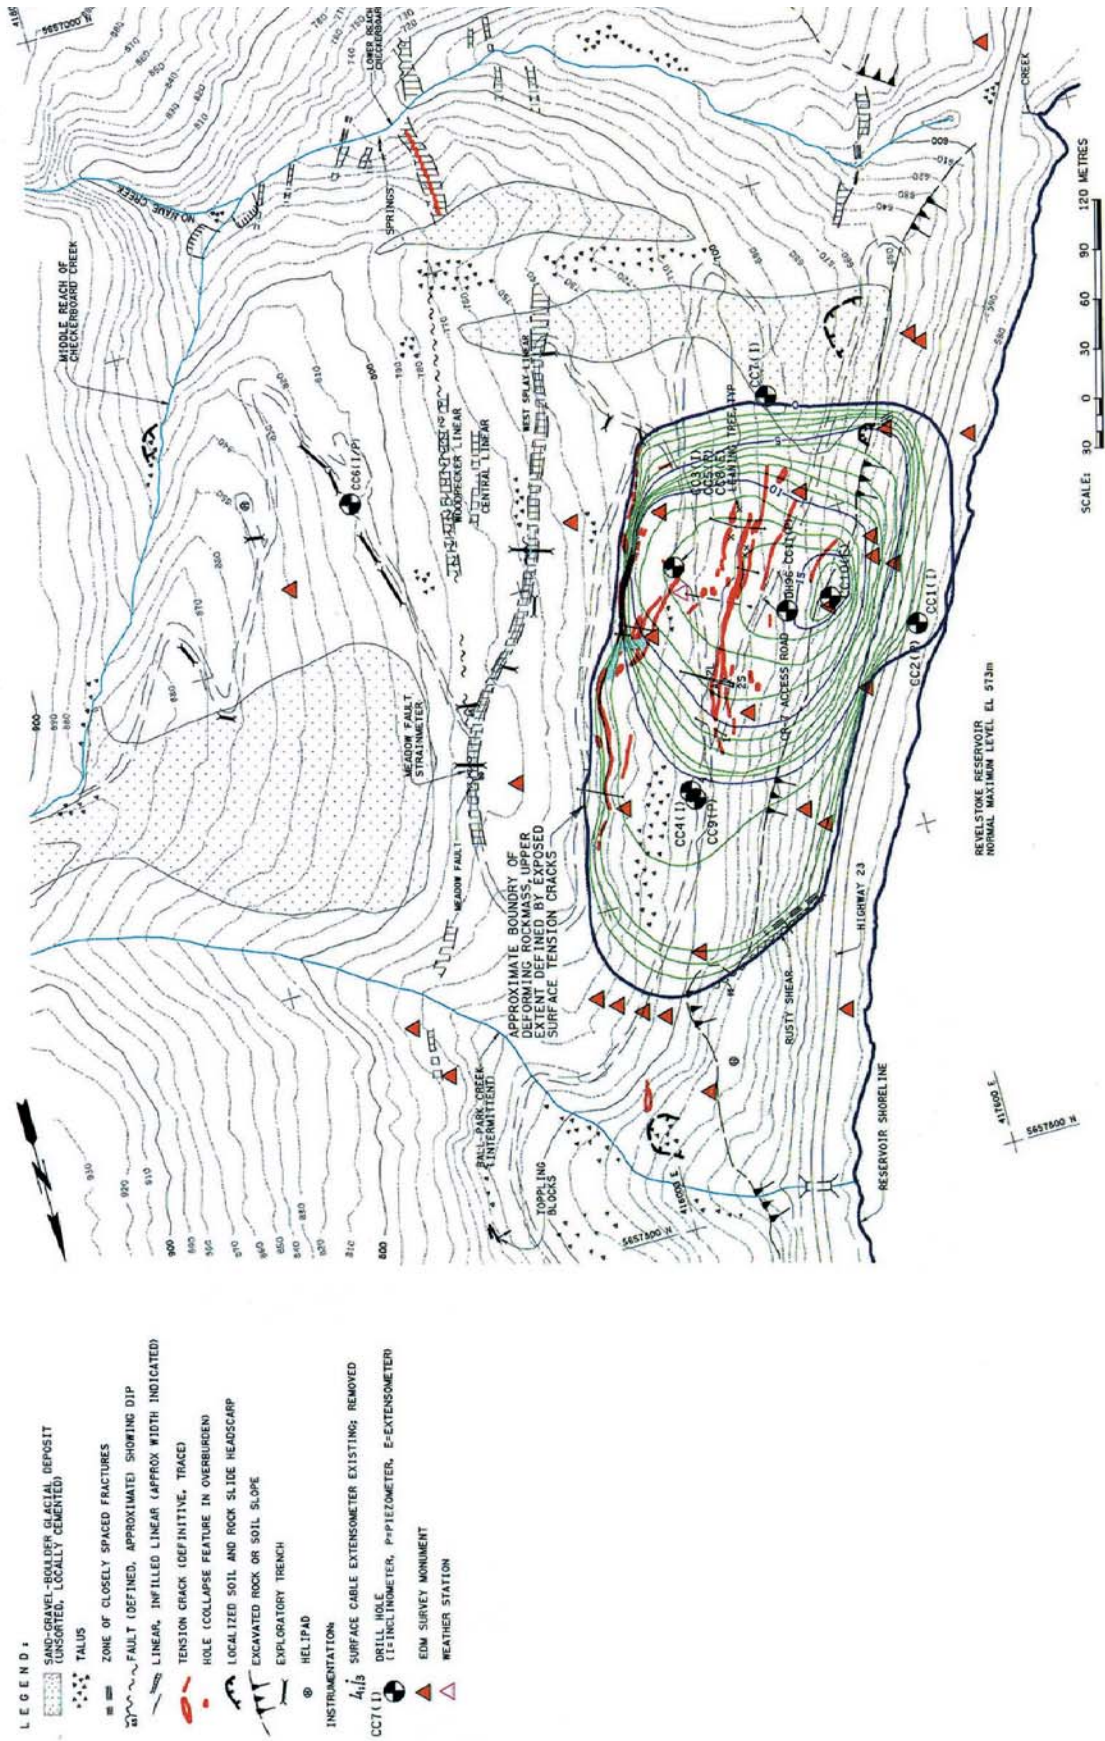
Conspicuous slope features include a series of open tension cracks and partially infilled bedrock linears oriented sub-parallel to the topographic contours. The open tension cracks are exposed in the central slope area between 650 and 740 m elevation (Figure 4) and are seen as discrete, planar to sinuous bedrock cracks in outcrop, and as collapse features where the cracks are covered by thin surficial deposits. The bedrock walls of the open tension cracks show no signs of glacial erosion, which distinguishes them from the infilled linears and indicates that opening of the tension cracks is post-glacial.

FIGURE 4 Plan of slope, illustrating slope displacement features, instrumentation, and displacement rate contours.

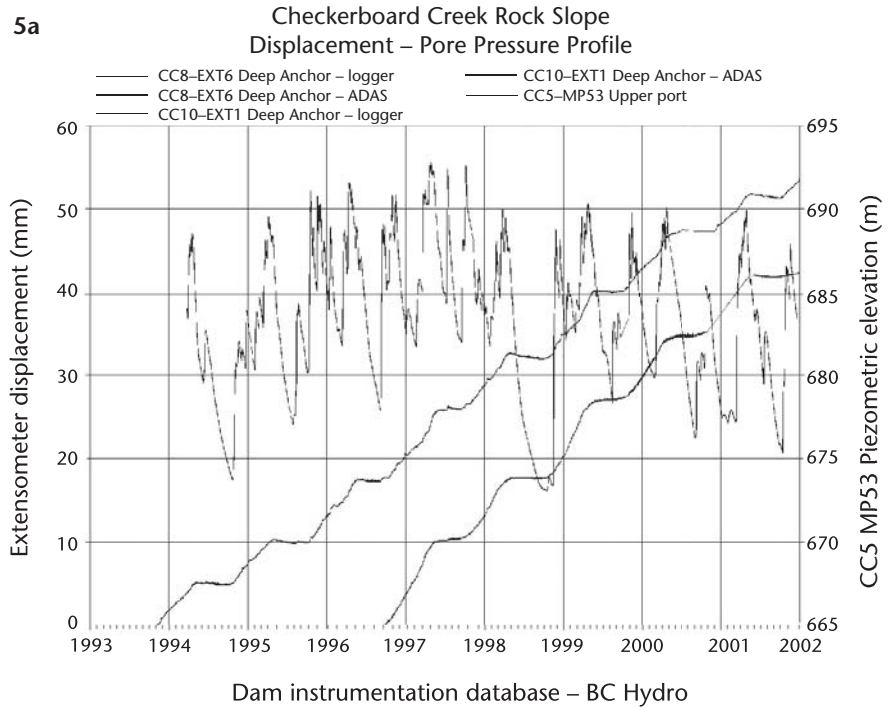
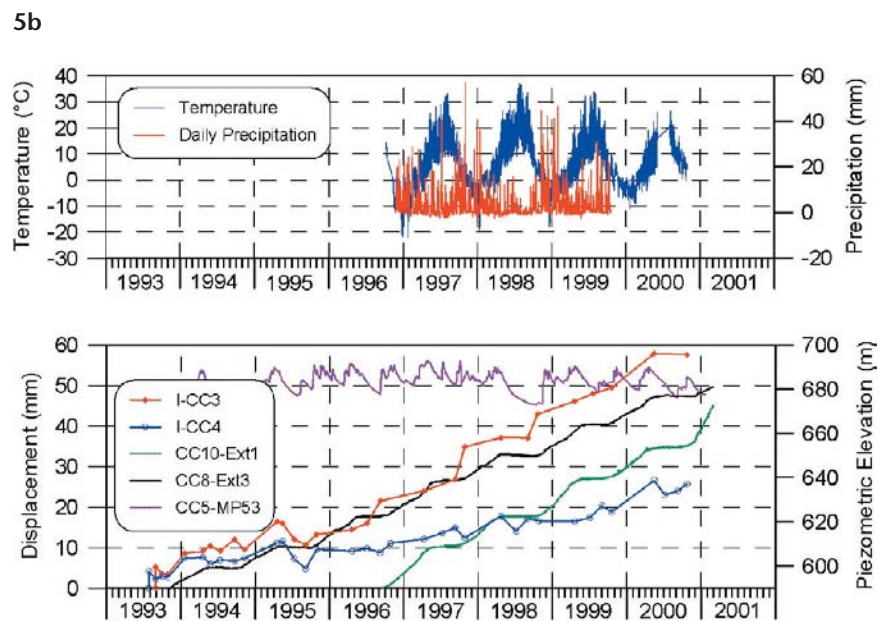
FIGURE 5 (a) Plot of slope displacement and piezometric pressure for the period 1993–2002. (b) Plot of slope displacement, piezometric pressure, and precipitation, illustrating the relationship between piezometric fluctuations and slope displacement.

Piezometric monitoring has indicated that continuously saturated conditions exist 50–80 m below the slope surface (Figures 3 and 5), which is below the base of the active slope displacement zone. Seasonal piezometric variations of ≤ 20 m occur, are greatest towards the top of the continuously saturated rock mass, and progressively diminish with depth below the slope surface.

- Average annual displacements are 5–15 mm, occurring exclusively during an “active” phase from October to April of each year. Between May and September of each year, essentially no displacement has been recorded to date (Figure 5a).
- Subsurface thermistors have recorded insignificant temperature fluctuations in the rock mass. Assessment of thermistor and surface climatic information has indicated that slope displacement is not explained by temperature effects alone.
