Re: Existing Glulam Bridges

**PROCEDURES FOR INSPECTION
AND EVALUATION OF
GLUED-LAMINATED BRIDGES,
MINISTRY OF FORESTS**

**Prepared by: Vera Pronker, P.Eng.
Bridge Engineer
Engineering Section
Timber Harvesting Branch**

Date: November, 1993

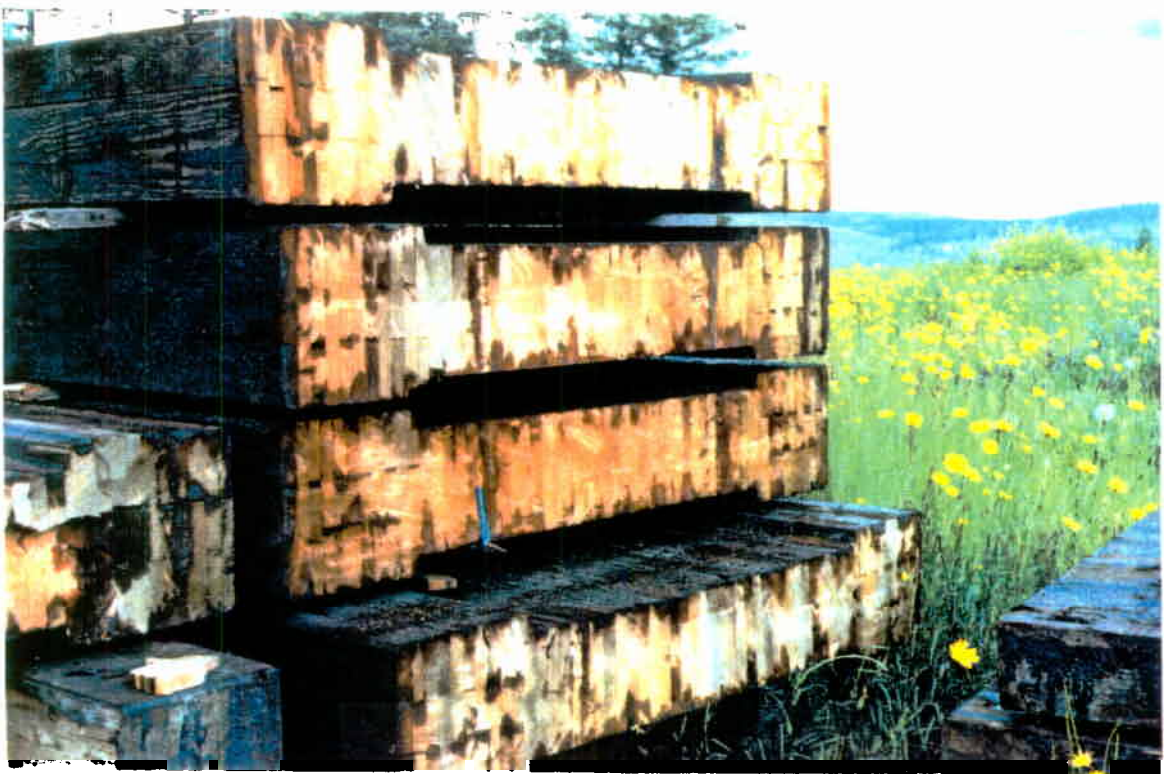
1.

Glued-laminated girders that were taken out of service, as a result of consultant's recommendations, due to observed cracks.

These girders are now stored in the service yard of Cariboo Forest Region.

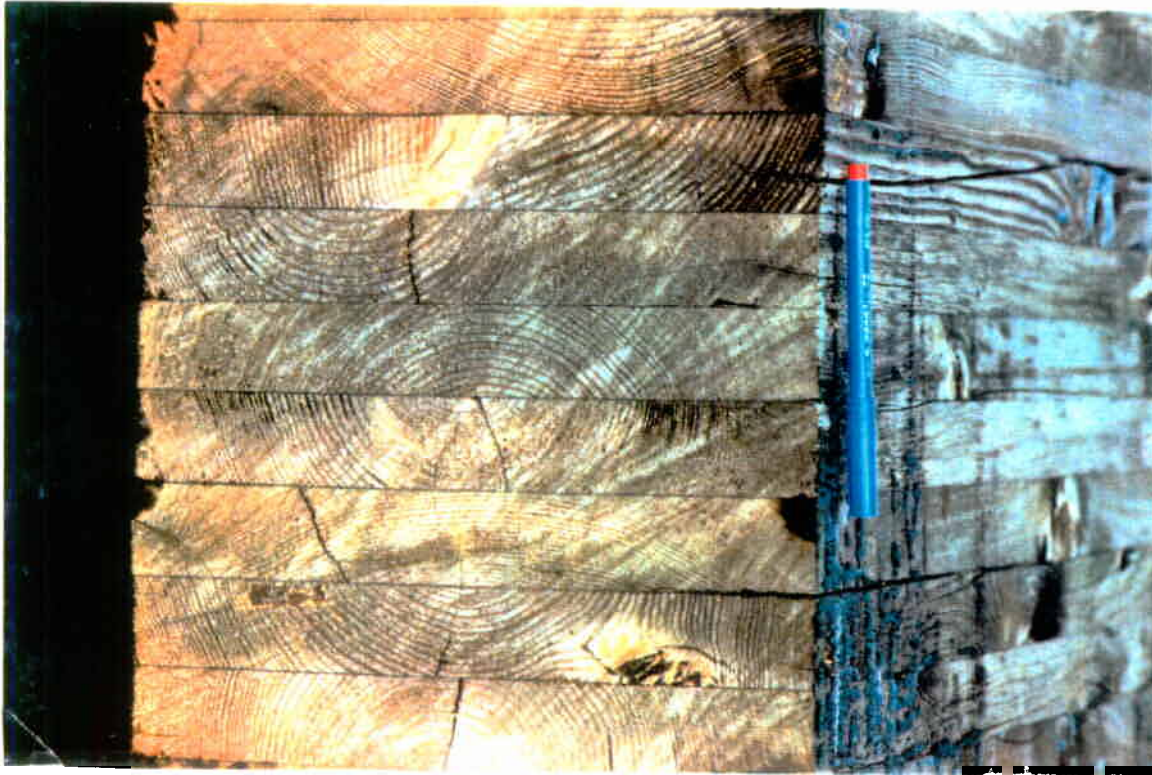
2.

The bridge girders were cut into 20.0 feet long segments for ease of transportation. It is interesting to observe the extent of the surface checking. These surface checks would certainly not reduce the capacity of the girder section !

(R. Foschi, report on Glulam Girder Bridges, 1992: "Structures with full through cracks with length over half the depth should be considered suspect. However, these cracks should not be confused with surface checks or cracks. Coring should be used to probe the depth of existing cracks.")

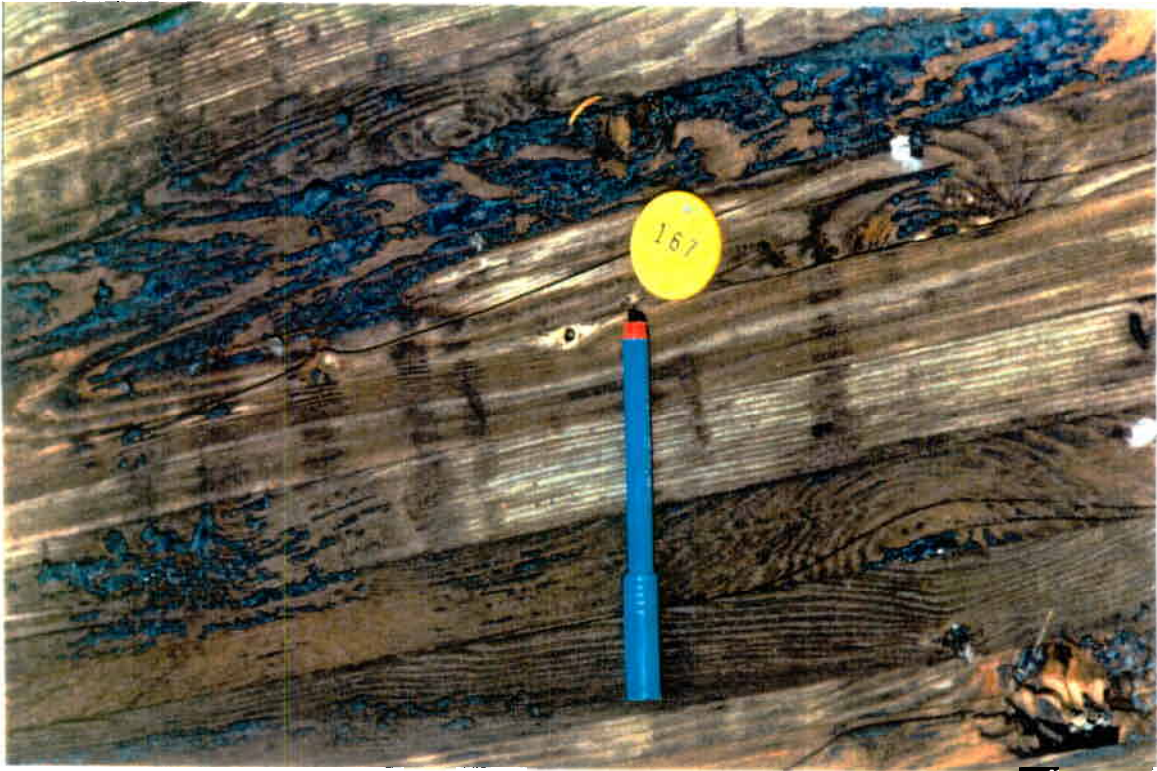
3.
Cracks were marked by tags by the inspector,
in order to observe their possible
propagation with time.
