Forest Sciences

Prince Rupert Forest Region

Extension Note # 04

The Mink Creek Earthflow

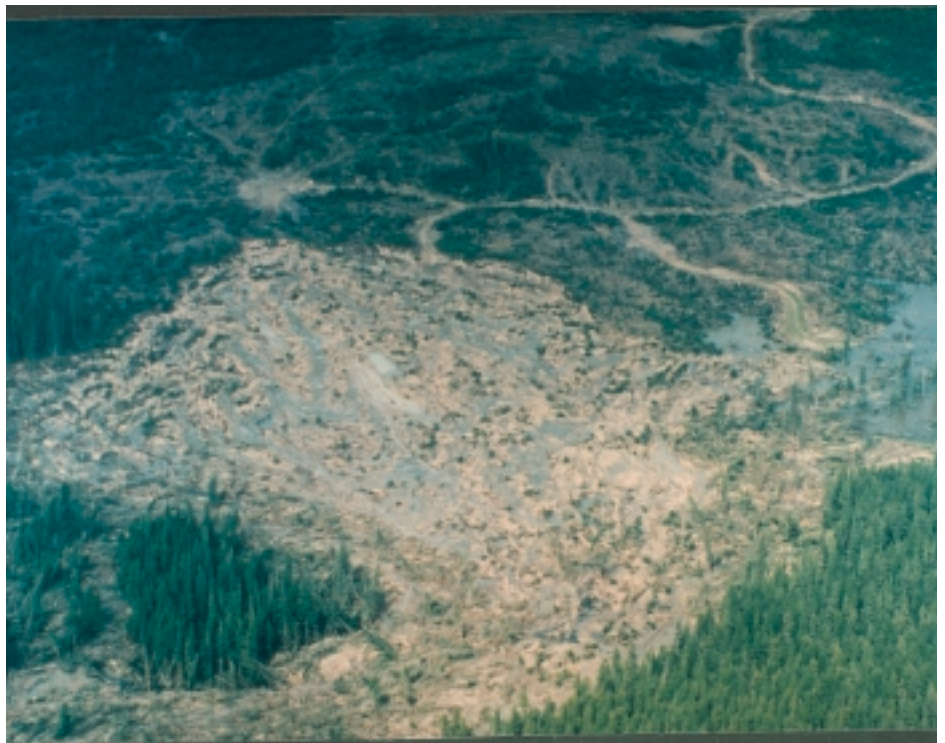
Figure 1. The Mink Creek earthflow retrogressed about 600 meters.

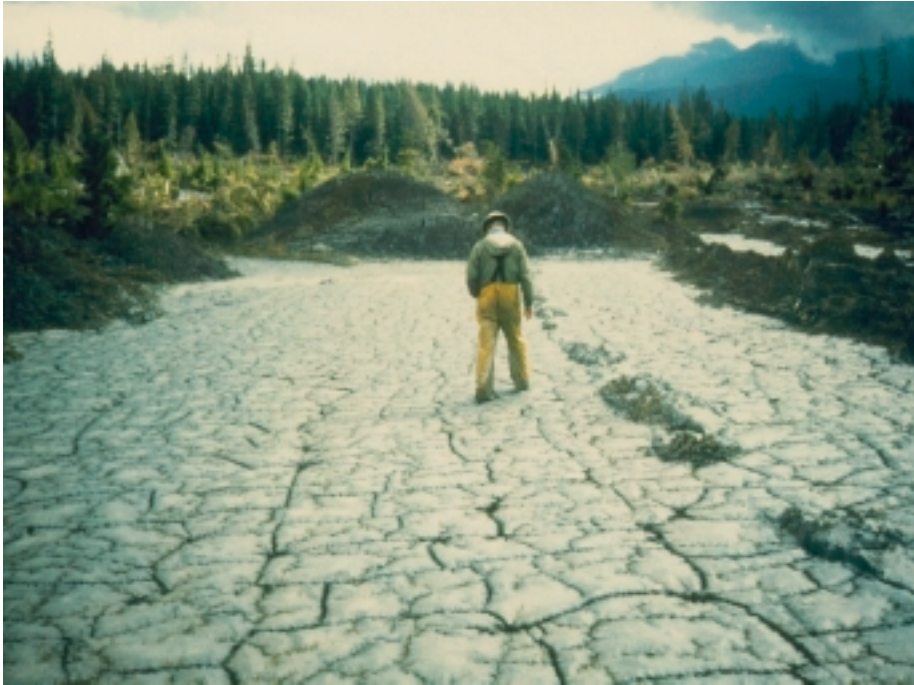
Figure 2. Exposed failure plane in centre of flowbowl. Spoil lineation in the centre of photo parallels the direction of flow.

There are two distinctive areas in the main flowbowl. The eastern section of the failure contains a relatively small amount of landslide debris. Extensive areas in its center reveal an exposed failure plane (Figure 2). Where the failure plane is exposed, bedding dips down-flow at about 3°. Debris sliding along a dipping slip-surface travels more rapidly than debris on a horizontal slip-surface. Lineations of spoil on a clean surface, trending parallel to the flow direction, are possibly indicators of rapid, high energy debris transport. These features may be the result of flakesliding (where a large mass of material slides simultaneously rather than retrogressively). Ridges and intervening wedges, indicating retrogressive failure, are more common in the western part of the failure (Figure 3). Generally ridges trend perpendicular to flow direction.

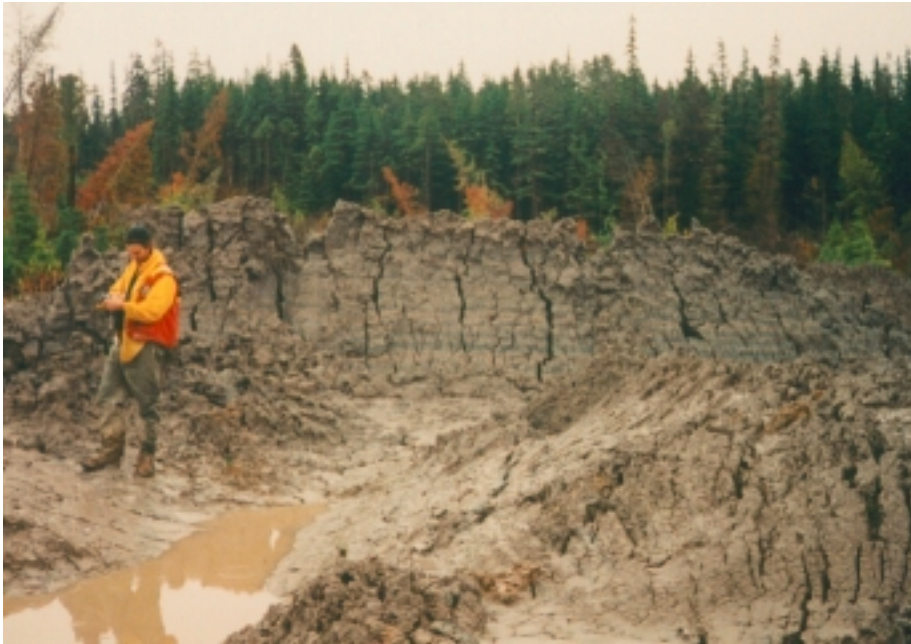
Figure 3. Ridge with horizontal bedding slid towards trees along a slightly dipping failure plane.

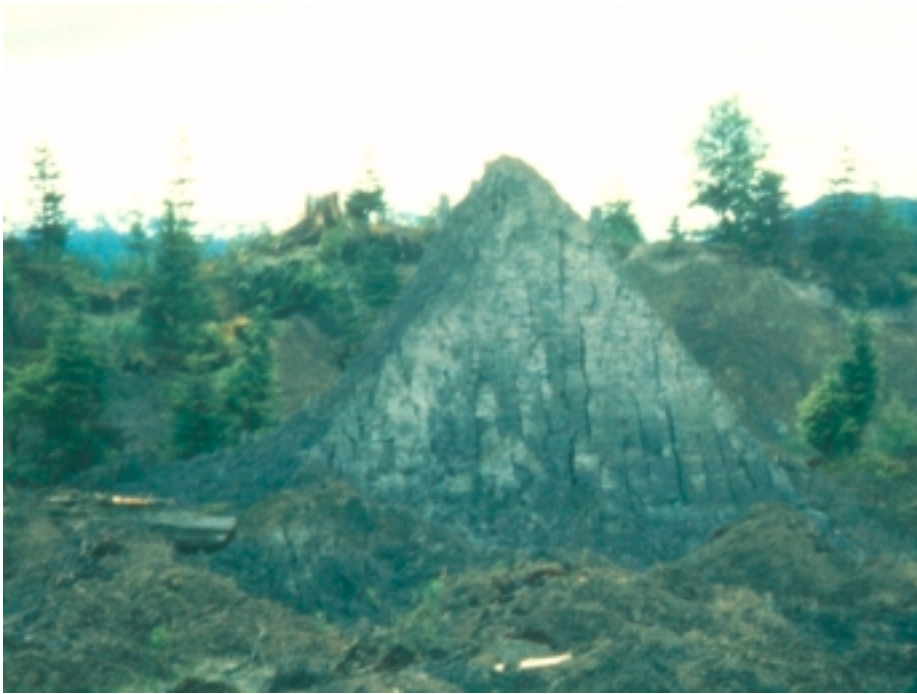
The flowbowl contains numerous ridges, and remarkable pyramidal structures (Figure 4) - portions of ridges - that have slid along a failure plane. Bedding in these structures is horizontal, or nearly so, indicating there was no rotational failure. Between ridges, intervening wedges of debris collapsed under their own weight. In some cases wedge material rotated off ridge flanks.

Figure 4. Remarkable, horizontally banded prism slid along a nearly level, to slightly dipping, failure plane. Prism is approx. 4.5 m high.
