**SNOWY RIVER RESOURCES LTD.**

November 3, 2003

Re: Whipsaw Creek streambank restoration works.

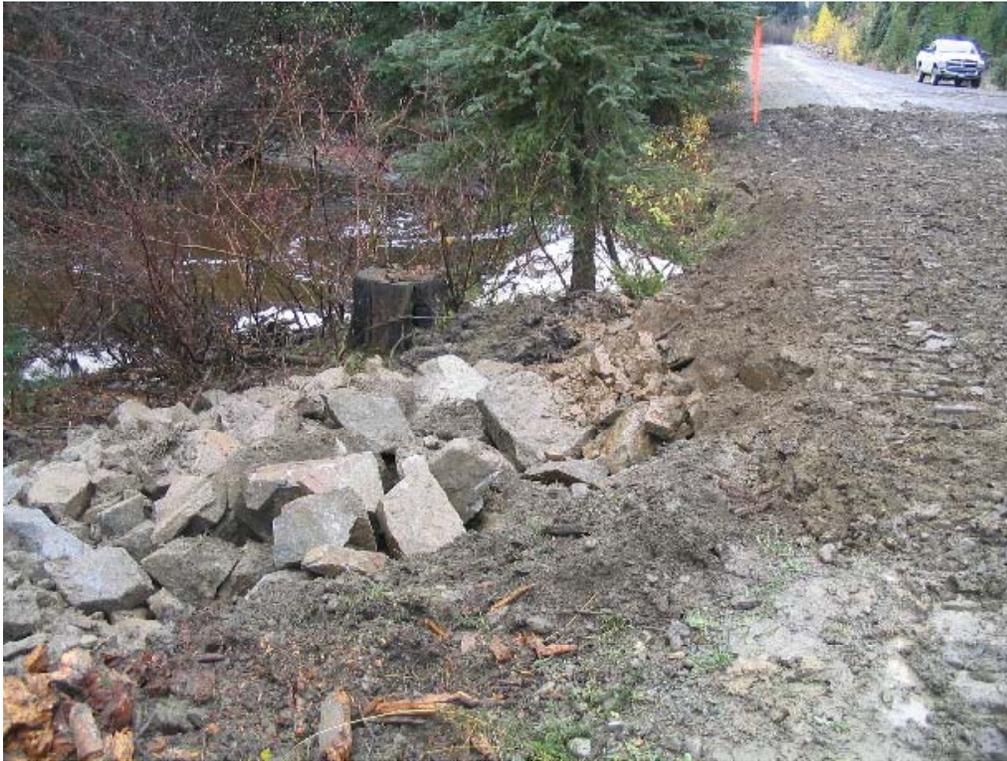
**SITE 1: 13.1 KM WHIPSAW FSR**

Photo #1 shows an upstream view of the rock installation after it has been installed and graded to the road surface level.

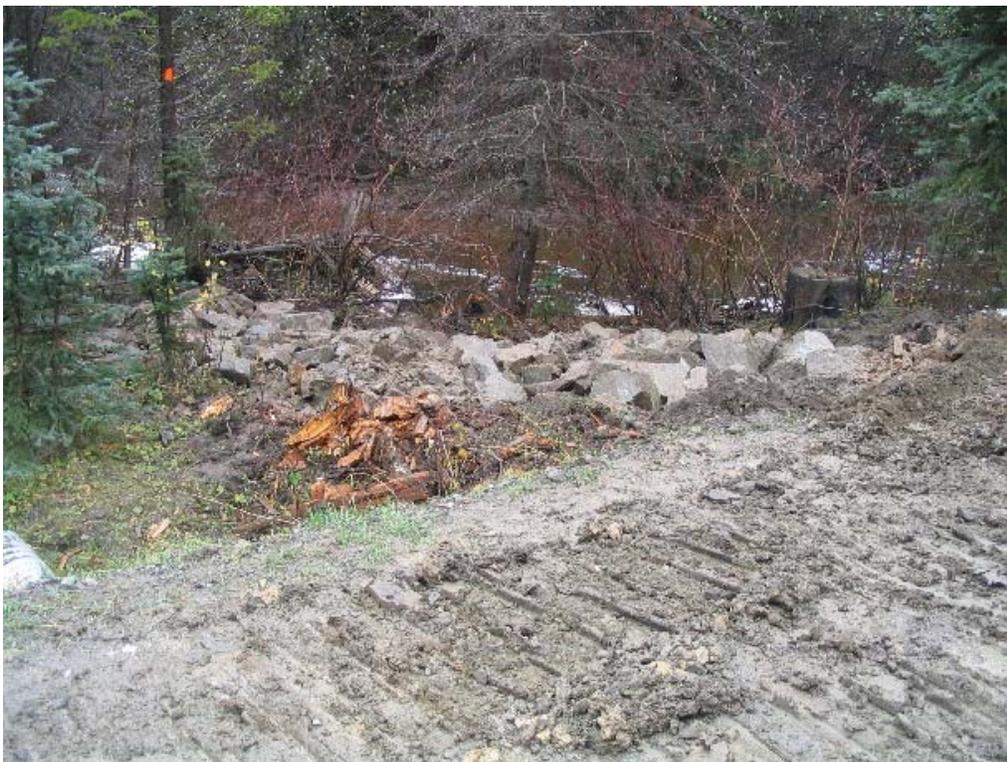
Photo #2 shows a view of the built up berm to prevent further erosion and washout over the bank.

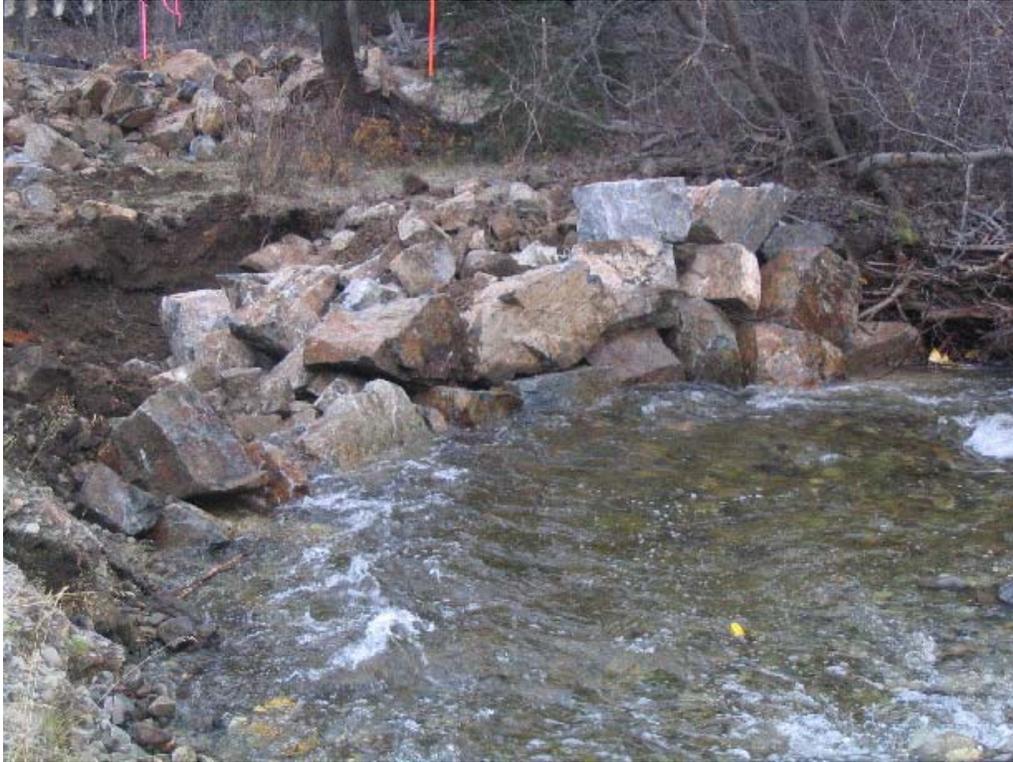
**Site 2: 13.2 km Whipsaw FSR**

Photo #3 shows the rock bank installation of the critical corner of site #2. This bank was eroding rapidly just prior to installation due to significant rainfall throughout the previous week.

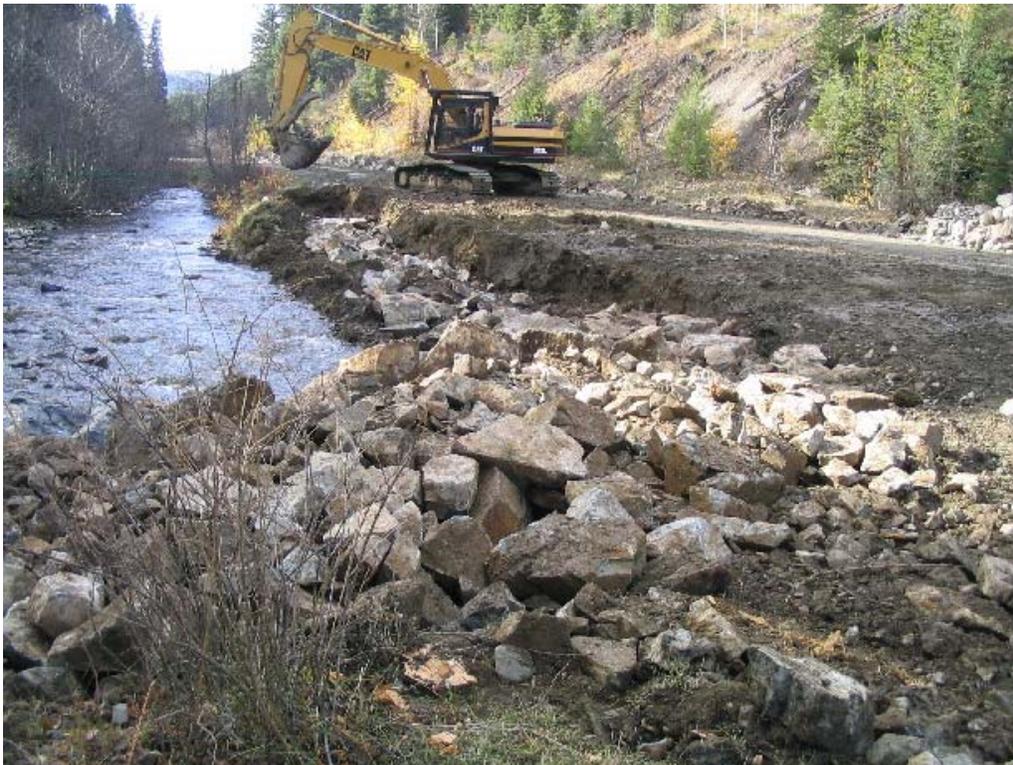
Photo #4 is an upstream view of bank installation showing the first level of rock being installed. The critical bank in the foreground has been built up slightly above road level and was covered with earth to allow for plants to establish growth.

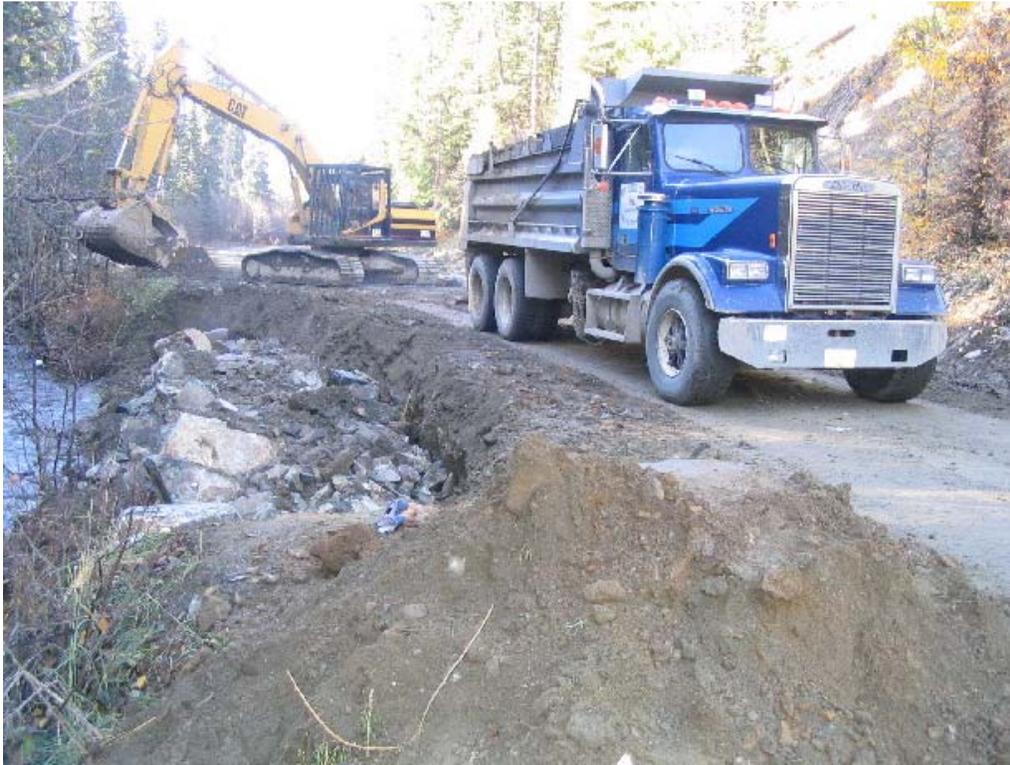
**SITE 3: KM 13.3 WHIPSAW FSR**

Photo #5 is an upstream view showing excavation in progress. It is a good visual indication of how far the bank was reinforced beneath the driven road surface.

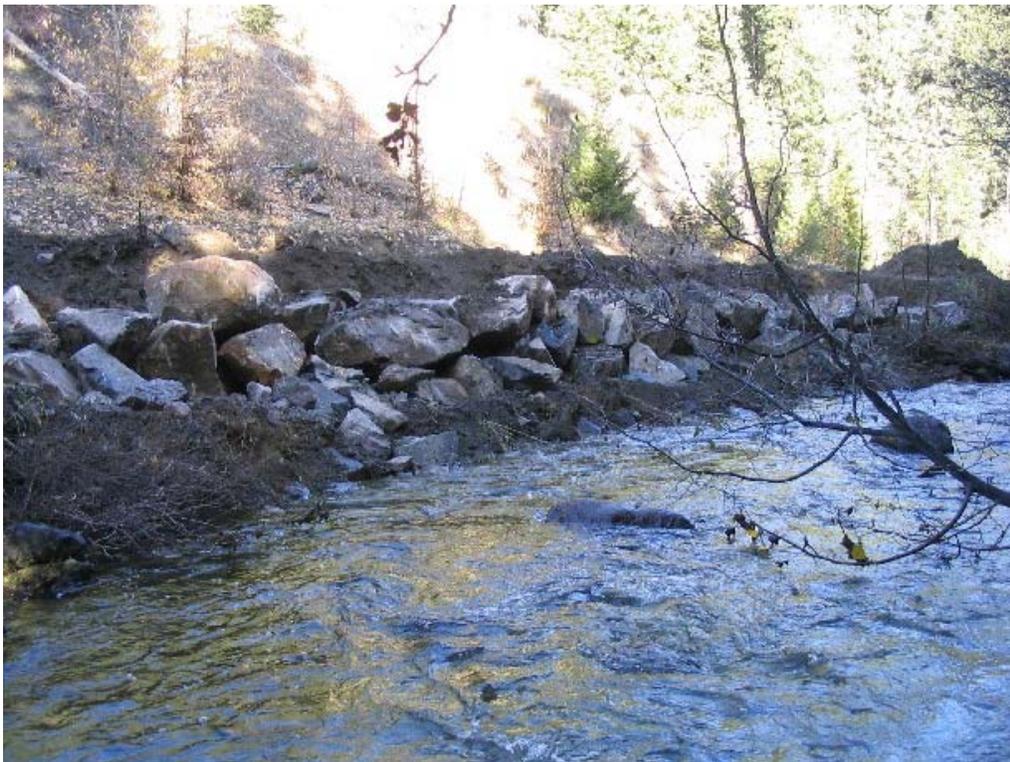
Photo #6 is a cross view showing the height of the first layer of boulder/rock installed.

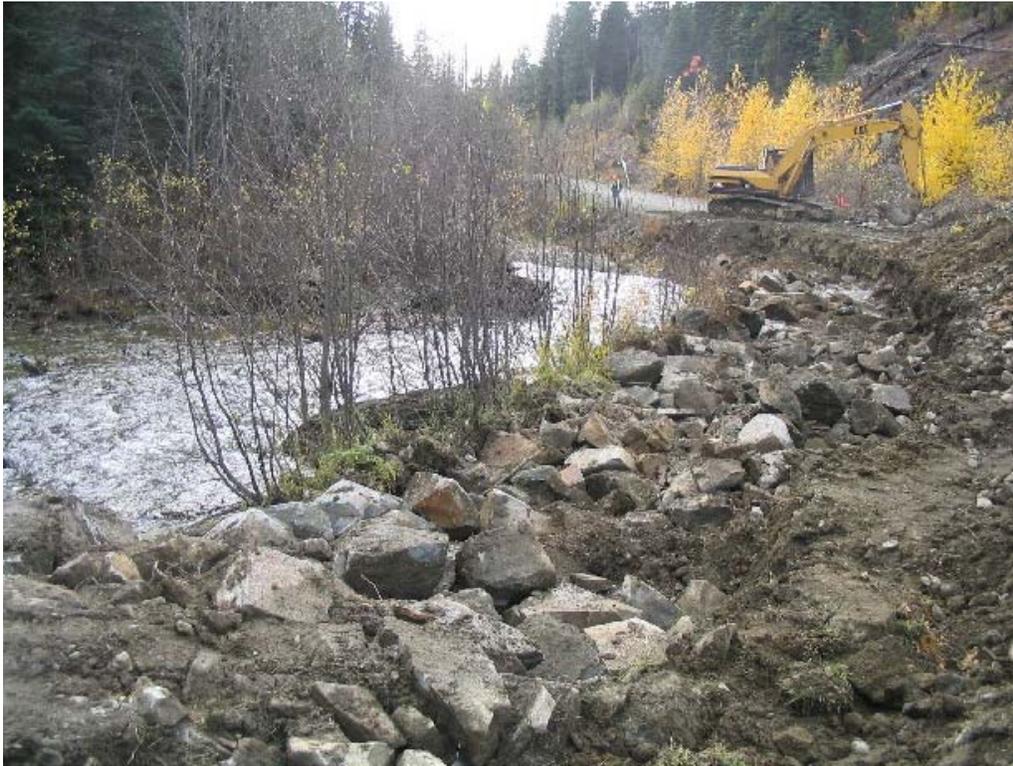
**SITE 4: KM 14 WHIPSAW FSR**

Photo #7 is an upstream view with the first layer of rock installed.

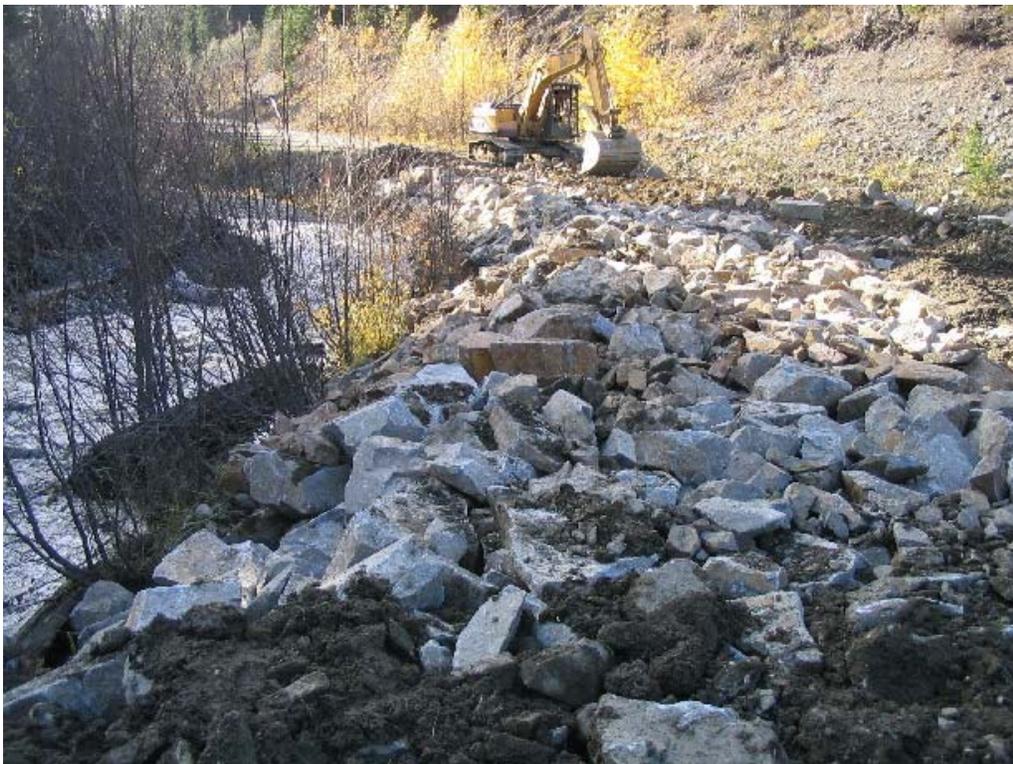
Photo #8 shows the final steps of bank installation. The area was then covered with soil to aid in plant growth.

Woody shrubs were kept along the streambank to allow their root systems to continue functioning as fish habitat.
