## **Project Completion Abstract Machmell River Intake**

The objective of this project was to re-establish flow along the right bank of the Machmell River to the Xausmdas channel by way of an intake. This channel had become isolated from the river as a result of logs and sediment being deposited in close proximity to the intake due to a previous storm event.

Machmell River

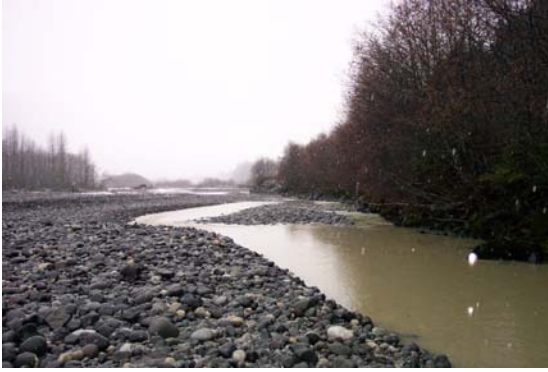
Photo 4  
Downstream view of completed channel

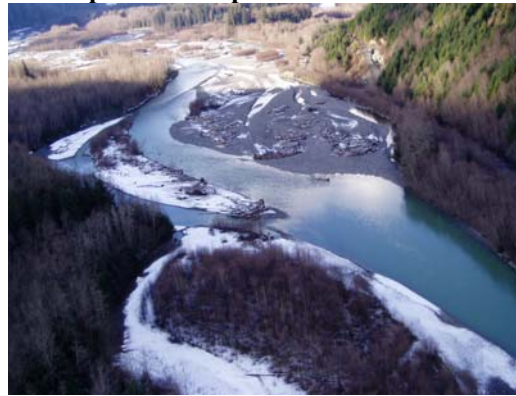
A recent storm event triggered extensive floodplain erosion along a stretch of the Machmell River upstream of the intake for the Xausmdas Channel. Damage to the floodplain resulted in large quantities of wood and sediment being introduced into the river causing a reduction in flow along the right bank. The impact to the Xausmdas channel was the isolation of the intake from the main channel with ground water supplying only 45L/s of flow at the intake. It is anticipated that this flow will decrease as the main channel recedes in coming winter months. Sockeye salmon were observed in the isolated ponds along the right bank where spawning had recently occurred. The drying up of the wetted areas along the right bank could affect the survival of salmon eggs in the main stem and Xausmdas Channel

**Photo 1**  
Down stream view of debris and sediment that has temporarily reduced flows along the right bank.

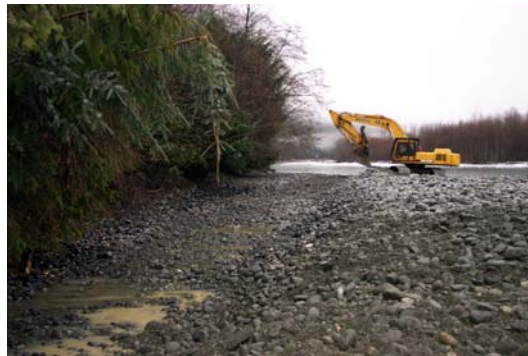
**Photo 2**  
Construction of connection channel

On November 22, 2003 under the supervision of Alma Van't Schip, an EX300 excavator, proceeded to execute the prescription developed by Bruce Walsh. The excavator entered the Machmell River gravel bar from the Machmell Mainline using a log to minimize impact to the river bed. A short connection channel was excavated 3 m wide for a distance of 40 m. The depth of the channel is 1 m at the down stream end to 0.5 m at the upstream end. The excavated material was spread thinly over the left gravel bar. The completed works will augment ground water flows at the intake and increase salmon egg survival along the right bank and in the Xausdas Channel.

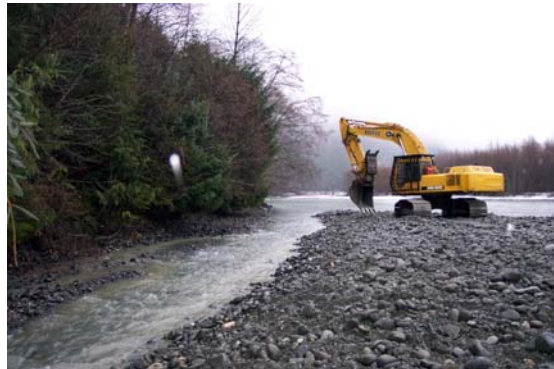
**Photo 3**  
Upstream view of completed channel
