## Project Completion Abstract for Fish Passage Restoration Projects (engineering activities)

### [3000 Road, Site13/1722, Fulton River Watershed, Northern Interior Forest Region]

FIA Investment Schedule Number: NOTSA 032502  
Project Number: 2502001  
Contract Number: 06-FIA-06  
Fiscal Year: 2006/2007

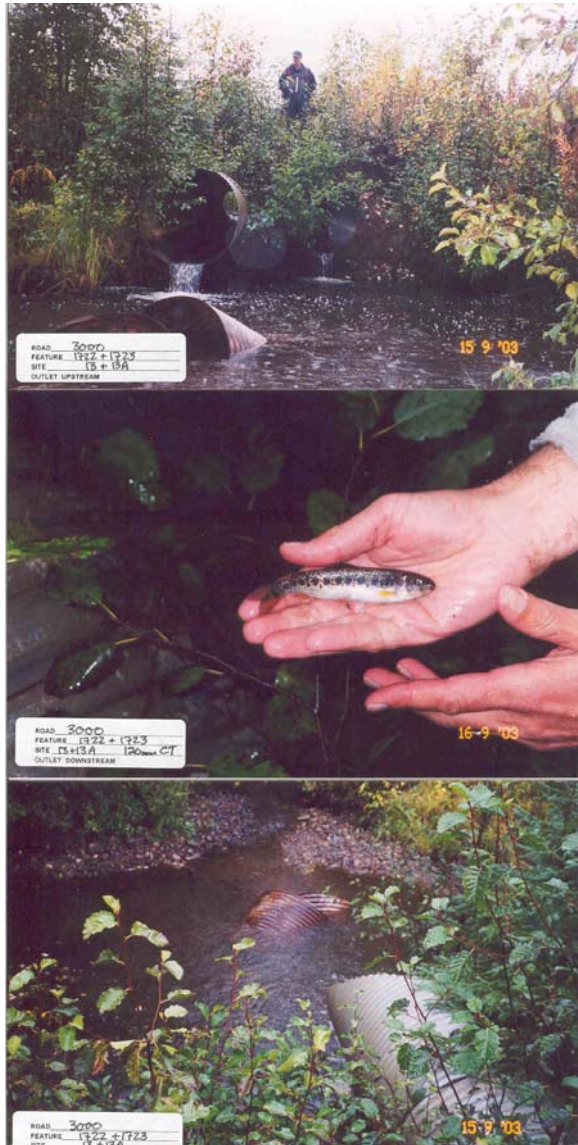
Fish Passage Culvert Inspection – Sept. 15/03  
Barriers – Partial; Culvert slope (4.4%) and culvert water velocity (1.2m/s) are barriers to juvenile fish passage upstream  
Priority rank score – 41 (H)  
Fish Species (CT) – 6 Habitat Value (H) – 9  
Barrier (Partial) – 7 Habitat (>1km) – 9  
% Stream Barred (>70%) – 10  
Upstream Barriers (Yes) – 0

**Photo 1.** 3000 Road-Site 13/1722 culvert outlet conditions. 35cm outfall drop on both culverts.

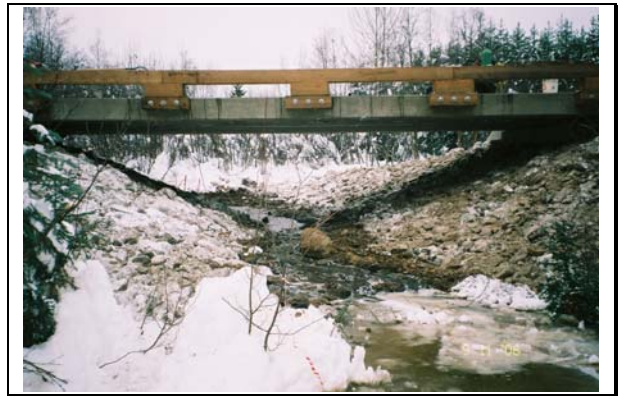
**Photo 2.** 3000 Road-Site 13/1722, u/s view of reconstructed stream channel (Nov.9/06).

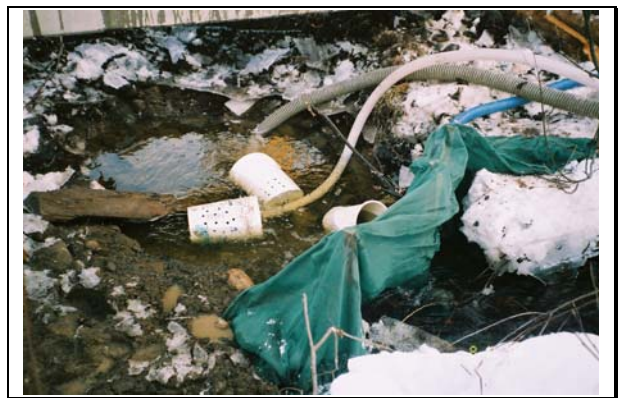
**Photo 3.** 3000 Road-Site 13/1722, Sumphole at u/s end of in-stream work site.
