**Forintek
Canada
Corp.**

**Improved Processing Efficiency of Post Mountain Pine Beetle
Wood, Part II**

March 2007

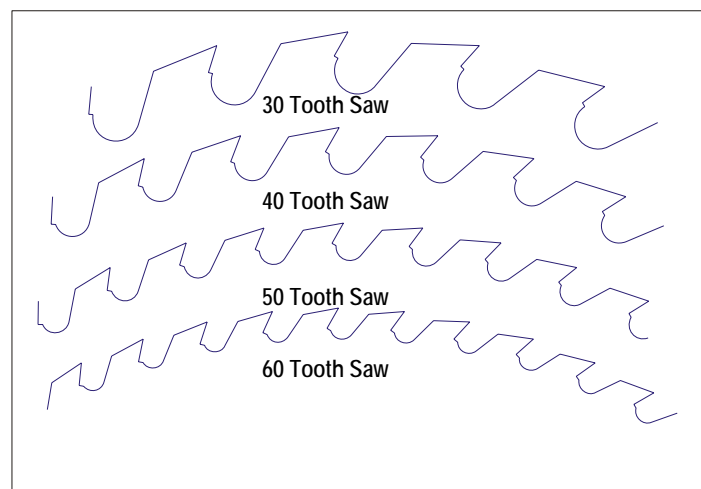
Figure 3.1 *Tooth profiles for the saws*

The codes used in the report, 301, 402,....302, 402,refer to the number of teeth and the set of saws. For example 402 refers to the 40 toothed saw from set #2.

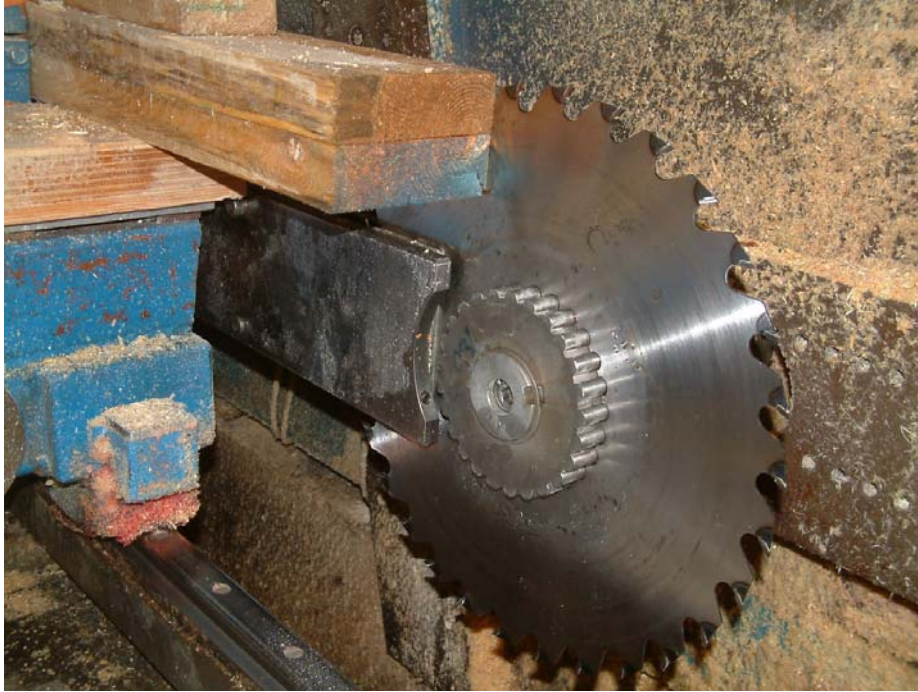
Photo 3.1 Details of guided saw and height of cant with respect to the saw

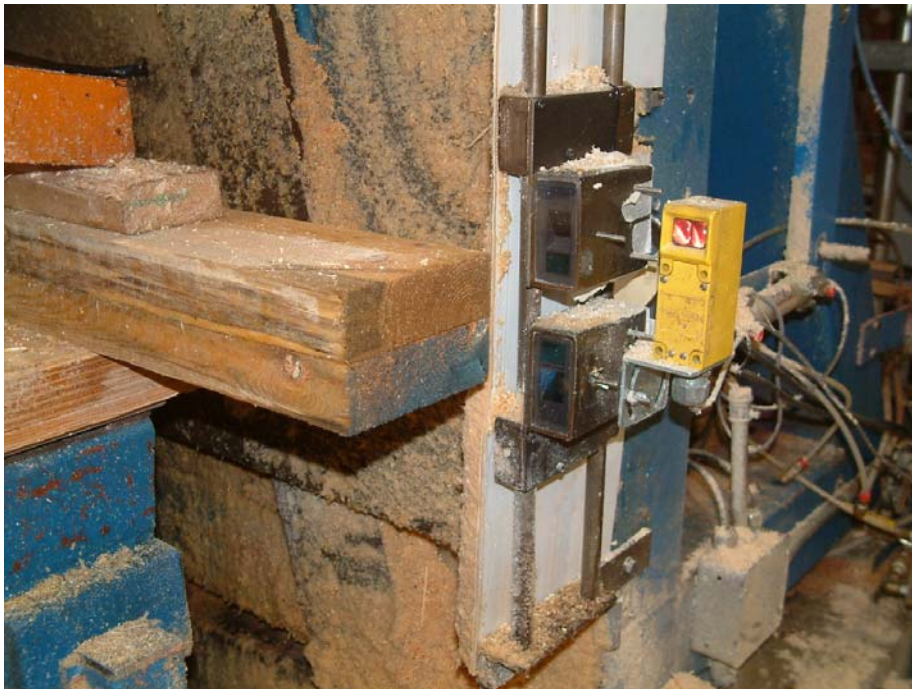
Photo 3.2 Laser probes used to measure surface deviation on cut board

The testing procedure involved making cuts in 10ft long cants, made up from two rough green 2"x 8" boards, and then measuring the cut surface of the wood. Sixteen cuts were used to determine the cutting accuracy for each sawing condition. The overall depth of cut was 3.4", this was considered a good approximation of a single arbor machine cutting 4" lumber and a double arbor machine cutting 6" lumber. These two dimensions are by far the predominant products produced in the BC interior. The cant height was such that the saw remained completely buried during the cut. In this way, the conditions of the lead saw in a double arbor machine were duplicated. Photo 3.1 show details of the saw and the positional relationship between the 2 board cants and the saw. Photo 3.2 shows the two laser probes used to measure the cut surface.

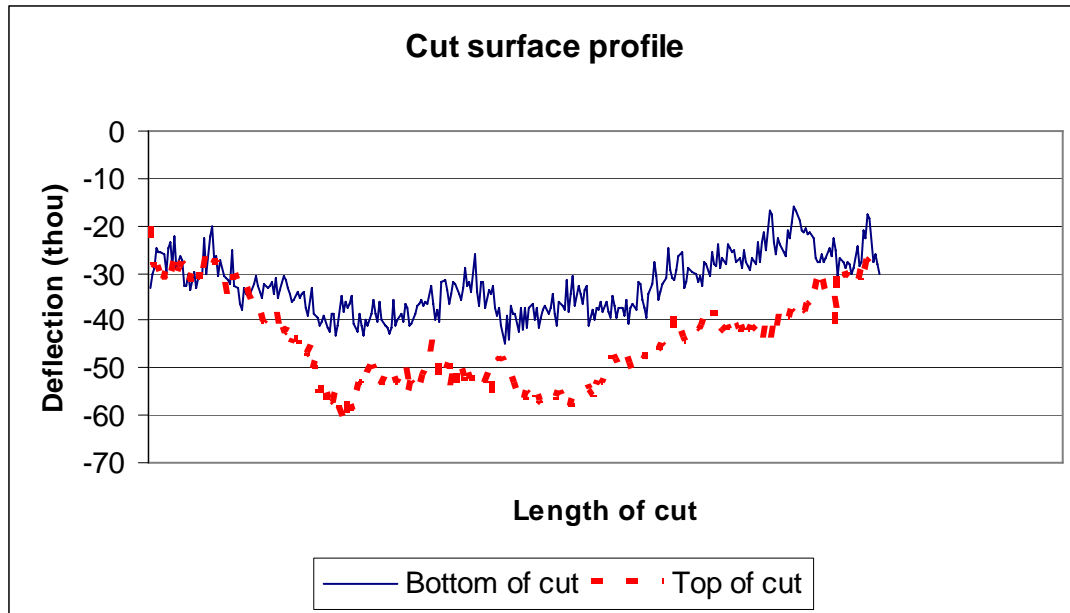
Figure 3.2 shows a typical plot of the output from the laser probes from which the sawing accuracy was determined. A negative deflection indicates the blade is leaning away from the cant. The standard deviations of the profiles, measured at the top and bottom of each board, were calculated and recorded. The mean value of the difference between the top and bottom probes was also recorded; this gives an indication of the wedging (the amount the saw leans over) that is occurring.

Figure 3.2 Laser plots of cut profiles at top and bottom of cant

As in Section 3 (Figure 3.2), traces of the surface profile of the cut face at the top and bottom of the cant were used to determine the standard deviation of the cut as well as the mean value of the difference between the two traces. The mean difference of the two traces provides a measure of the “wedging” that occurs due to the blade leaning over in the cut.

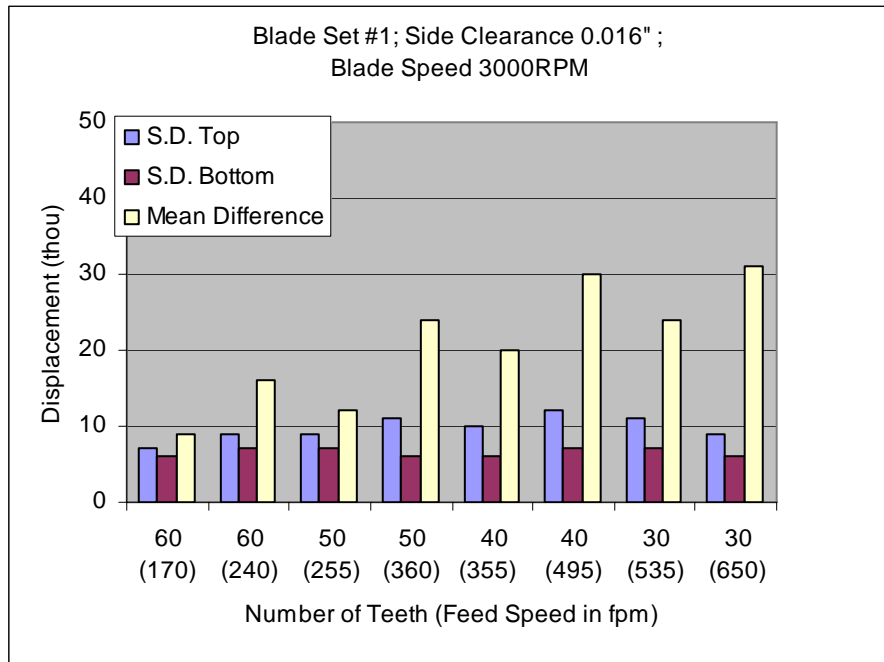
Figure 3.3 presents a comparison of the standard deviation (SD) of the top and bottom traces, as well as the mean value of the difference between the top and bottom records, for the four different pitched blades in set #1. In this figure the listed feed speeds correspond to gullet feed indexes (GFI) of 0.5 and 0.7. Figure 3.4 presents the same data for blade Set #2. As may be seen the data trends are similar in both plots.

These results indicate that increasing the GFI generally increases the saw deviation. The exception was the deviation measured at the bottom of the cant, nearest to the guides, which remained relatively constant.

Figure 3.3 Effect of feed speed and number of teeth on cutting accuracy (blade Set #1)

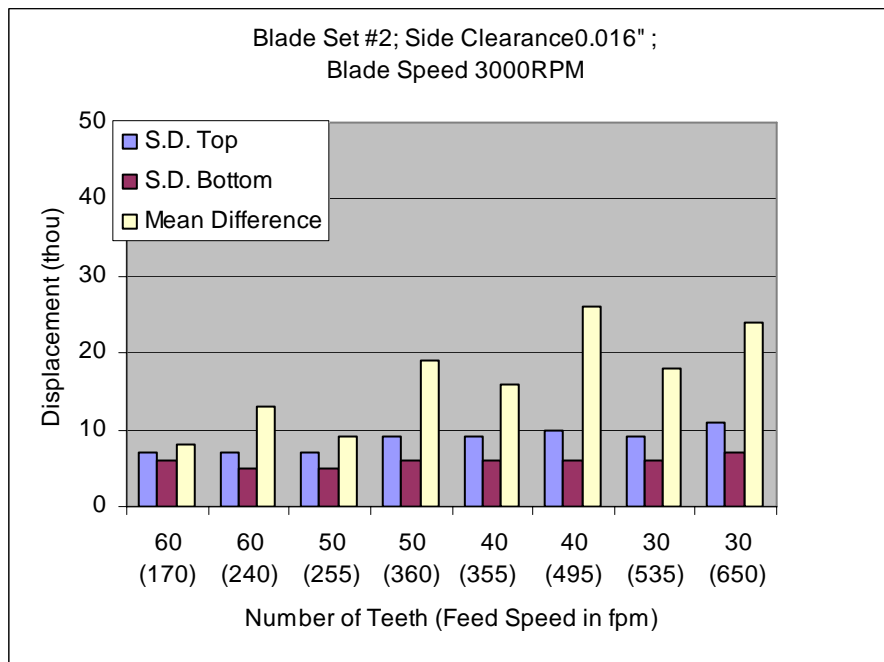
Figure 3.4 Effect of feed speed and number of teeth on cutting accuracy (blade Set #2)

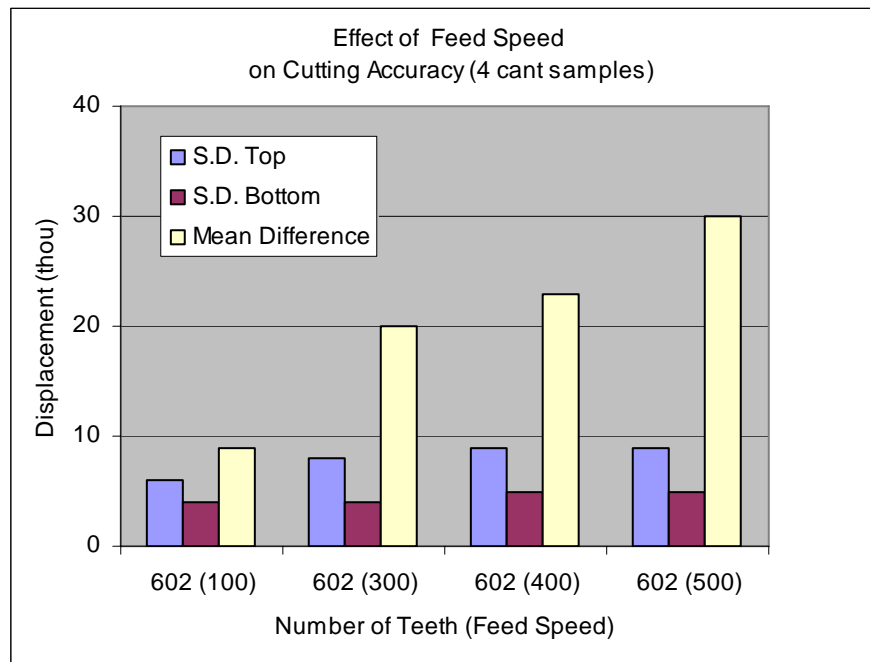
Figure 3.5 presents the results of running a 60 tooth saw at different feed speeds, up to a maximum of 500 fpm. In these tests only four board samples were used. The tests were designed to see how the 60 tooth saw responded to over feeding of the gullet. The results indicated that it was reasonable to conduct further testing of the 60 tooth saw at such high feed speeds. The GFI's were 0.42, 1.25, 1.67 and 2.08 for the four increasing feed speeds shown. As would be expected the wedging and the standard deviation, measured at the top of the cant, increase with feed speed.

Figure 3.5 *Effect of feed speed on cutting accuracy of 60 tooth saw*

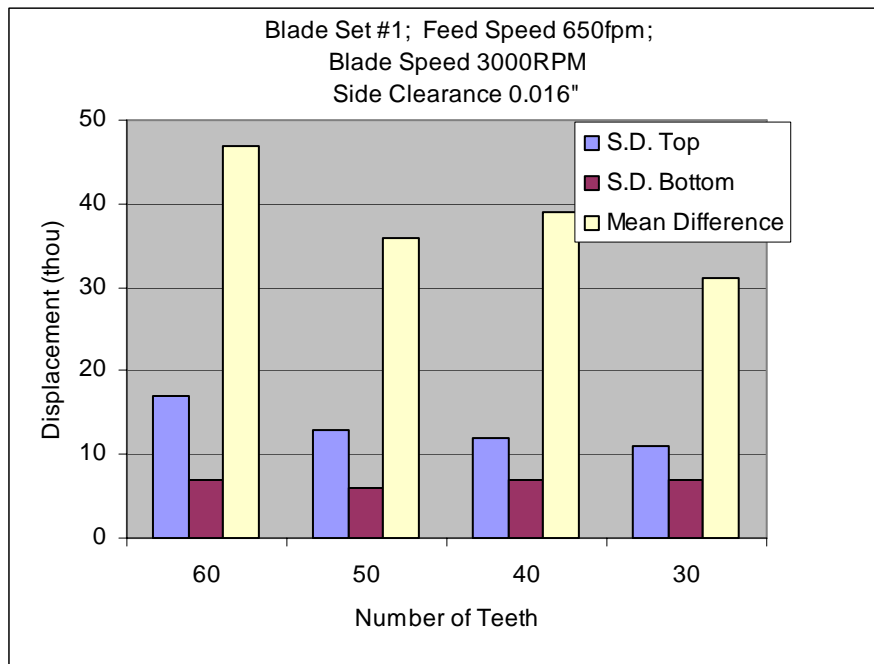
Figures 3.6 and 3.7 present a comparison of the results for the four saws in Set #1, for side clearance values of 0.016" and 0.005". Figures 3.8 and 3.9 present the same comparison of results for the four saws in Set #2. The blade speed was held constant at 3000 RPM and the feed speed was 650 FPM. The GFI's for this condition were 0.88, 1.36, 1.86 and 2.71 for the 30, 40, 50 and 60 tooth saws respectively.

Figure 3.6 Saw set #1 with slide clearance of 0.016"

These results indicate significant differences between the performances of saws with different numbers of teeth. In particular, the saws with 60 teeth perform significantly worse when the side clearance is reduced from 0.016" to 0.005" (when measuring the SD at the top of the cant). There is not a significant difference between the cutting accuracy of the 30 tooth saws when the side clearance is reduced.

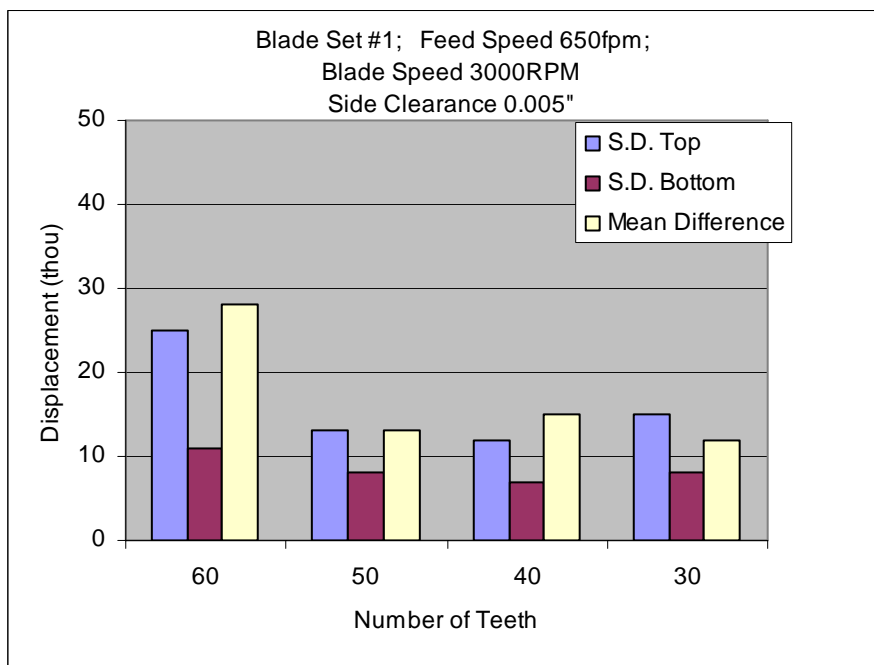
Figure 3.7 Saw set #1 with side clearance of 0.005"

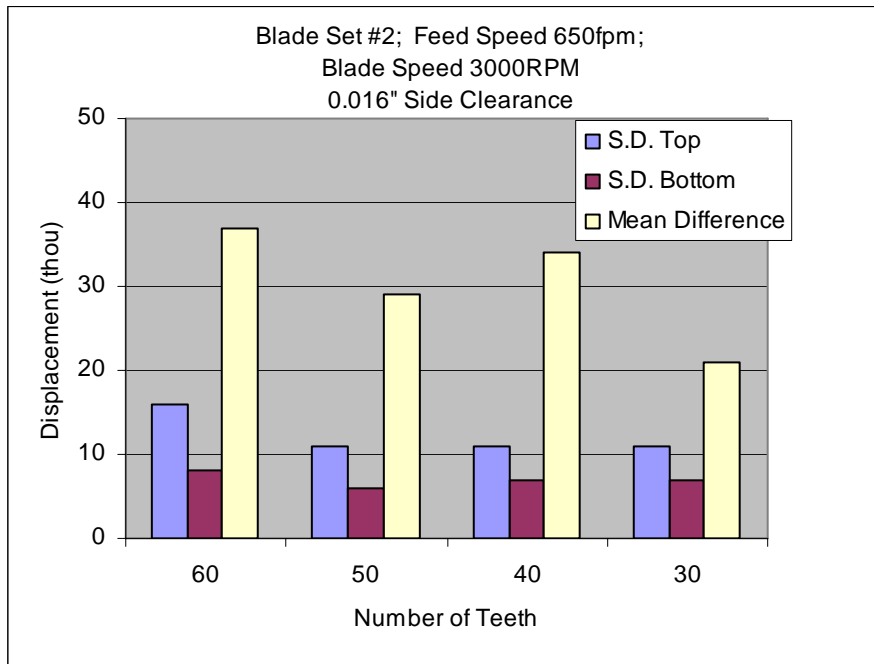
Figure 3.8 Saw set #2 with side clearance of 0.016"

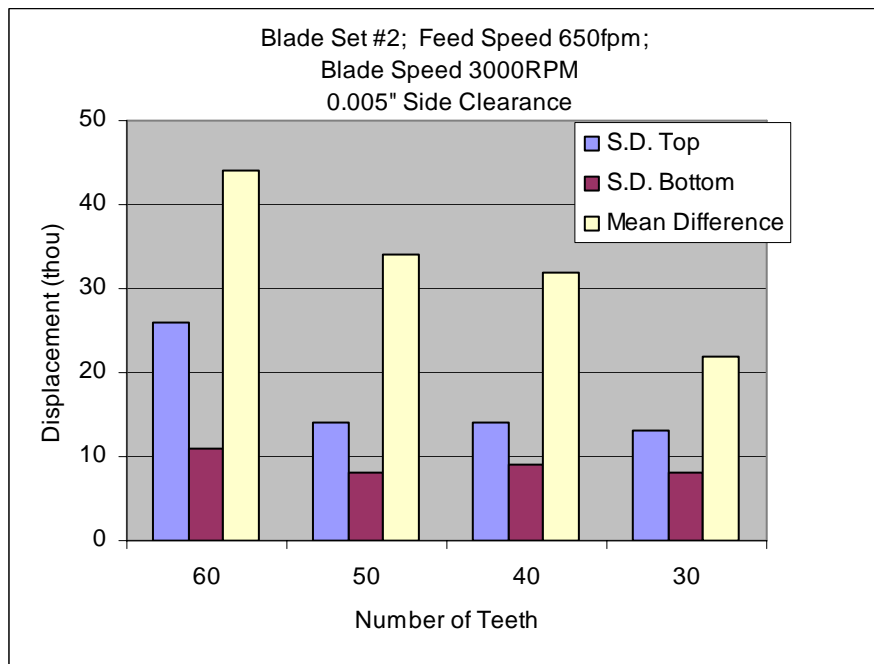
Figure 3.9 Saw set #2 with side clearance of 0.005"

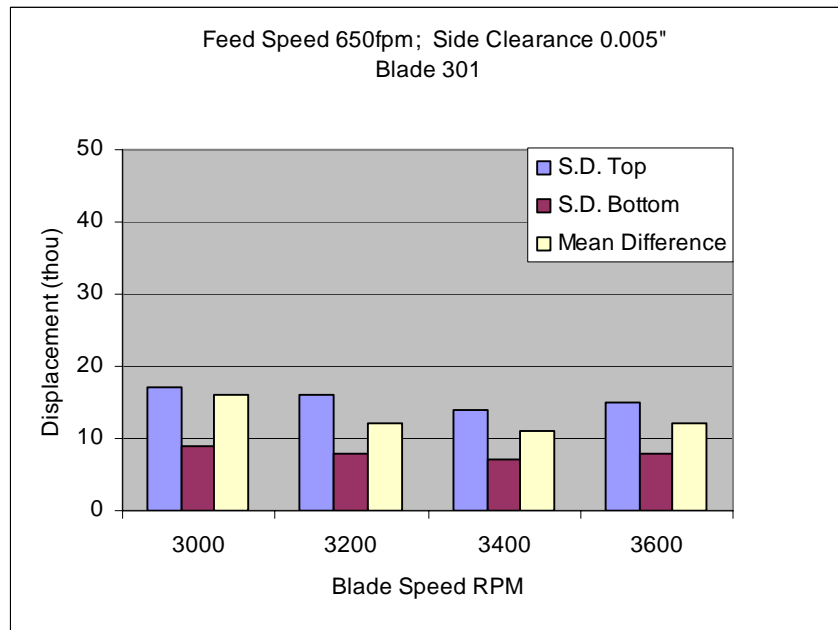
Figures 3.10 and 3.11 show the results of changing the blade speed while keeping the other parameters constant. As may be noted, blade 301 has better cutting accuracy at all blade speeds but, in the case of both saws, the cutting accuracy is essentially constant, with some slight tendency to improve as the speed increases. It may be noted that the first critical speed of this saw in the region of 3200 RPM.

Figure 3.10 Effect of blade speed on cutting accuracy blade 301

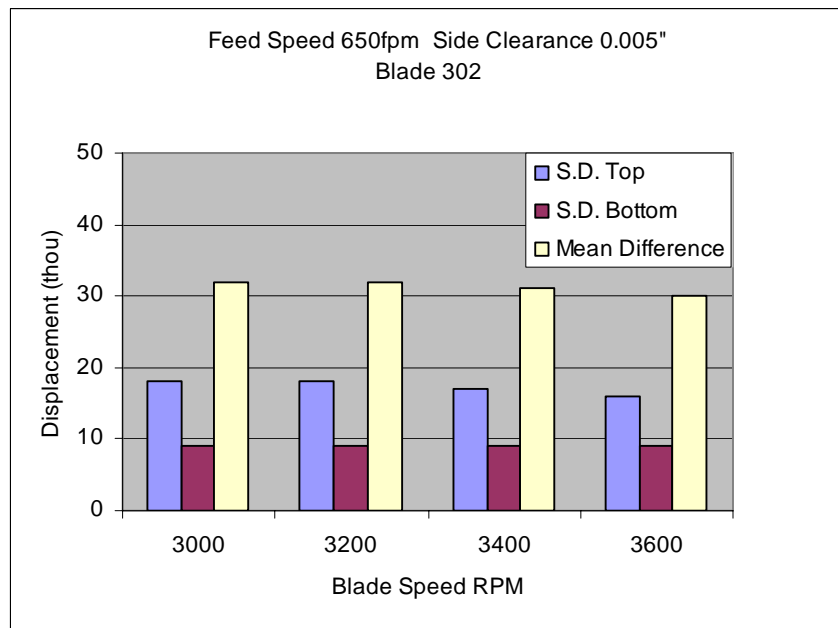
Figure 3.11 Effect of blade speed on cutting accuracy blade 302

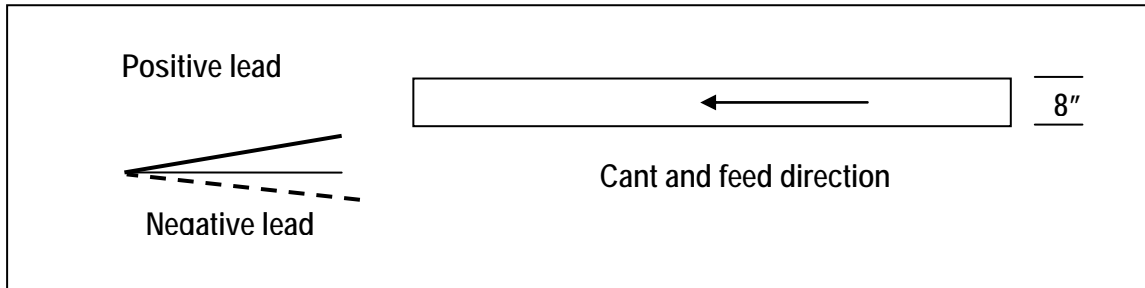
To emulate the effect of alignment errors in a feed system the saw guides were deliberately misaligned with respect to the direction of the feed. The amount of misalignment was measured over a 6" length of the guide pad. A positive value refers to the saw leading into the cant (Figure 4.1).

Figure 4.1 Plan view of saw misalignment

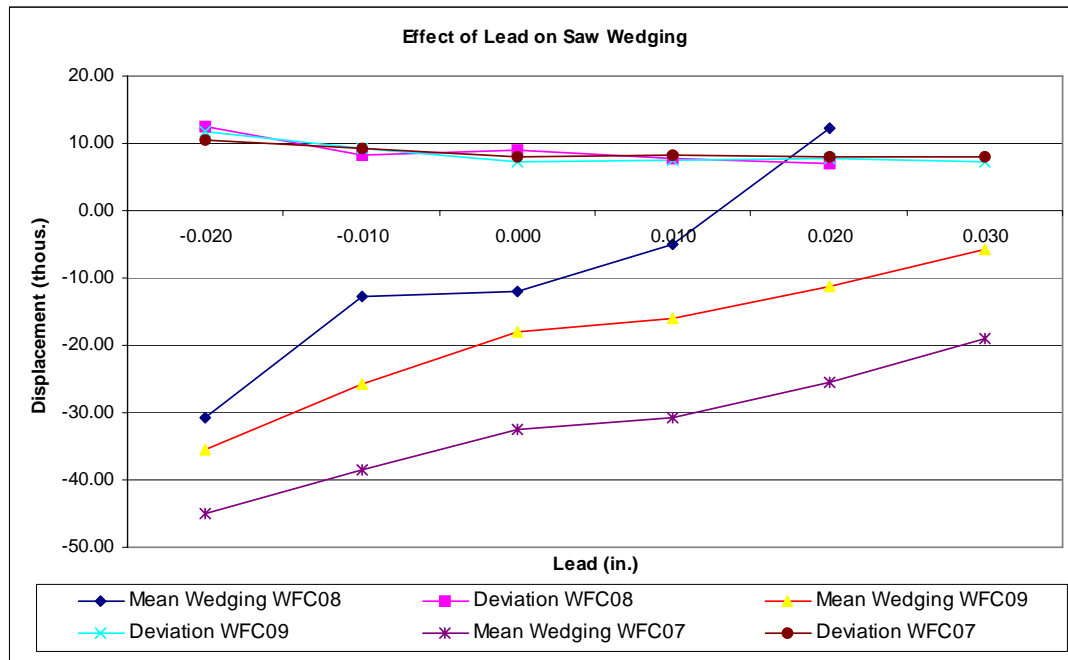
The effect of misalignment on the cutting behaviour of all three saws is shown in Figure 4.2. The three saws behave differently with respect to the lateral displacement, however, the shape of the traces are similar. This difference in behaviour between saws is very common and is the reason that three saws were used for these tests. Interestingly, the ‘standard deviation’ (upper traces) are relatively insensitive to saw lead. This is likely due to a stabilizing effect from the interaction between the saw and the wood. The non zero deflection for a perfectly aligned saw (zero lead) is thought due to the influence of the relatively narrow boards being cut from the cant. Previous work has shown that the cutting power reduces as the saw approaches the edge of the cant (Lubkin, 1957).

Figure 4.2 *Effect of saw lead on wedging*

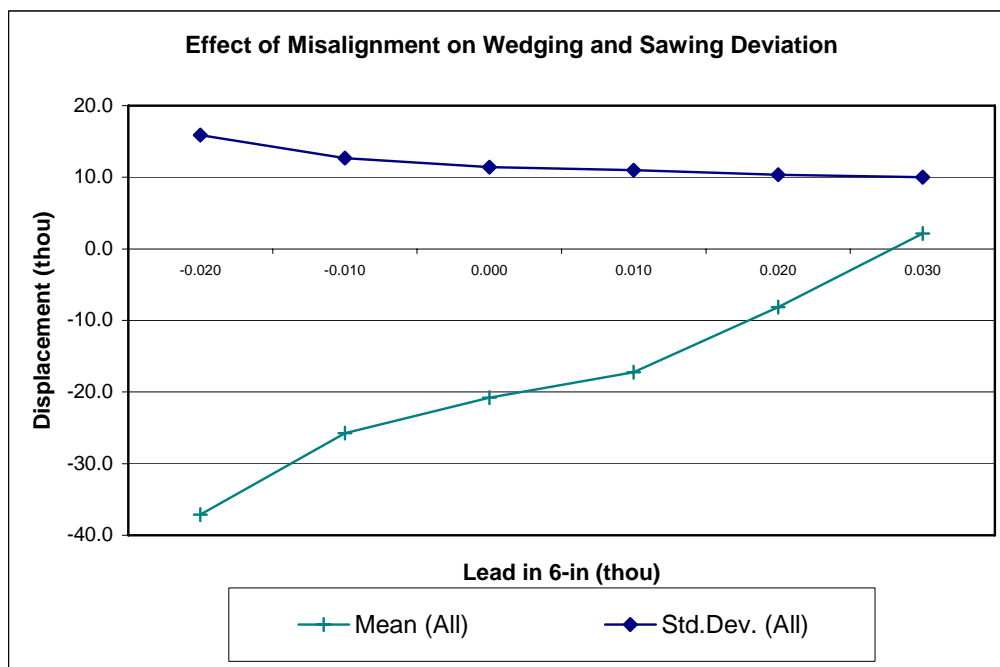
The results of the saw misalignment tests are summarized in Figure 4.3. The lower trace is the average wedging for all three saws. The upper trace is the average standard deviation of the bottom and top of the cut. The slope of the wedging with respect to misalignment (lead), is 0.43 in the +/- 0.010" range, increasing to just below 1 outside this range.

Figure 4.3 *Effect of misalignment on wedging and sawing deviation*

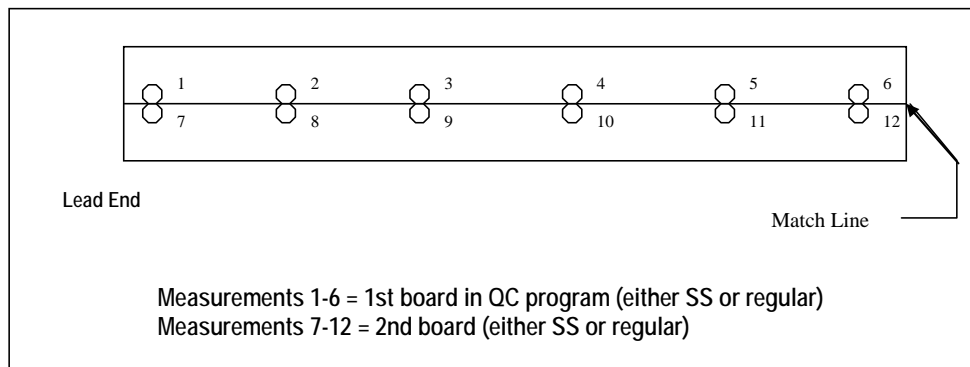
To determine the cutting accuracy of both saw types board measurements were taken either side of the match line (Figure 5.1). This gives a closer representation of the actual saw performance because the edge of the board nearest to the saw guides has very little sawing deviation and including this edge in the measurements gives an artificially low value. During the one month test period the sawmill Quality Control department took 1,692 measurements on the side sawn by the regular saws (282 boards) and 1,720 measurements for the side sawn by the stainless steel saws (285 boards). The results show that the Stainless saws had 6.3% lower total sawing deviation than the regular saws (see Table 5.1).

Figure 5.1 Location of board measurements

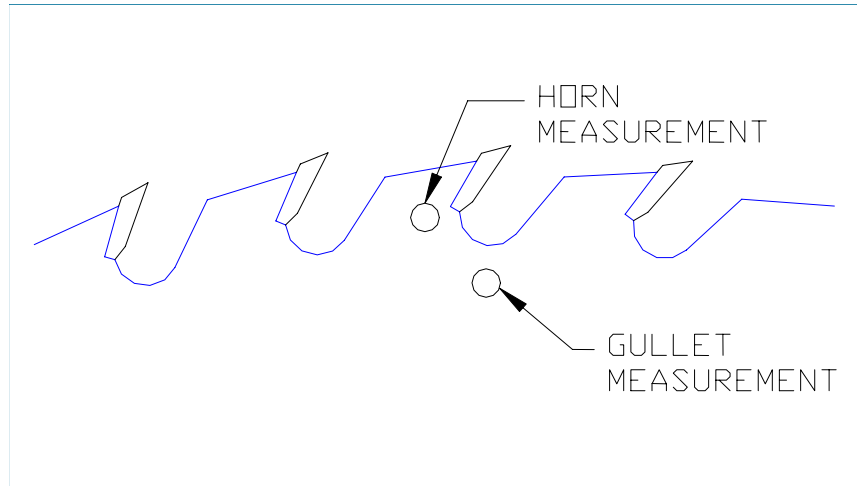
To determine the wear rates of the blades the plate thickness was measured in two places (Figure 5.2) and the gullet corners were just measured. Measurements were made when the saws were new and again before the first re-tipping. Table 5.2 shows the thickness measurements for the test saws from new to just before the first re-tipping and before the second re-tipping. All but one of the wear measurements is less than a thousandth of an inch and can be considered due to measurement variation rather than wear. Plate wear before the first re-tipping was less than the measurement error for both the regular and stainless. Unfortunately, the saw history was not traceable prior to the second re-tipping, hence the missing data in Table 5.2. Stainless saw plate wear before the second re-tipping was still less than the measurement error.

Figure 5.2 Plate wear measurement locations

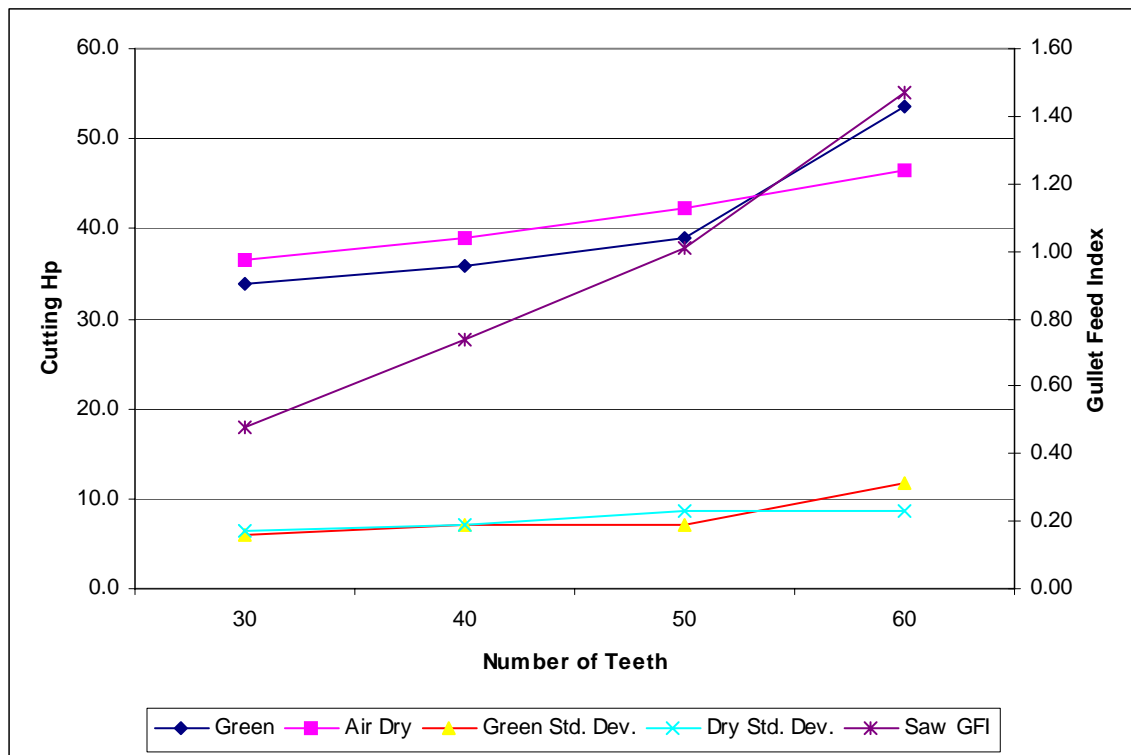
Net cutting power for the four saws is shown in Table 6.3. As expected, cutting power is higher for the dry wood, with the exception of the results for the 60 tooth blade. During the cutting of wet wood noticeable packing of sawdust in the gullets was observed with the 60-tooth saw. This packed sawdust did not clear during cutting and the added friction increased the cutting power, accounting for the sudden increase in power for this saw in wet wood (Figure 6.1). Sawdust packing did not appear to be a problem when cutting the dry wood.

Figure 6.1 *Cutting power and gullet feed index for the four test saws*

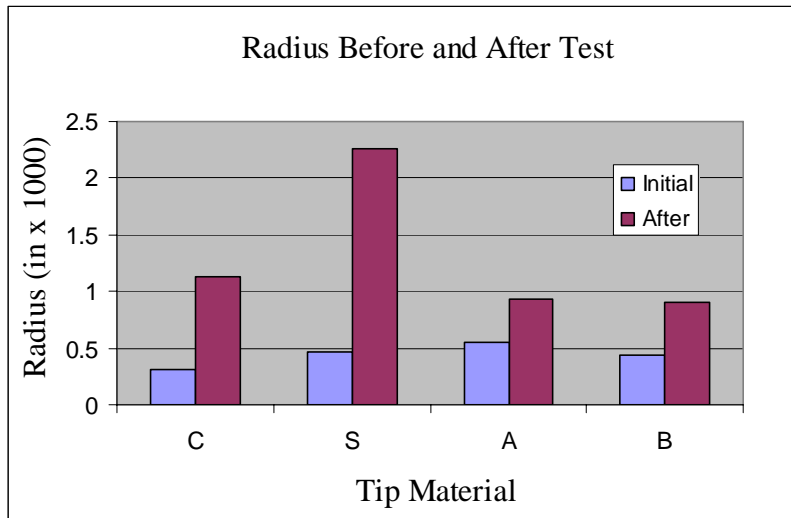
Impressions were taken from three tips of each type. The tip radii from before the test and after 7 hours of cutting are shown in Figure 7.1. Due to the wear mechanism of the different materials, the initial tip radius is not a major factor when considering wear. However, as all the tip radii were similar, the final radii can be taken as a good indicator of wear rate.

Figure 7.1 Tip radii before and after 7 hr. cutting test

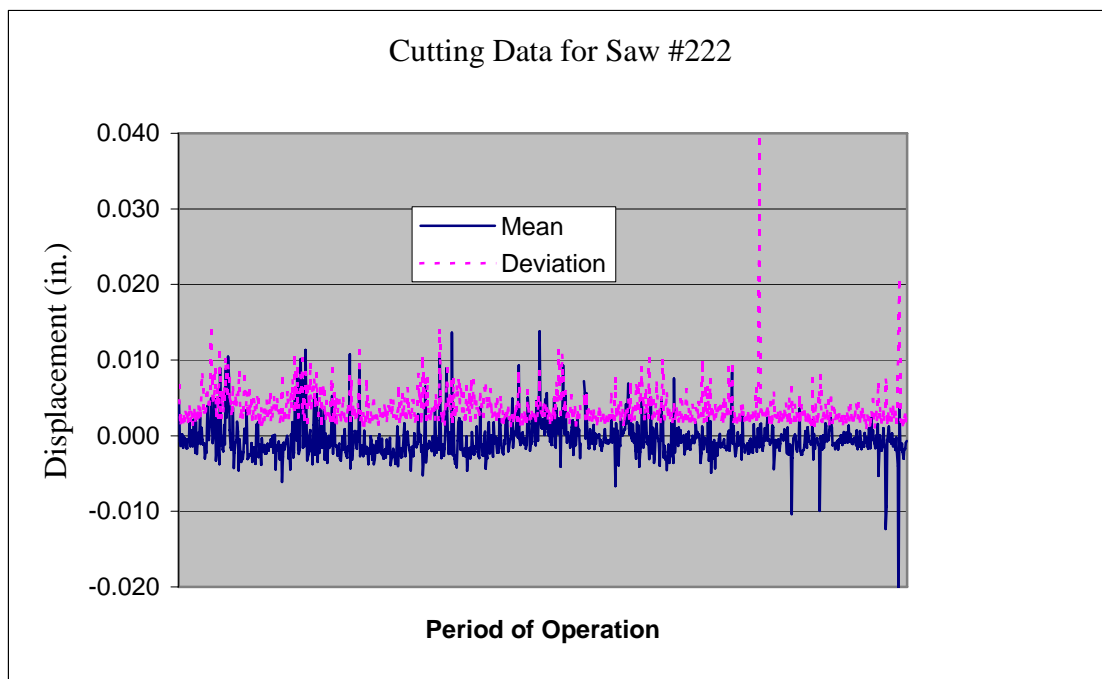
Figure 8.1 *Typical saw cut data*

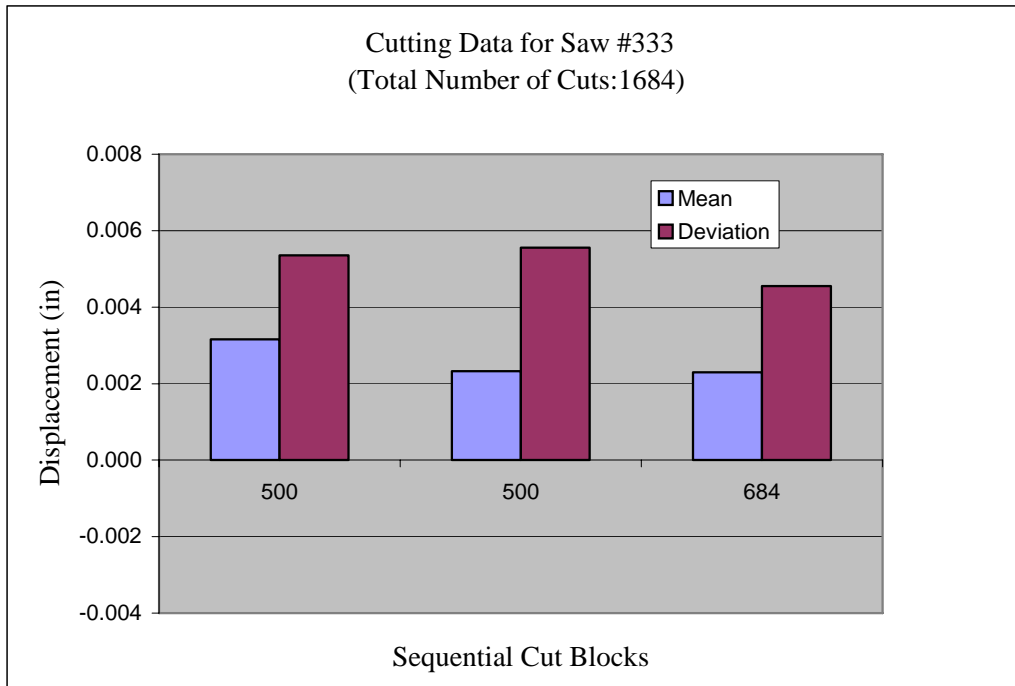
observed. Figures 8.2 to 8.6 show typical sawing performance of the saws broken down into blocks. The size of each block is indicated by the number of cuts that are incorporated into the mean and standard deviation bars.

Figure 8.2 Cutting performance of Stellite™ tipped saw no. 333

Examining the available data and comparing Figures 8.2 to 8.6, it is apparent that there is no clear difference between the two types of saw blade, even at the end of a 7-hour run, when one would expect the swaged saws to be quite dull. Some blades improved with time, others deteriorated and some switched part way through the period of operation. Changes in log size and quality throughout the shift could account for the variability between consecutive blocks of data. There were also some problems with logs breaking, twisting and moving during the chipping and sawing process. This can easily damage a saw and affect the performance. It should also be noted that these are fairly heavy band saws (15-ga) for the average depth of cut (7") and this could well be one reason for the lack of difference in the two saw types.

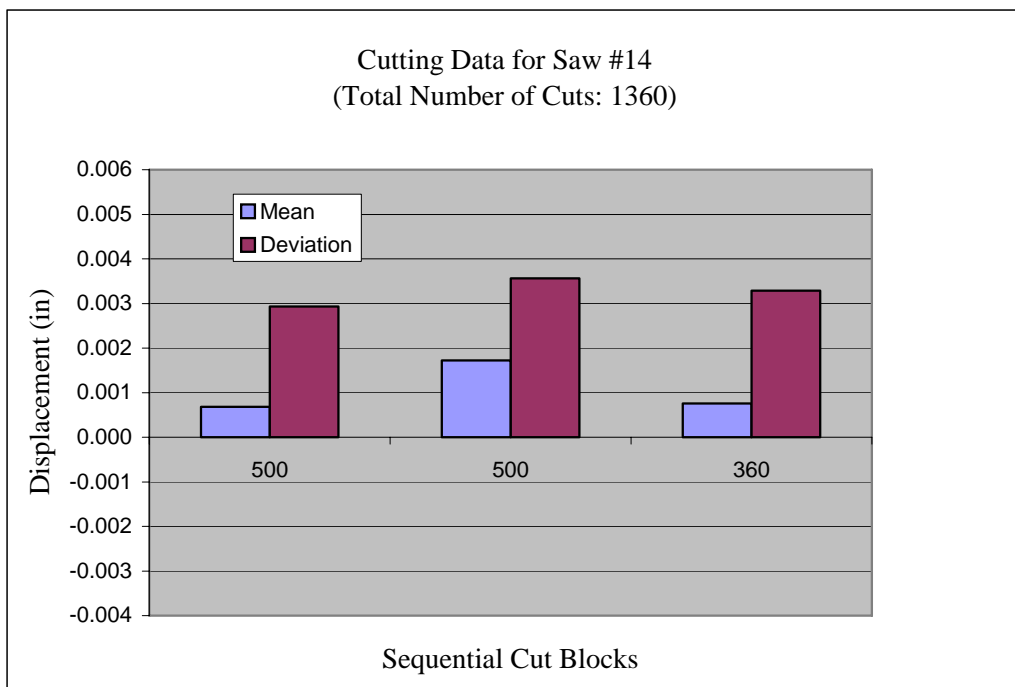
Figure 8.3 Cutting performance of swaged saw no. 14

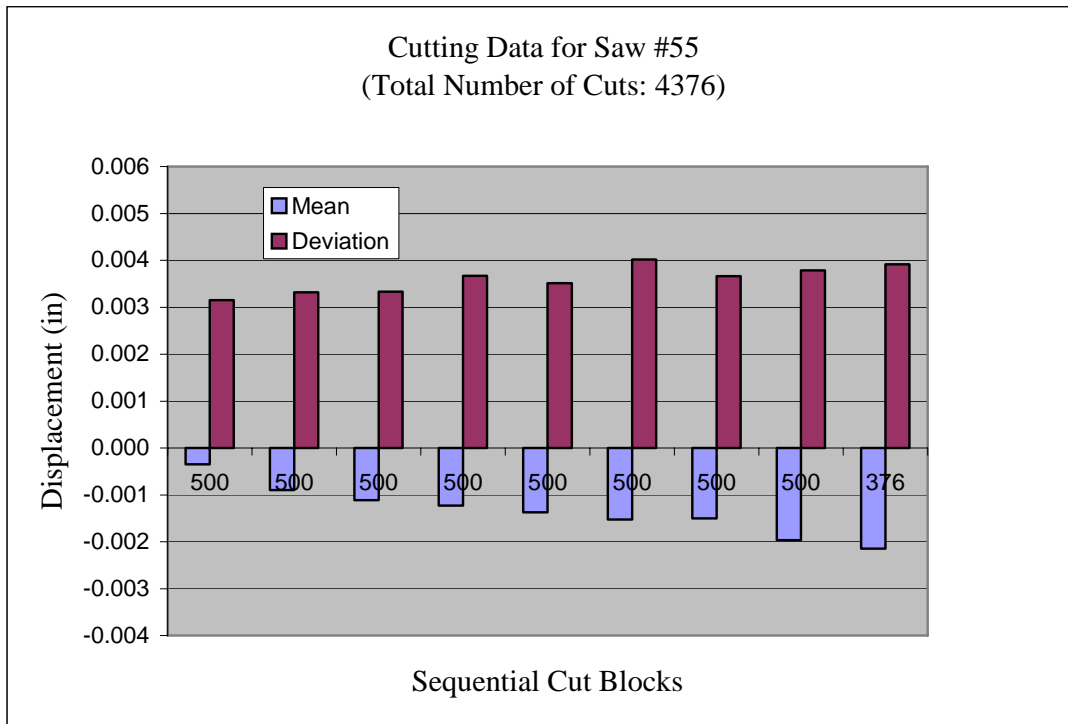
Figure 8.4 Cutting performance of swaged saw no. 55

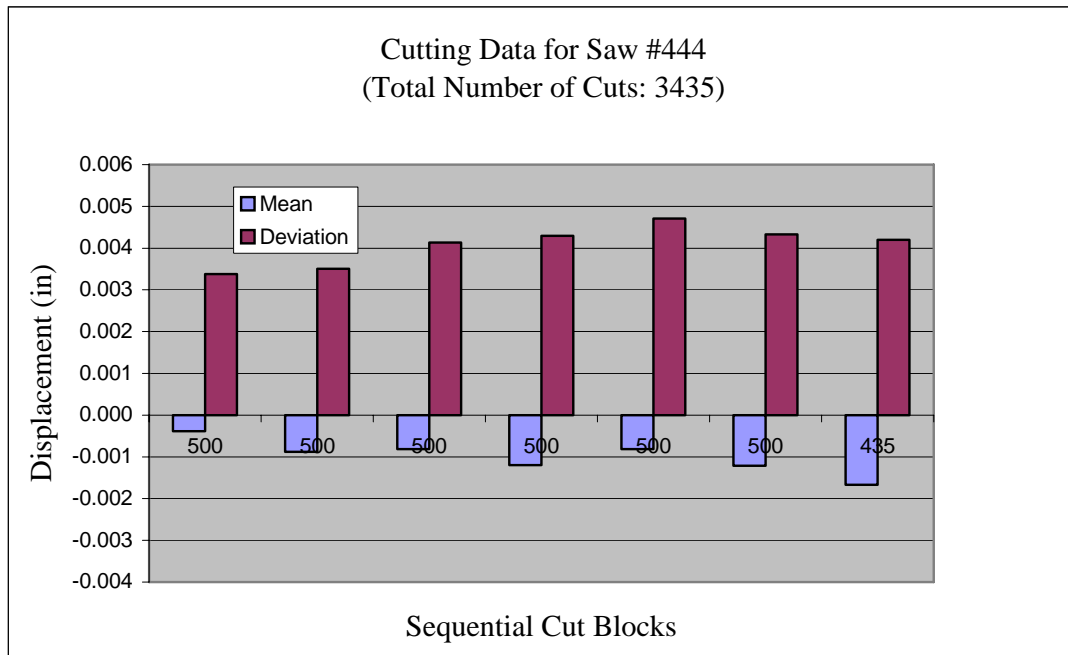
Figure 8.5 Cutting performance of Stellite™ tipped saw no. 444

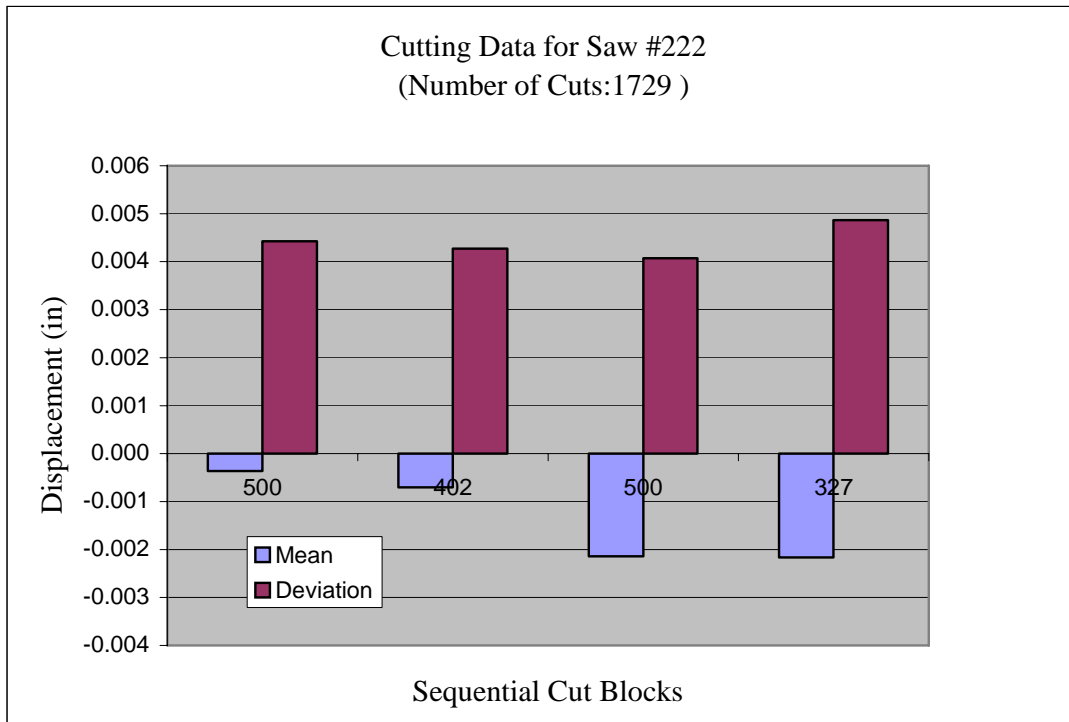
Figure 8.6 Cutting performance of *Stellite™* tipped saw no. 222
