SLOPE STABILITY PROBLEMS ASSOCIATED WITH TIMBER HARVESTING IN MOUNTAINOUS REGIONS OF THE WESTERN UNITED STATES

D. N. SWANSTON

This paper was presented at the "Symposium on Forest Operations in Mountainous Regions," in Krasnodar, U.S.S.R., August 30-September 11, 1971.

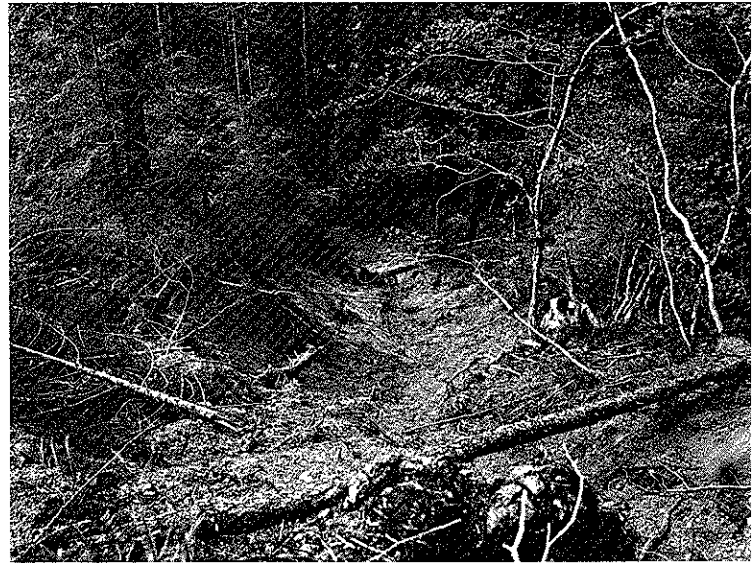
Figure 3-b. Channel scour event in undisturbed timber on the H. J. Andrews Experimental Forest, Oregon. This event occurred as a result of failure near the head of the drainage.

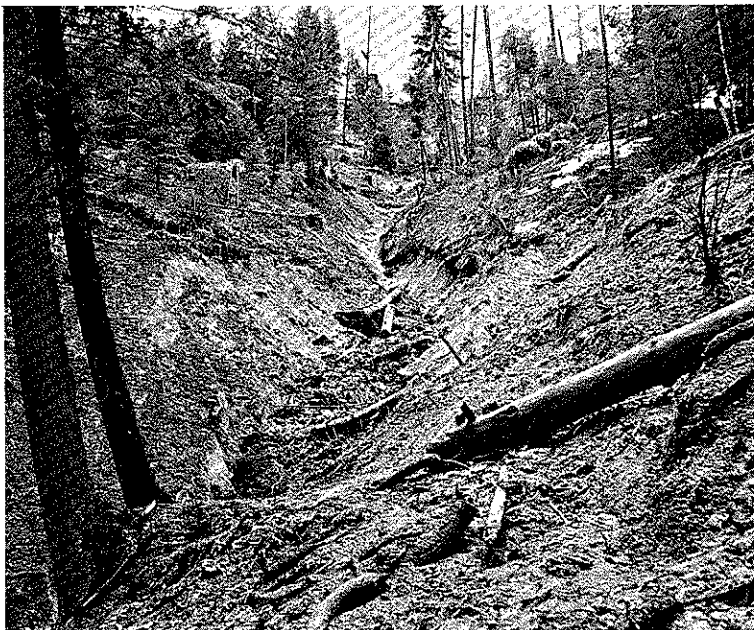
Figure 3-c. Debris torrent developed in an intermittent stream channel along the South Fork of the Salmon River in Idaho. Initial failure occurred in road fill near the ridgetop.

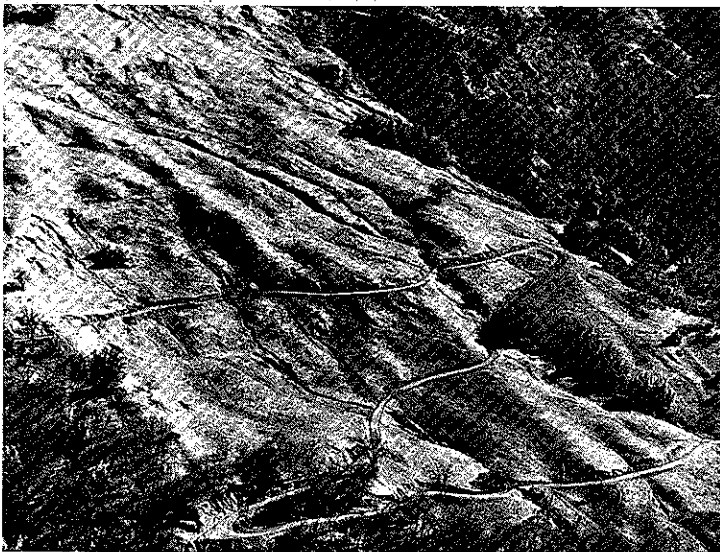
Figure 4-c. Massive slope failure in the northern California Coast Ranges. The failure has resulted from creep and progressive failure in a deeply weathered series of greywackes, shales, bedded cherts, and limestone lenses of Cretaceous Age.

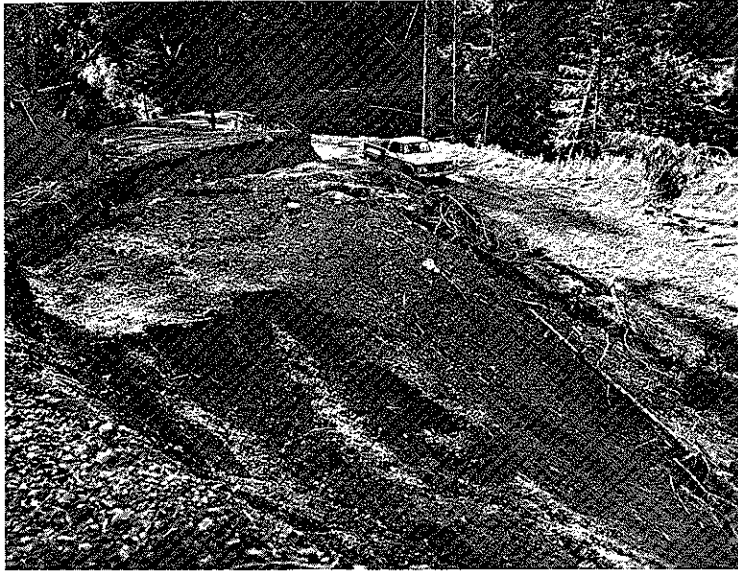
Figure 6. Examples of mass soil movements resulting from failure along a road right-of-way.
 a) Road fill failure in the Cascade Range of Oregon. Failure resulted from plugged side drainages and resultant saturation of the road prism.

In Idaho, Megahan (see footnote 1) reports about 90 percent of the soil mass movements which occurred along the South Fork of the Salmon River during a storm in April 1965 (a total of 89 events) resulting from soil failures along the logging road right-of-way. Most open-slope failures occurred in shallow granitic soils on slopes in excess of 50 percent. Again, the greatest number of these resulted from road fill failures followed by failures resulting from obstructed road drainage (fig. 6).

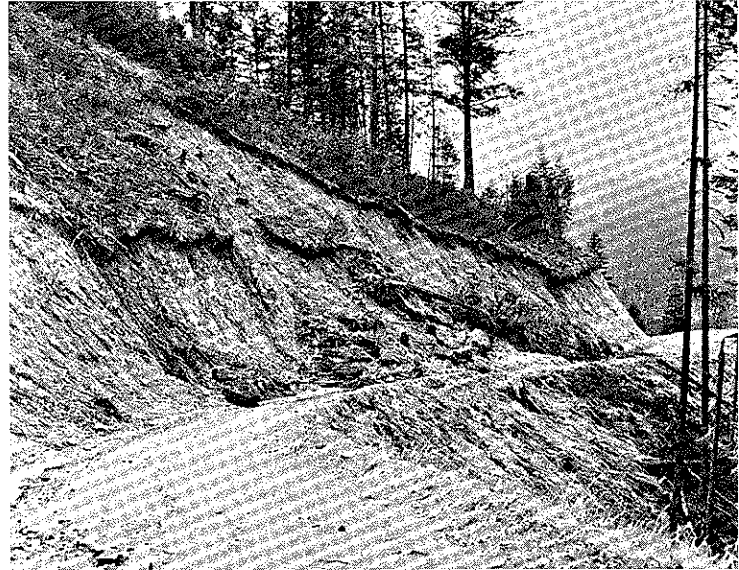
Figure 6b. Backslope failure along a logging road in the Salmon River Mountains of Idaho. Failure resulted from undercutting of the slope toe.

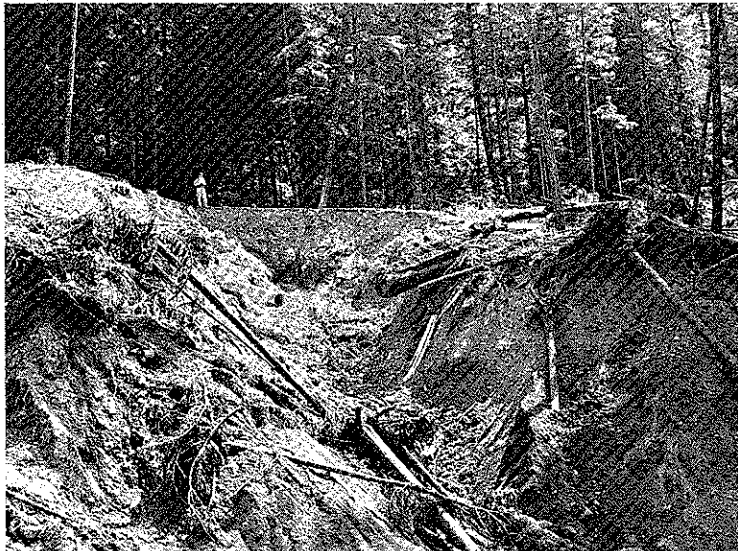
Figure 6c. Failure due to inadequate road drainage in the Cascade Range of Oregon.
