## Dynamics of Hazards within Watersheds

### ABSTRACT

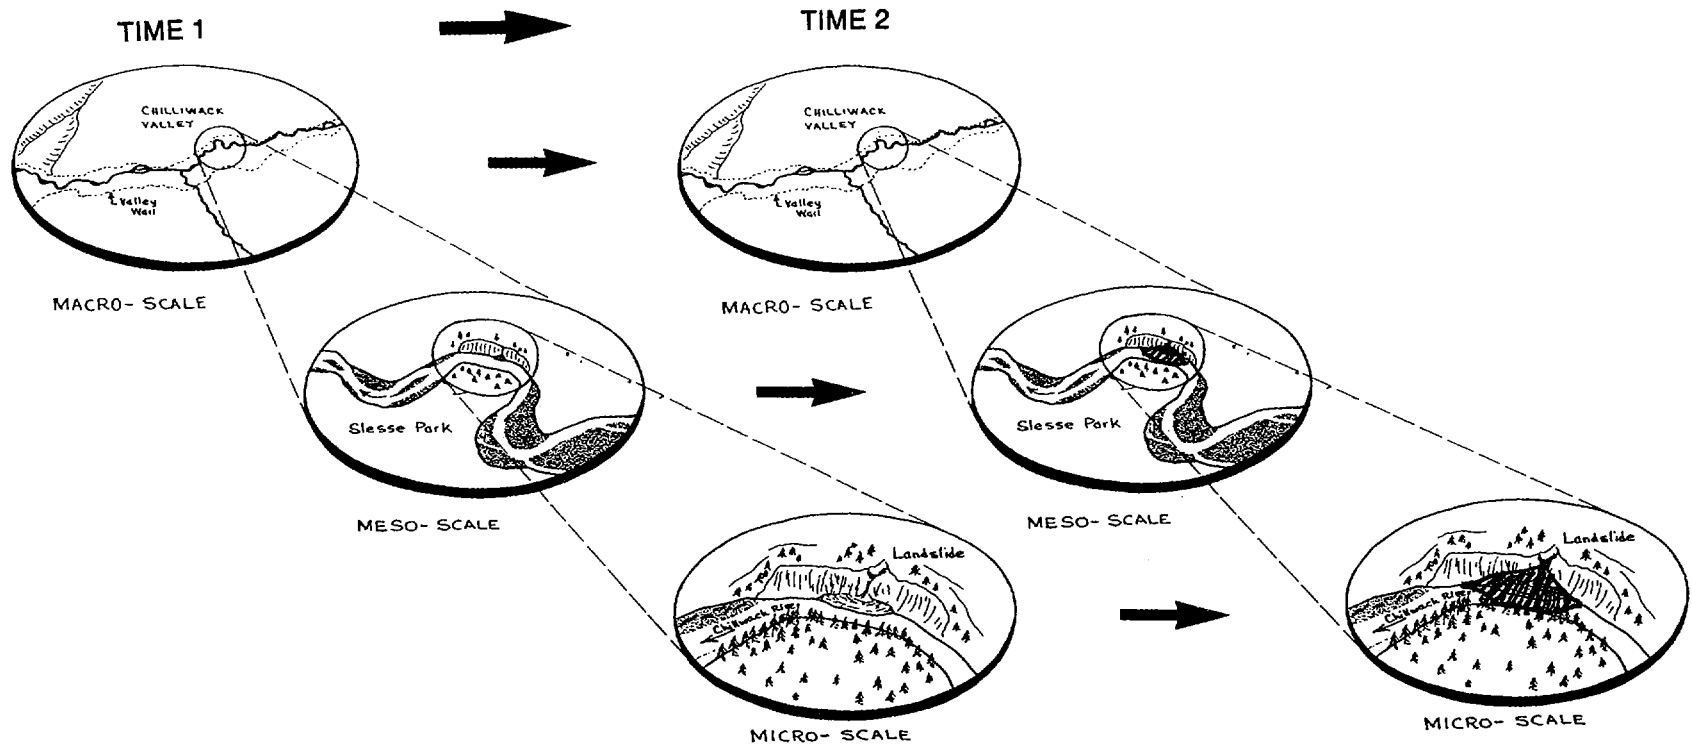
**FIGURE 1**  
**SCOPE OF GEO-HAZARD STUDIES**  
**INVOLVING SPACE AND TIME**

In order to understand the dynamics of various types of hazards a study framework should involve the following three space scales coupled to varying time scales as shown in Figure 1:

The dynamics of the geomorphic hazards related to space as well as time.

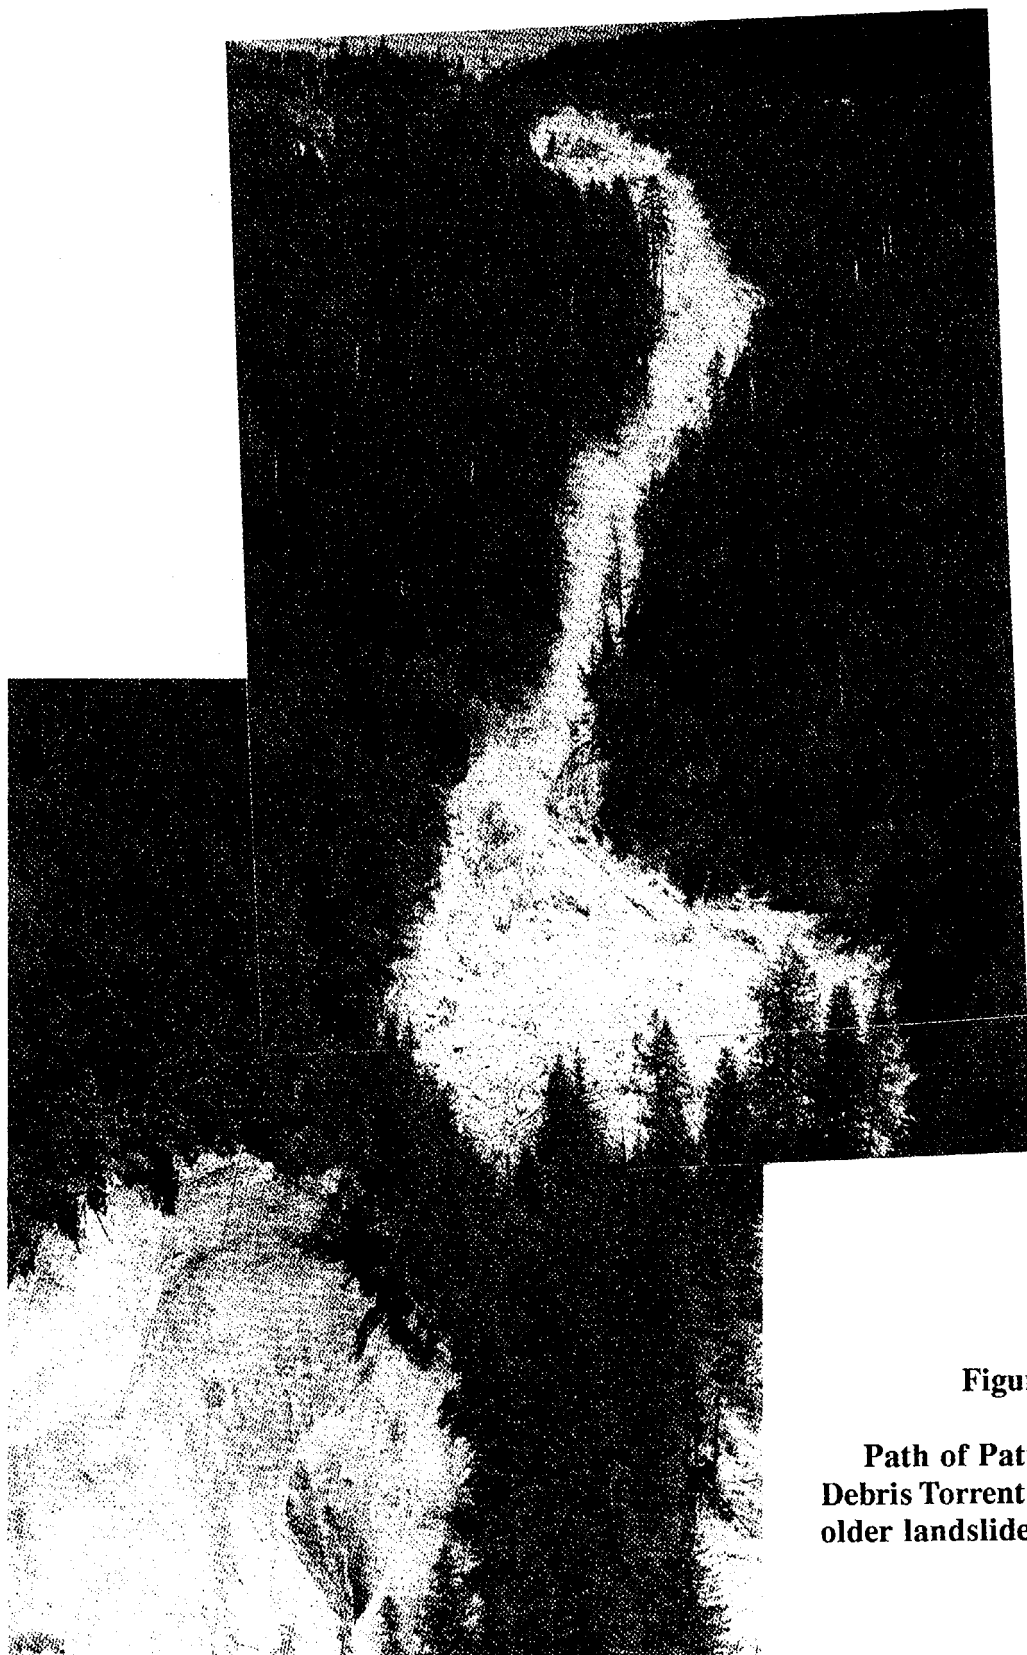
**Figure 2**

**Path of Pattison Creek  
Debris Torrent just bypassing  
older landslide shown at left.**

a small gully at el. 940 m (Figure 2). The landslide scar is up to 50 m wide, 100 m long and 10 m deep. It occurred on a section of slope inclined on average at 25°. The side scarp reveals glacial till consisting of silty sand, gravel and cobbles.

At el. 600 m, the debris flow track widens and deflects to the left (east) on encountering a bench formed of ice contact deposits. At this point, the debris flow narrowly missed the head of the large slide scar formed during the 1960 debris flow, which is still actively eroding (Figure 2).

landslide shown in Figure 2 headcuts into the 1990 landslide. If a time scale was not a part of the impact study, the community along the creek may not be prepared for another debris torrent.

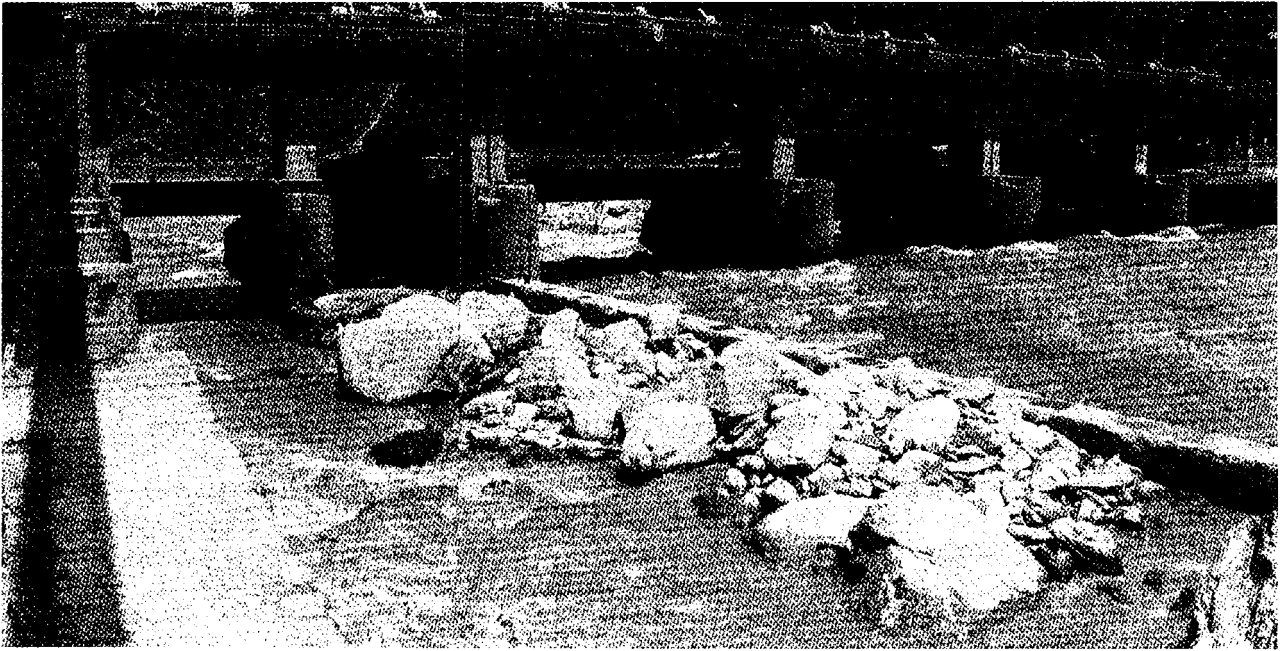
**Figure 4**

**Diversion Structure on Sun Kosi - Nepal.**

**The three left gates have been totally destroyed  
by a debris torrent in 1986.**

**The three gates on the right were being opened  
just prior to the flood surge.**
