Assessment of Debris Flow Potential Newman Creek, Howe Sound

A Report to
British Columbia
Ministry of Transportation and Highways
South Coast Region

ASSESSMENT OF DEBRIS FLOW POTENTIAL NEWMAN CREEK, HOWE SOUND

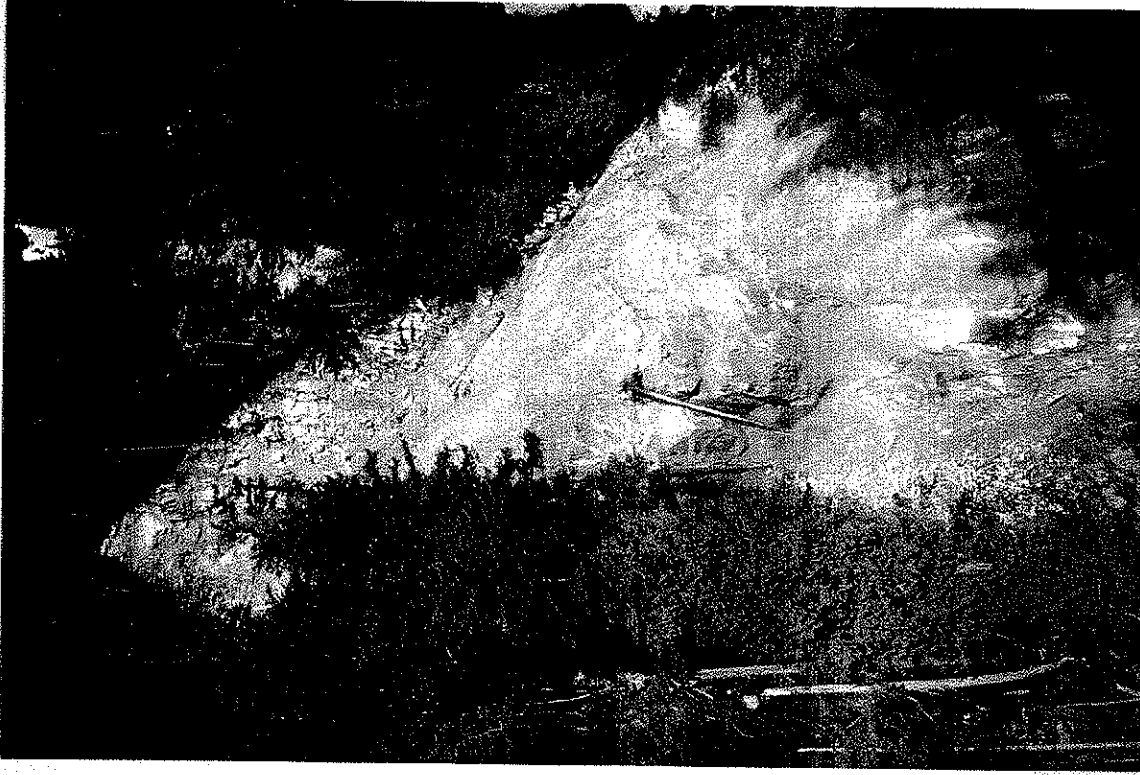
As estimated from the helicopter altimeter, Slide A began at approximate elevation 885 m. The mid-point of the toe of the slide at the creek is at approximate elevation 800 m. From the 1:50,000 topographic map, the creek gradient at that point is approximately 32°. From the topographic map, the average side slope at the slide location is approximately 38°, although it appears steeper in the field (Photo 2).

As shown on Photos 1 and 2, Slide A is roughly an elongated triangle in shape. As estimated from the helicopter and the helicopter photos, the downstream side of the triangle has an approximate 110 m slope length, the upstream side has an approximate 70 m slope length and the base has an approximate 75 m slope length along the creek. The majority of the slide debris originated from the upper 1/3 of the slide. It is estimated that the headscarp has a height of approximately 8 m,

From the helicopter reconnaissance there appears to be a high likelihood of further ravelling of the slopes in the vicinity of Slide A. In particular, the recently exposed, highly fractured bedrock, weathered bedrock and colluvium exposed by Slide A, and the similar materials in the narrow ridge between Slides A and C, show a very high likelihood of further ravelling or even landsliding (Photos 2, 3, 4 and 5).

Photo 2 (DFV98/02/09/1-19)
Close-up of Slide A showing the steep side slopes and near vertical headscarp.

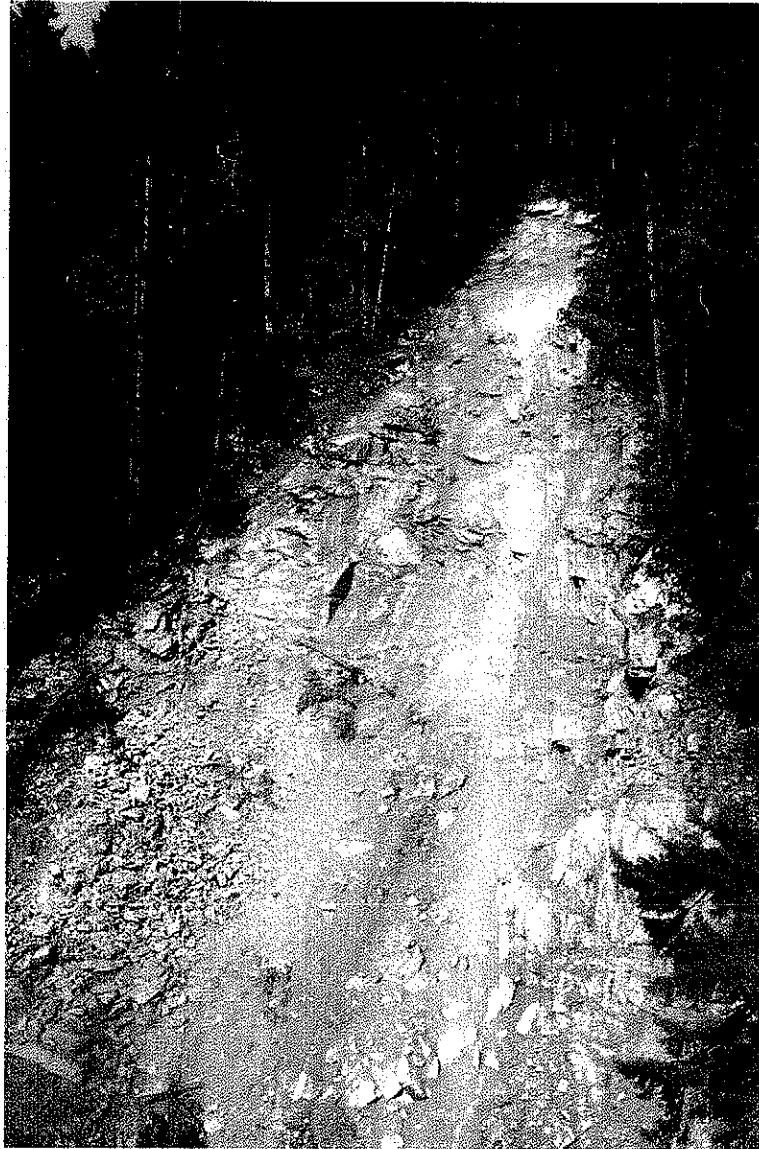
Photo 3 (DFV98/02/09/1-21)
Front view of Slide A showing the material
exposed on the failure plane.

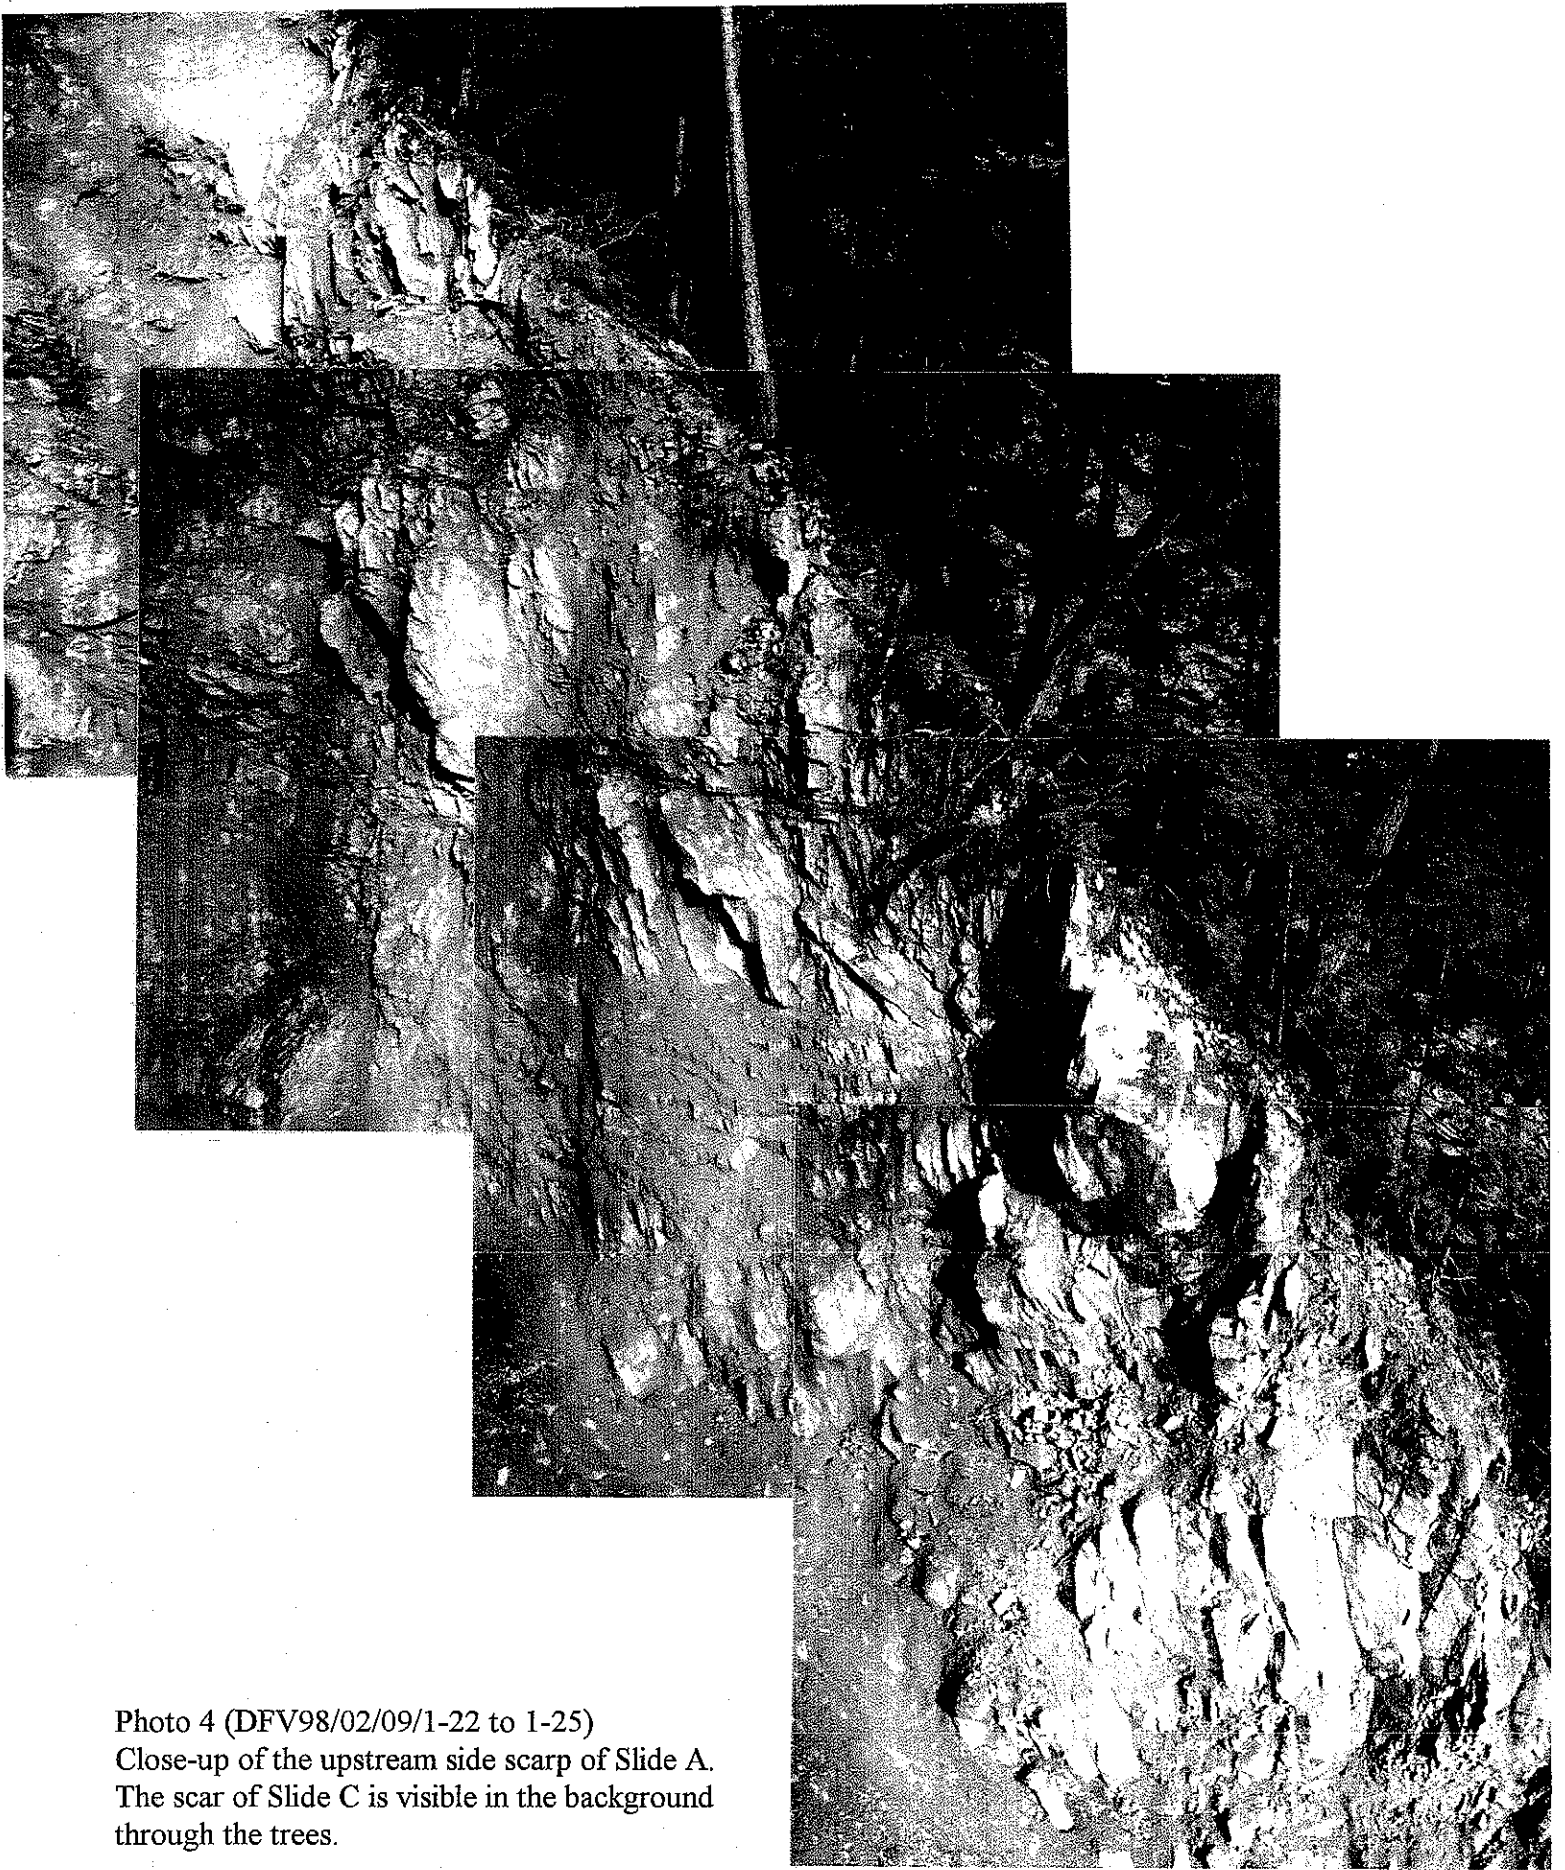
Photo 4 (DFV98/02/09/1-22 to 1-25)
Close-up of the upstream side scarp of Slide A.
The scar of Slide C is visible in the background
through the trees.

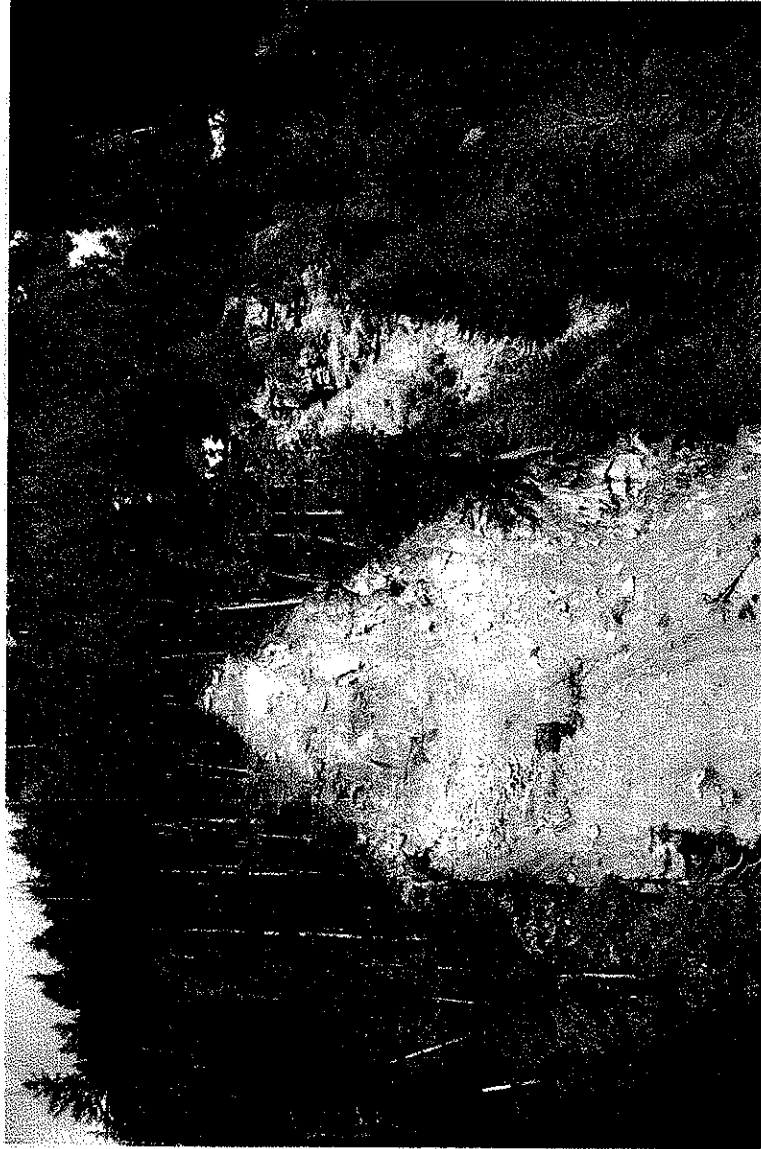
From the material exposed in the headscarp and along the sides of slide A, the material in the upper portion of the landslide was moderately to highly fractured, fresh to weathered granitic bedrock overlain by a thin layer of colluvium. Moderately fractured and sound fresh bedrock is left exposed at the base of this upper portion, however, highly fracture fresh and weathered bedrock is exposed in the sides (Photos 3 and 4). The material derived from the lower portion of the landslide was highly fractured weathered granitic bedrock and colluvium. For the most part, sound fresh bedrock is exposed in the bottom of the lower portion of the slide and weathered highly fractured bedrock and colluvium is exposed in the sides. The bedrock and overlying material on the upstream side of Slide A forms relatively narrow ridge of material between Slide A and Slide C (Photo 5).

Photo 5 (DFV98/02/09/1-20)
Overview of the upper portions of Slides A and
C showing the narrow ridge that separates the
two.

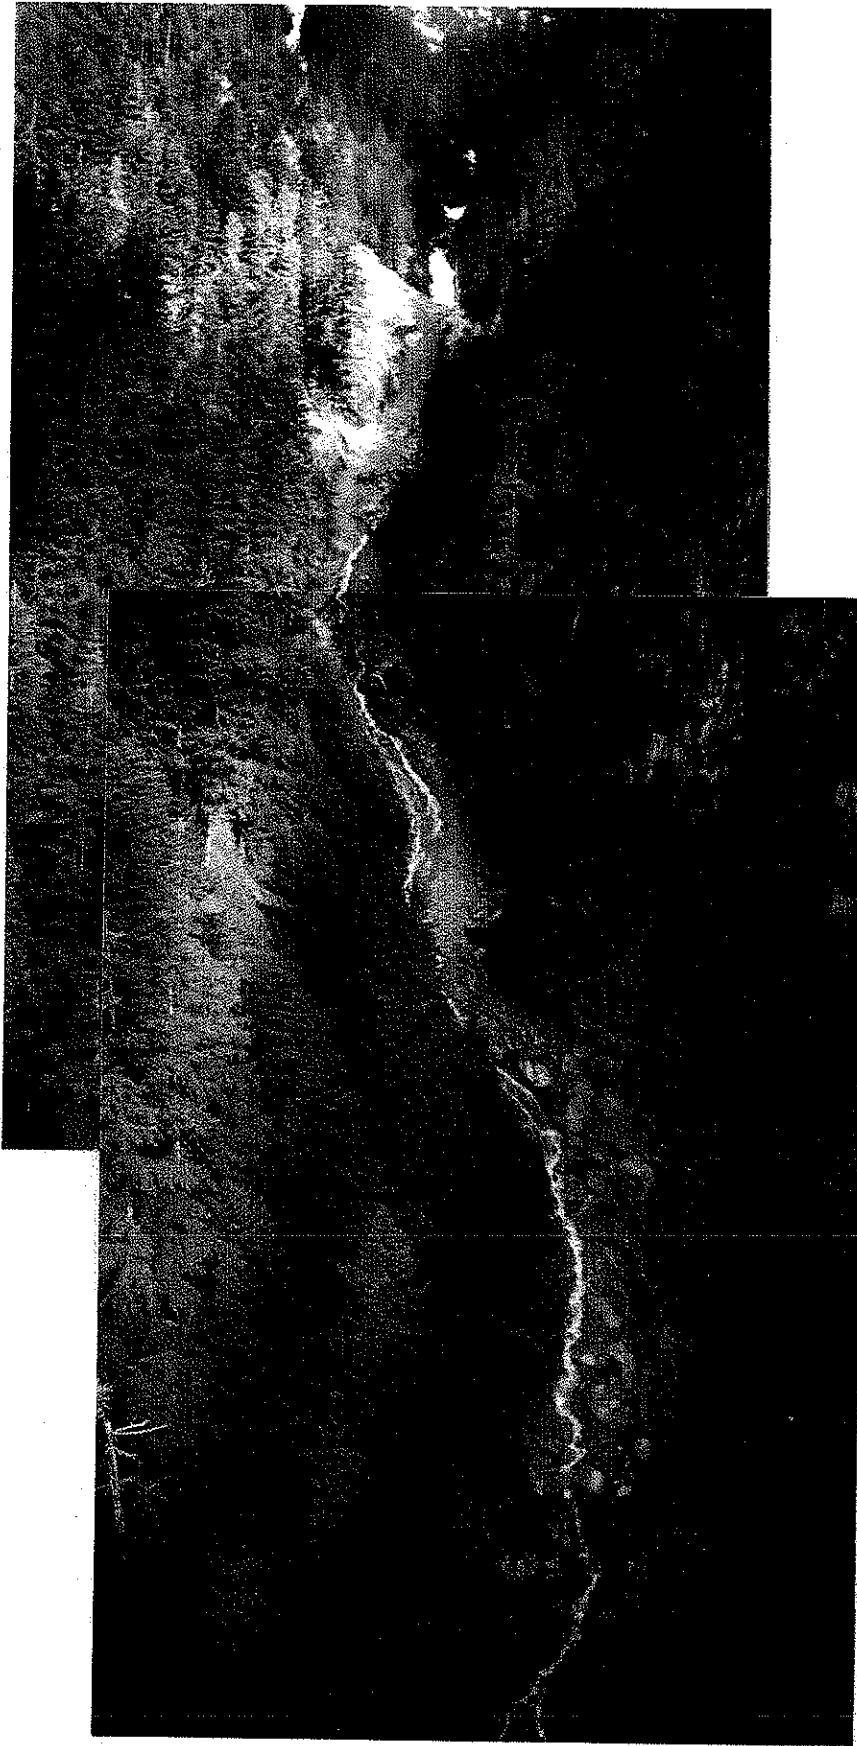
Photo 6 (DFV98/02/09/1-12,1-13)

Looking upstream along the flow path of Slide A debris along the creek channel.
The toe of Slide A is visible in the left background of the panorama.

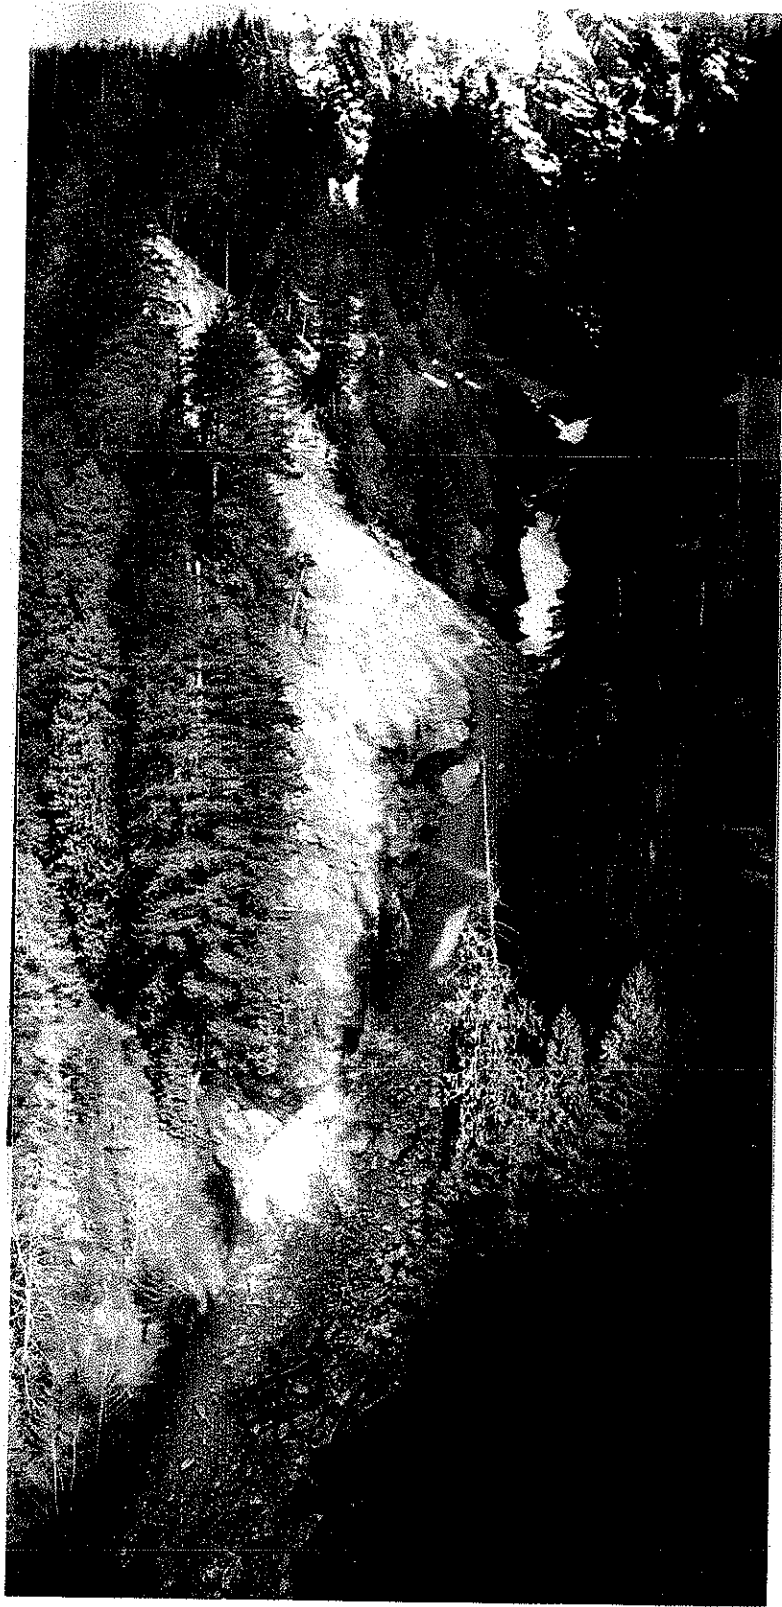
Photo 7 (DFV98/02/09/1-17,1-18)

From the helicopter photos and video taken on January 31, 1998 by BCMOTH and the helicopter reconnaissance on February 9, 1998, snow is evident in the creek channel immediately upstream of the Slide A. It is likely that at least the upstream portion of the landslide debris fell onto snow. Similarly, on both January 31, 1998 and February 9, 1998, the water in the creek was flowing beneath the snow from approximately 30 m upstream of the upper reach of the landslide, beneath the landslide debris, and for approximately 50 m downstream of the landslide (Photo 7). A

Close-up of toe of Slide A. The water flow in the creek channel is beneath the snow in the background and the landslide debris in the foreground.

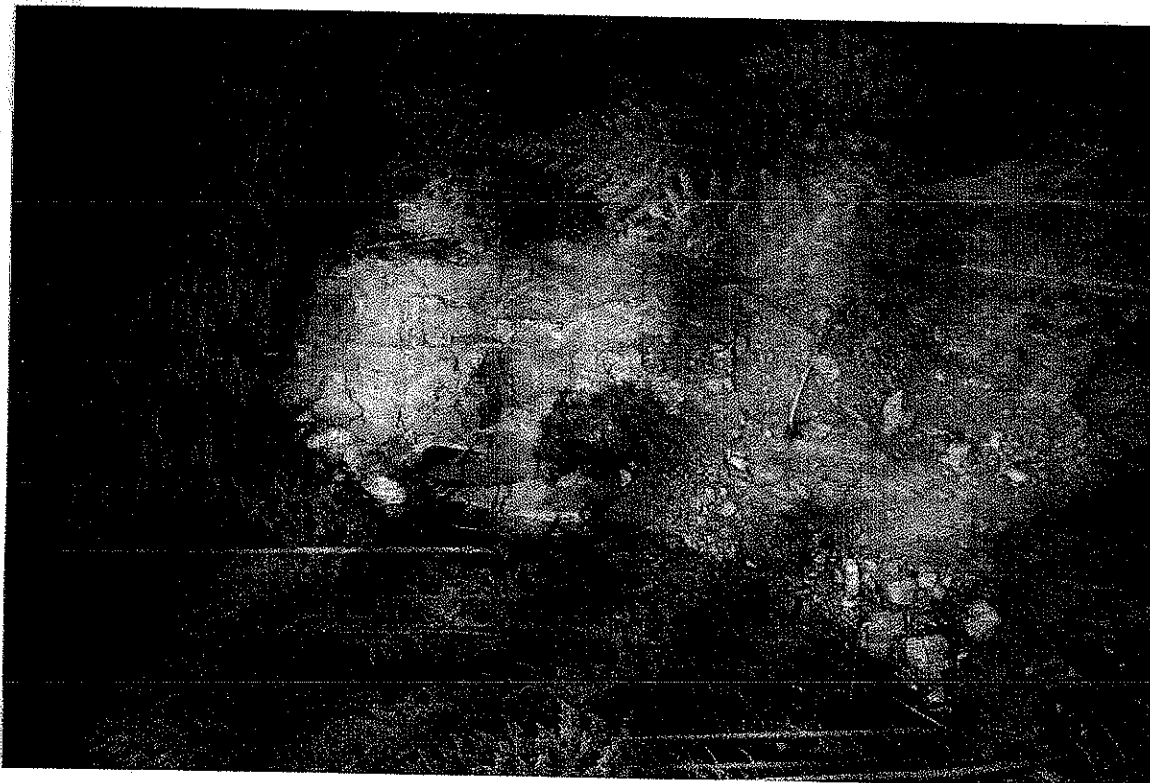
The headscarp of Slide E is at approximate elevation 700 m as estimated from the helicopter altimeter. Slide E, which parallels the major tributary to Newman Creek, travelled down an estimated 40 ° to 50 ° slope, and entered Newman Creek at approximate elevation 350 m, which is the approximate location of the deactivated logging road crossing (Photos 10 and 11). The headscarp is near vertical and exposes fractured granitic bedrock (Photo 12). The slide path is estimated to average 10 m to 15 m in width, and 500 m in length. The landslide removed the standing timber, some weathered bedrock and the overlying colluvium. Over the length of the slide path, the thickness of material removed is estimated to be less than 1 m. Presently exposed along the slide path are patches of relatively sound bedrock, patches of coarse granular inorganic material and some relatively fresh looking de-barked logs and fallen trees with the needles still on the branches. A small pile of fresh looking debris was noted at the toe of this landslide (Photo 13).

Photo 12 (DFV98/02/09/2-4)
Front view of the headscarp of Slide E.

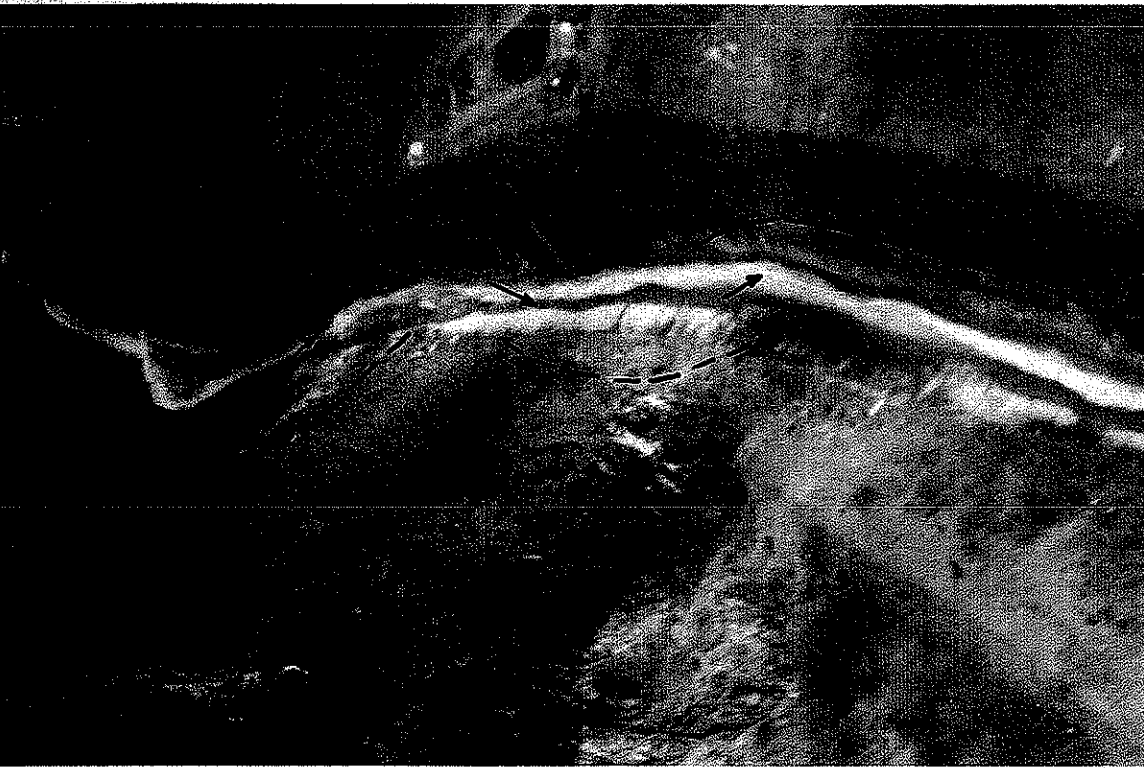
During the January 1, 1997 debris flow, the debris came close to overtopping the south side of the Newman Creek diversion channel just upstream of the water supply reservoir. Reasons for this likely include the sinuous path that the debris had to follow around the waterfall, the fact that this debris flow event may have been more fluid than most debris flows in this area, and the vertical height from the bottom of the channel to the top of the south side slope is less than the 8 m called for in the original BCMOTH design.

volume as it was estimated from the material remaining at the mouth of the creek. I also understand that once the debris passed the sinuous restriction at the waterfall (immediately upstream of the apex of the Newman Creek fan) it continued to flow in a sinuous manner down the upper portion of the Newman Creek diversion channel. The debris eroded the rip-rap on the north side of the diversion channel, immediately below the waterfall, and according to Dave Buckley, the upper surface of the debris came to within 0.6 m (2 feet) of the top of the diversion channel on the south side of the channel just upstream from the water supply reservoir. Below that point, the debris "sloshed" back and forth across the diversion one more time before it reached the highway bridge (Photo 14).

In addition, the BCMOTH design for the diversion called for a minimum 8 m vertical height from the base of the channel to the top of side slopes. Based upon the 1997 BCMOTH 1:250 scale plan of the upper portion of the diversion, entitled "Highway 99, Newman Creek Debris Chute, Site Plan for PEP Repairs", from the upstream end of the diversion to just downstream of the water supply reservoir, the vertical height from the bottom of the channel to the top of the south side slope is less than 8 m and is only 6 m at its lowest point (Photos 14 and 15).

Photo 14 (DFV98/02/09/3-3)
Overview of the upper portion of the Newman Creek diversion. Indicated on the photo is the approximate flow path of the January 1, 1997 debris flow. The water supply reservoir is located on the right side of the photo.

Recommendation 2: To immediately reduce the likelihood of overtopping the south side of the diversion channel, it is recommended that the top of the south side of the channel be raised from the apex of the fan to the downstream end of the water supply reservoir. One relatively simple, quick and practical method of raising this section of the berm would be to use several lifts of anchored lock-blocks. I have discussed the design concepts of such a structure with Mr Jacques Dupas, PEng, BCMOTH Howe Sound District Engineer.

Recommendation 3: As a longer term measure to reduce the sinuous flow path around the waterfall, consideration could be given improving the geometry of the flow path immediately below the waterfall. One method would be to extend the north side of the upstream end of the diversion channel further to the north and to then, with a large radius curve, direct the flow back into the existing diversion channel. The area of suggested extension is the area covered by riprap up until January 1, 1997. On this date, this riprap was removed by a debris flow and the area was subjected to a great deal of scour. After the 1997 event, BCMOTH replaced this riprap and the associated scour hole with concrete.

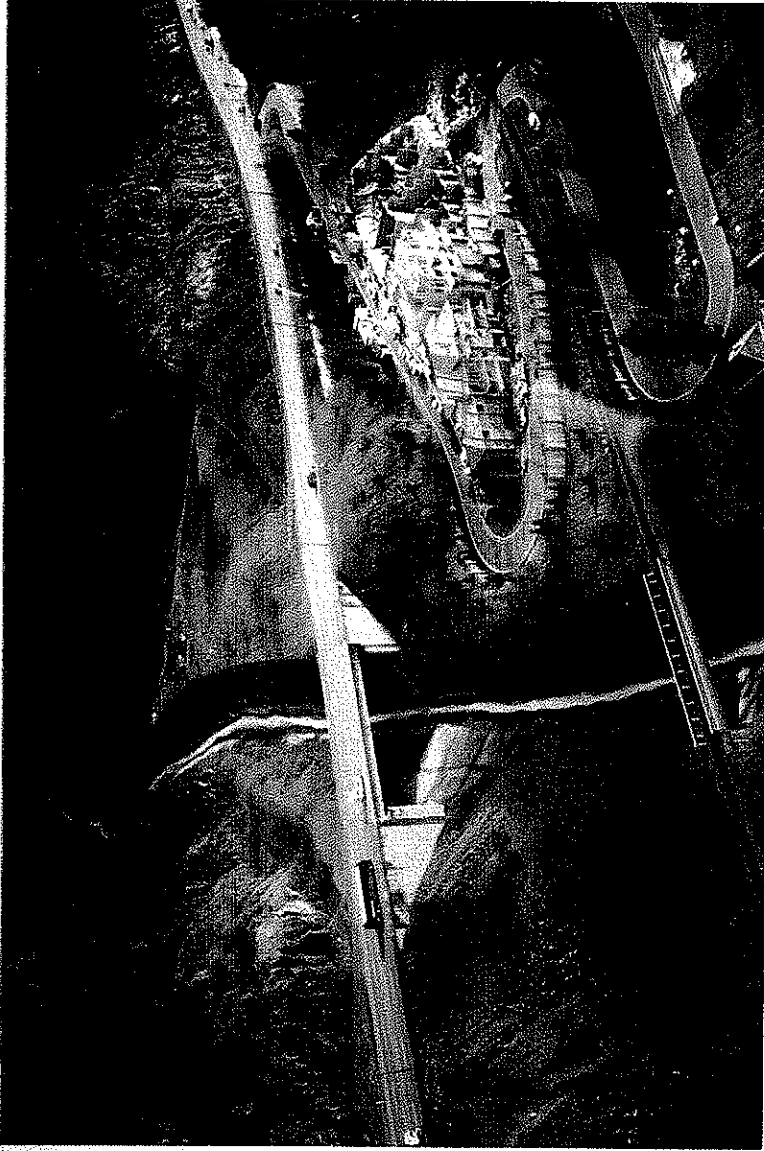
Photo 15 (DFV98/02/09/2-25)
Overview of the upper portion of the Newman Creek fan. The water supply reservoir is in the background, and the multiple-family dwelling under construction is in the right mid-ground.
