6.1 WARDANCE SLOPE AT BIG SKY, MONTANA

A 35–40° (70–80%) slope was logged for a ski run in the 1980s, creating a 1-ha start zone (Figure 141). Avalanches threatened four lots in a subdivision downslope and legal action ensued.

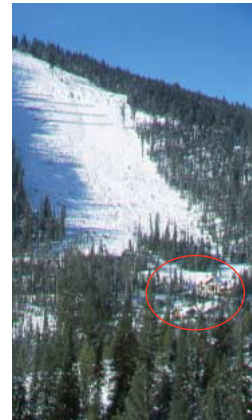
FIGURE 141
High consequence: a slope logged to create a ski run has potential to generate avalanches that might run out into high-value buildings below.

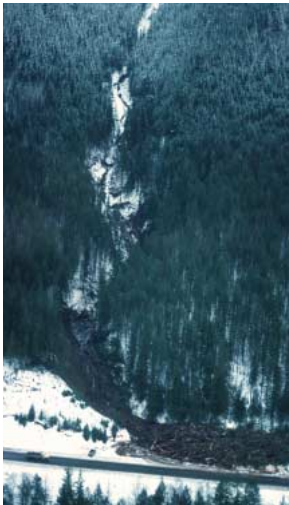
FIGURE 145 *The first of two snow avalanches originating in a clearcut stopped just before Highway 6. A second event blocked both the road and railway. (A berm has subsequently been constructed in the runout to protect the highway.)*

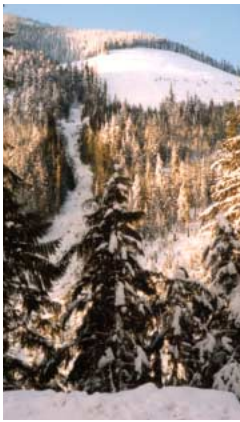
FIGURE 154 *New path resulting from slab avalanche triggered by explosives in clearcut above. The avalanche ran through the standing timber into the gully in the foreground.*

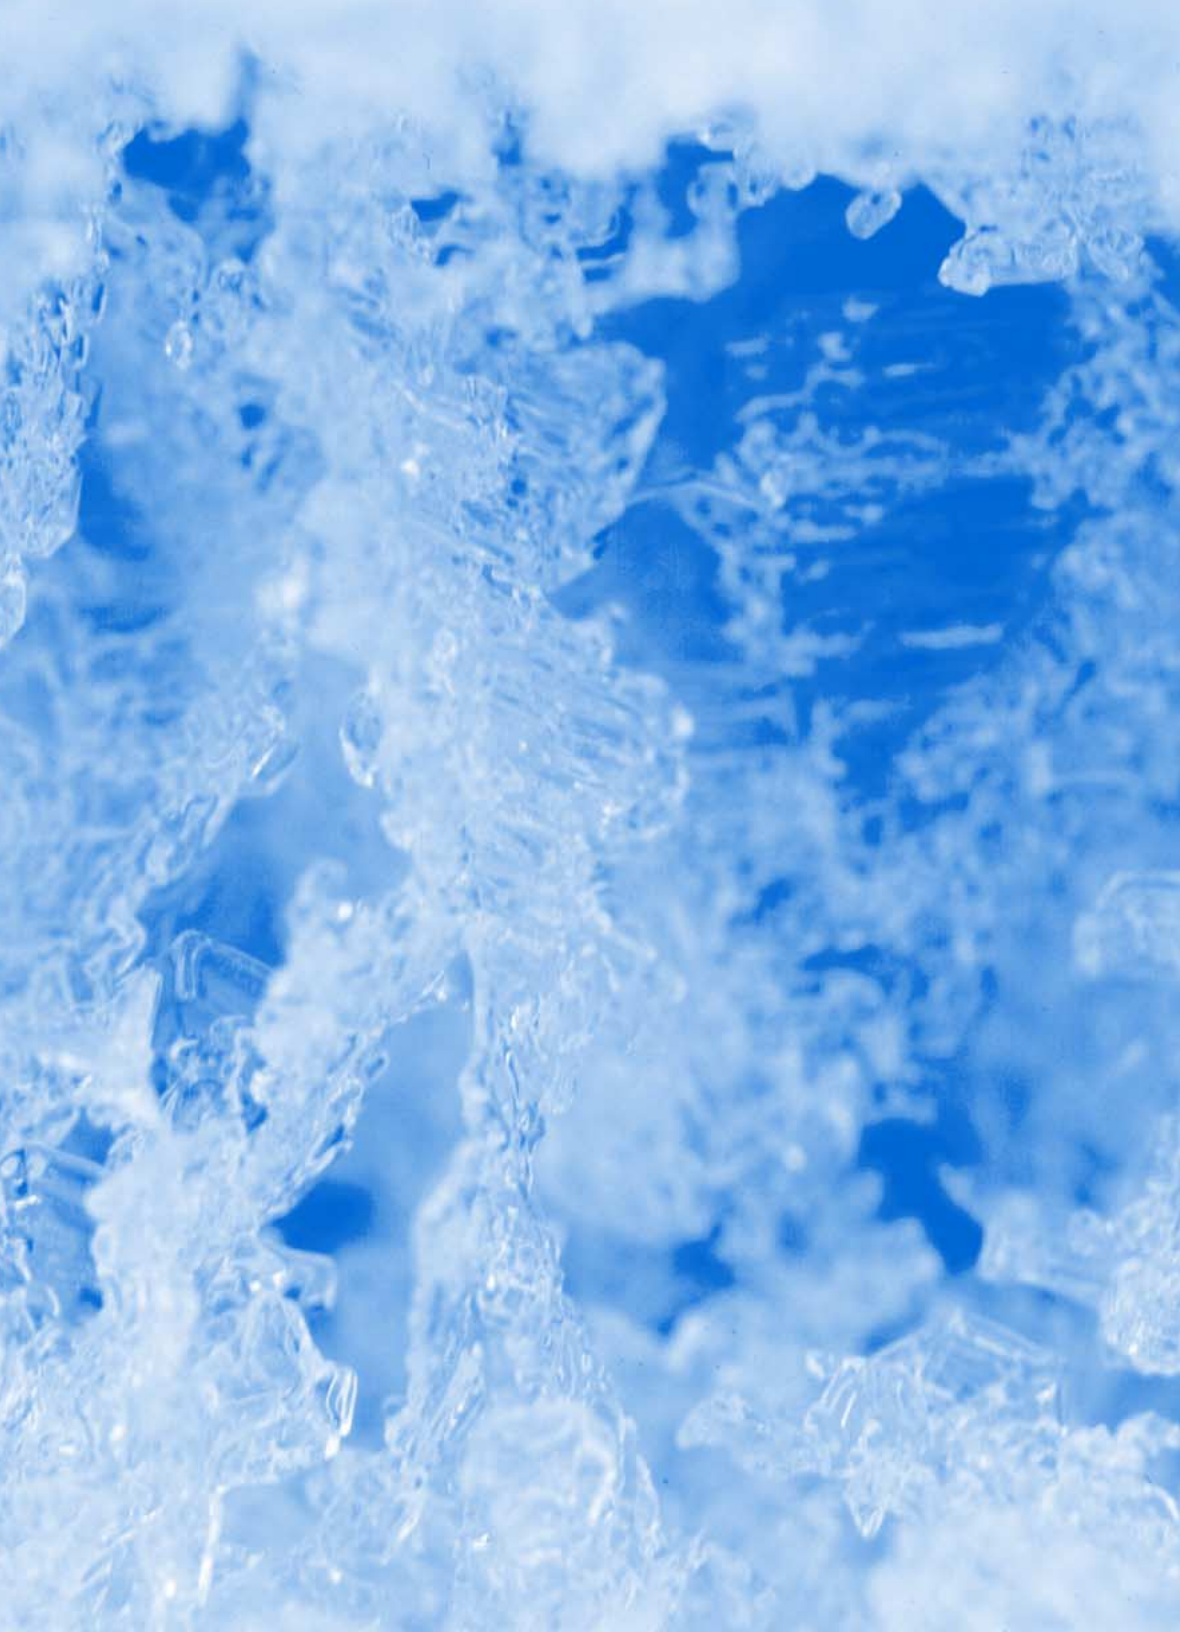
- whumpf 13, 136
- wildfire 47
- wind exposure index 32
- winter operations 119–121
 - safety 119–120

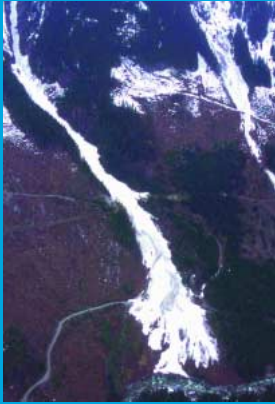
Snow avalanches in recently harvested areas can damage new forest plantations, destroy downslope resources, and endanger public safety. This Land Management Handbook reviews snow avalanche science as it applies to forestry. It presents risk assessment methods for use in forestry planning, outlines harvest designs, and describes
