Forest Research Extension Note

EN-017 Silviculture March 2003

Tree Growth on Rehabilitated Forest Roads in Southwestern British Columbia: Year 8 Results

By M.J. Douglas, P.J. Courtin, C.E. Bulmer, and R.K. Scagel

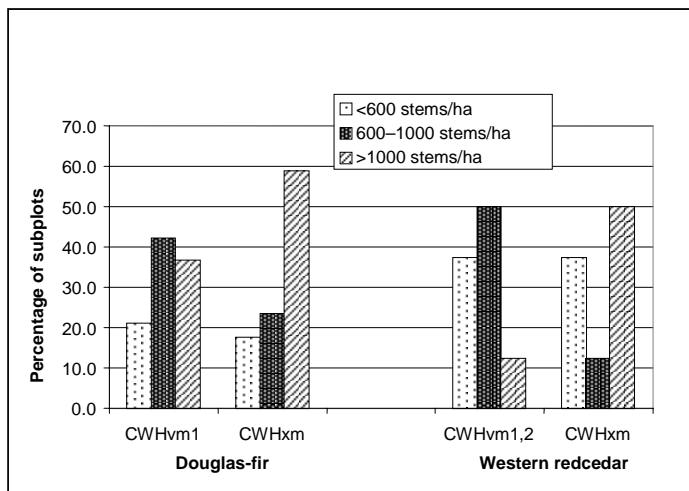
Figure 2. Stacking levels in the CWHvm1 and CWHxm for Douglas-fir and western redcedar.

Plots planted with Douglas-fir tended to have higher stocking levels than plots planted with western redcedar (Figure 2), but the results were variable (Figures 3 and 4)

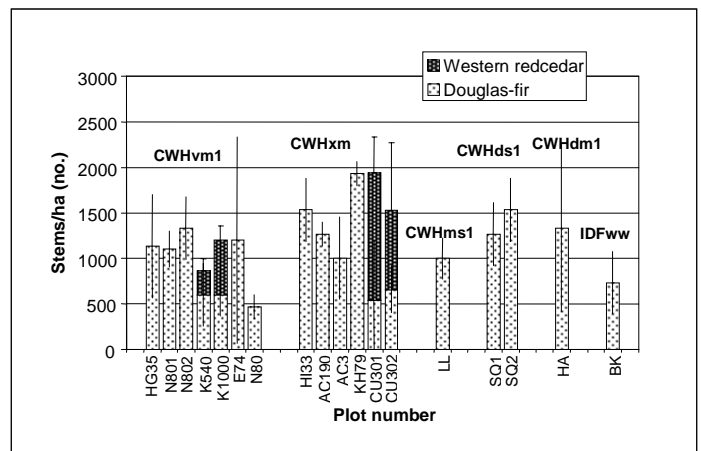
Figure 3. Stacking levels on plots planted with Douglas-fir. Western redcedar is also shown for plots planted with both species. Error bars represent 95% confidence interval of the mean for each plot (n=3 in most cases).

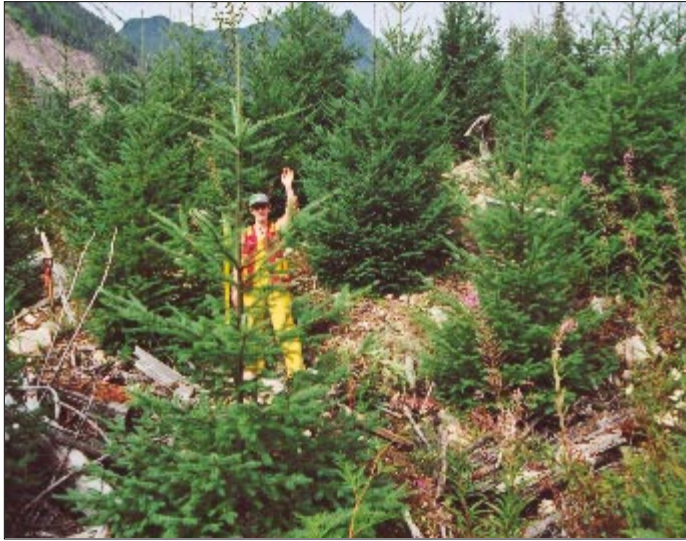
Figure 5. Plot HG35 had good stocking and growth of Douglas-fir.

Total tree height of Douglas-fir and western redcedar appeared to coincide with the results for stocking in some, but not all, cases. For example, plot HG35 showed good stocking and growth of Douglas-fir (Figure 5), while results for both stocking and growth were poor on plot K540 (Figure 6). Sometimes, however, the stocking levels and tree heights diverged, with good stocking and less height growth (e.g., plot E74). In two cases (plot K1000 and plot N80, Figure 7), tree growth was exceptional for the few trees that had established, despite poor stocking overall. Lack of stocking success on these plots may have been related to quality of the soil and/or subsequent factors, such as browsing by elk.

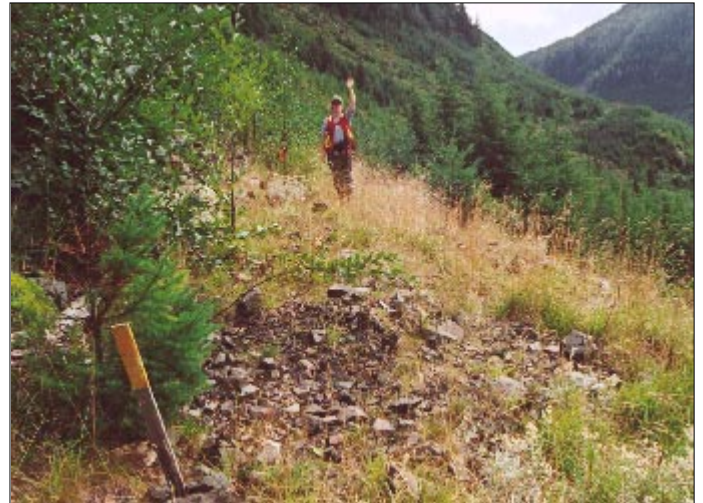
Figure 6. Low stocking levels and growth on plot K540 appeared to be related to a high component of large coarse fragments in the soil substrate, and limited decompaction. The site was located on a south-facing slope.

On some plots, unfavourable soil conditions may have been a key contributing factor to low survival rates. For example, low stocking levels of Douglas-fir and western redcedar on plots K540 and N80 were associated with a

very high component of rock and larger coarse fragments in the rehabilitated soil substrate, and shallow decompaction of the road surface.

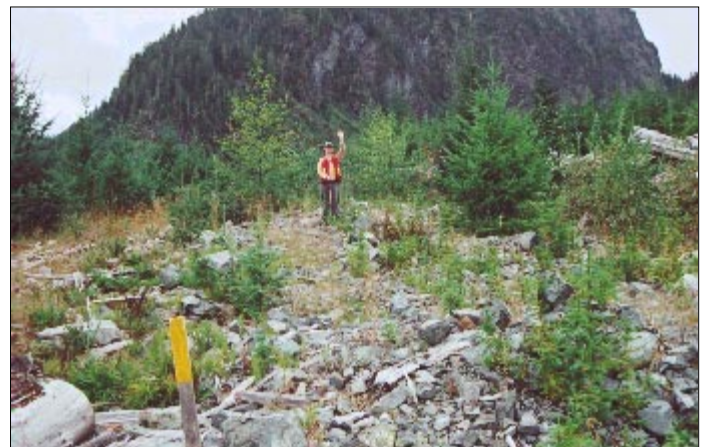
Figure 7. Plot N80 showed low stocking levels of Douglas-fir, but trees that had become established were growing well. A high content of coarse fragments in the road substrate, combined with poor decompaction, likely contributed to poor survival on this site.

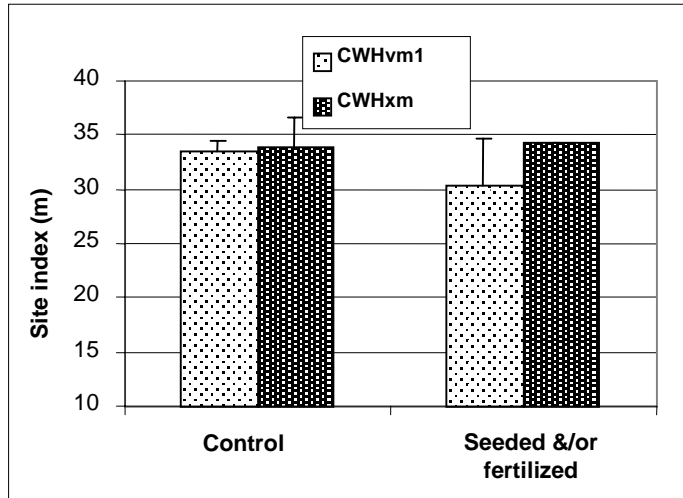
Figure 8. Site index for Douglas-fir on rehabilitated roads determined using the growth intercept method for trees with three or more years of growth above breast height. For the CWHvm1, n=2 plots for the control treatment (no seeding or fertilizing), and n=5 plots for the seeded / fertilized treatment. For the CWHxm, n=4 plots for the control treatment (no seeding or fertilizing), and n=1 plot for the seeded / fertilized treatment.

Site index of Douglas-fir growing on plots where seed and fertilizer were applied at the time of planting was evaluated using the growth intercept method (Nigh 1997), and compared to control plots where no further treatments were applied. In contrast to the results of Hickling et al., which showed improved early growth for fertilized sites, mid-term tree growth showed little difference

(Figure 8). These results suggest that the benefit of added fertilizer was confined to the establishment phase of seedling growth.

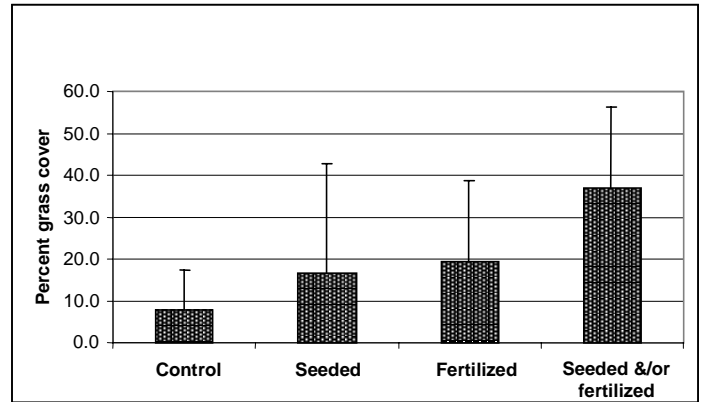
Figure 9. Percent grass cover for treated and control plots in all zones. High variation indicates that seed establishment varied for different plots. Error bars indicate 95% confidence intervals of the mean.

Despite high variability, a combination of seeding and fertilizing appeared to have positive effects on grass cover (Figure 9), suggesting that the benefits of these erosion control measures may persist for eight years or more. No major trends were observed between grass cover and either stocking or growth of Douglas-fir. Plots with high grass cover after eight years included K1000 and NW25 (Figure 10). Both plots were characterized by cool, moist site conditions, which may have encouraged productive growth of the grass. The abundance of the grass on these sites did not appear to have affected tree performance directly, but damage by elk was a problem on plot K1000. The extent to which the forage on this site attracted elk is not known.

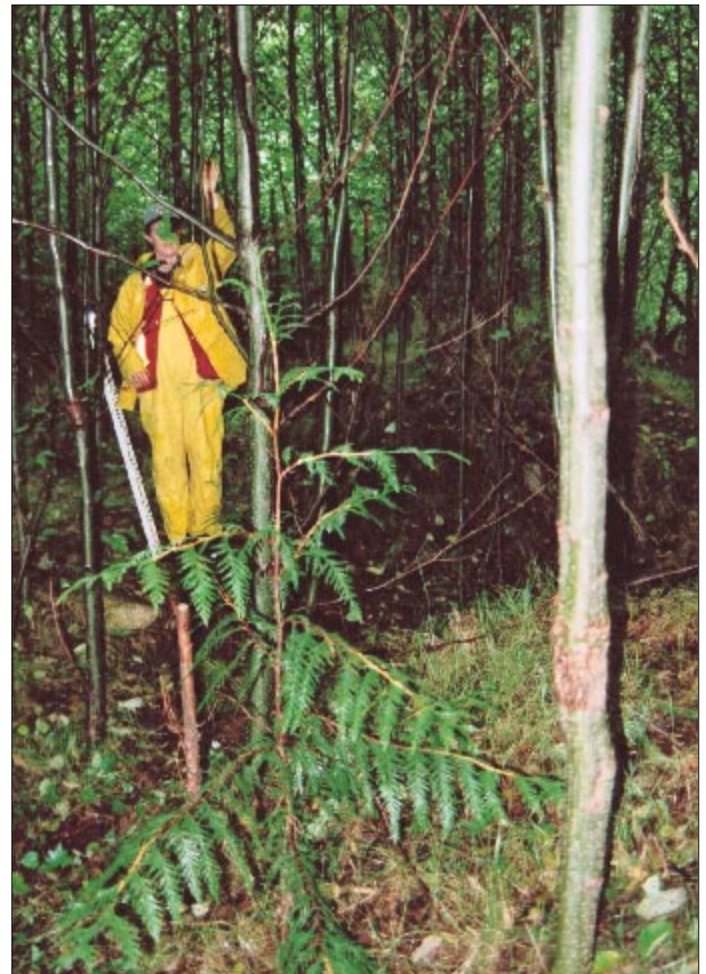
Figure 10. NW25 was a landing near Nahwitti Lake on northern Vancouver Island. Rehabilitation treatments included additions of topsoil and coarse woody debris, which likely contributed to the successful establishment of the grass and alder. The early establishment of grass and/or alder may have affected early growth of the planted western redcedar on this site.

recontoured plots. Plot NW25 was a rehabilitated landing, with large mounds consisting of large woody debris and topsoil material mixed together.
