Extension Note # 18

August 1996

Floodplain Erosion Hazard Mapping Zymoetz (Copper) River, Terrace, B.C.

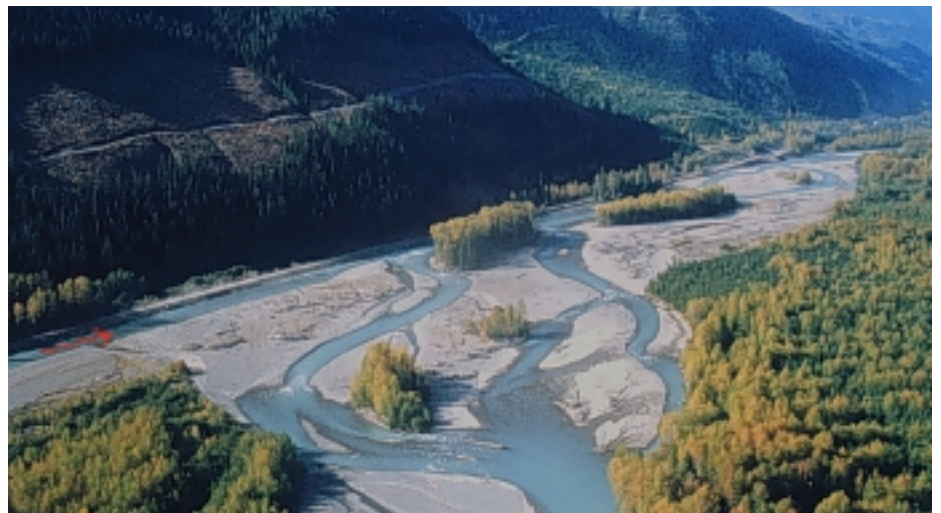
Figure 1. Gravel-bed character of the Zymoetz River, near kilometer 29.

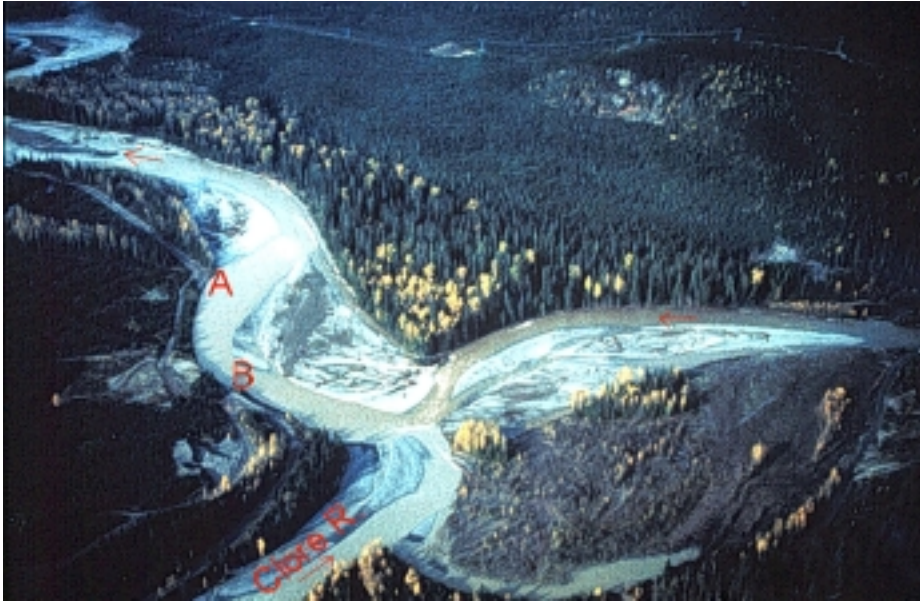
Figure 2. Clore River confluence. During the 1978 flood, 300 metres of the Copper River Road were eroded (between point A and B).

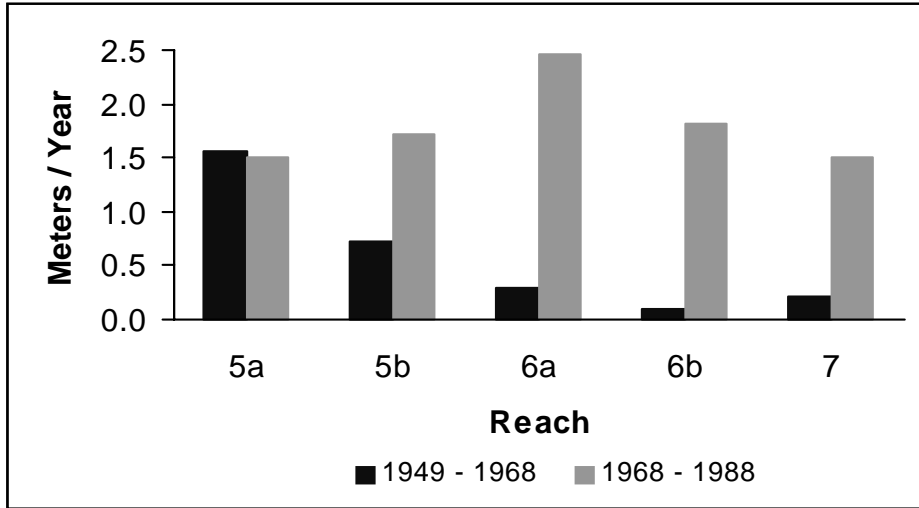
Figure 3. Mean annual bank erosion rate upstream (reaches 5b, 6a&b and 7) and downstream (5a) of the Clore River confluence before and after the 1978 flood.

Air photo interpretation and GIS mapping of the channel configuration since 1949 showed that the channel dynamics changed with the flood in 1978. Upstream of the Clore River junction, bank erosion rate increased 800 % during the 1978 and several smaller subsequent floods. Where the river had been flowing in a single-thread, sinuous channel, it became a wide, straight chute with large gravel bars separating several channels. At the Clore River junction, a long meander bend was abandoned. The new channel took on a straight course and eroded a gravel terrace and road for several hundred metres. A large amount of gravel entered the channel during the 1978 flood from previously forested channel banks and terraces. With every flood, highly mobile bedload pulsed down-channel, pushing the channel further into the floodplain, gravel terraces and scarp slopes.

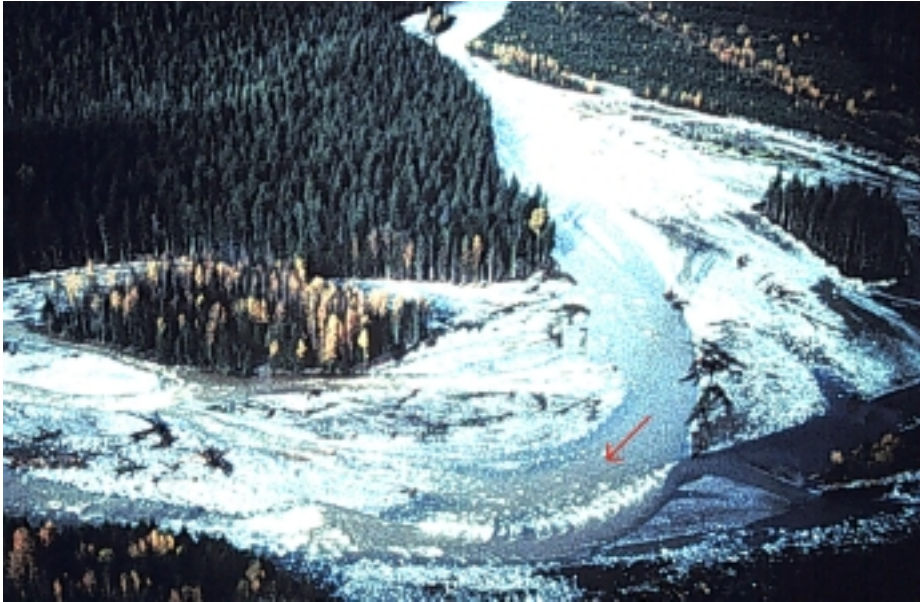
Figure 4. Rapid gravel bar accumulation and channel avulsion at the Kitnayakwa River confluence occurred during the floods in 1991. The pre-1991 channel along the very outside of the meander bend is now filled-in with gravel and sand.

During the floods in October 1991 and 1992, a channel avulsion cut through the Zymoetz floodplain near the Kitnayakwa River junction. This avulsion was in response to gravel

in-filling of the old channel bed; up stream, bank undercutting had destabilized an 80 metre tall scarp slope and mobilized a large amount of gravel. Vertical and lateral channel adjustment is now taking place at the site, as the river seeks to re-establish a stable channel configuration in response to the increased sediment supply and steeper channel gradient.
