Prince Rupert Forest Region

Extension Note # 35

Tsunamis on Troitsa Lake British Columbia

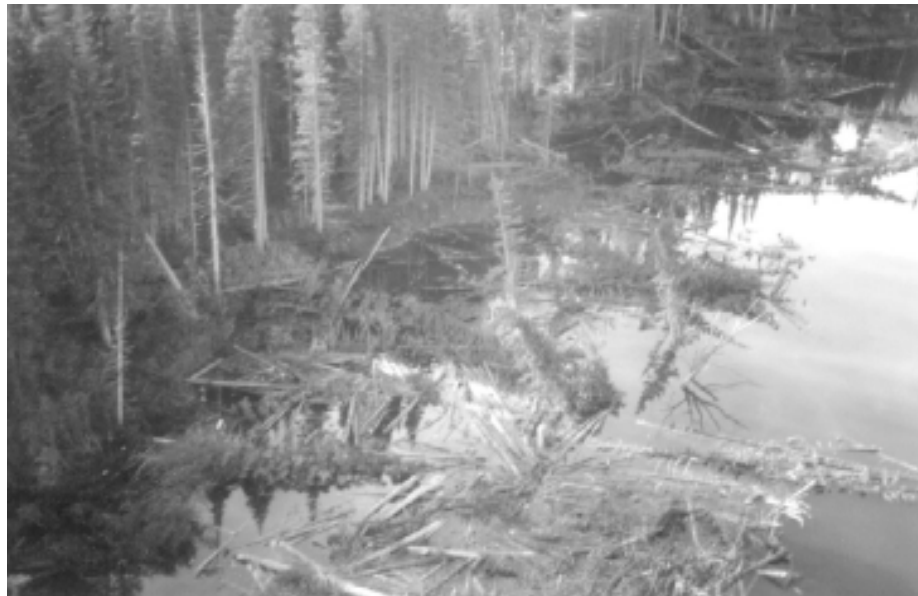
FIGURE 2. Floating debris at the landslide head scarp. Scarp extends 2 metres above the lake surface.

What occurred at Troitsa Lake on the morning of October 6, 1998 and unsettled the lake for 4 hours was triggered by a large underwater landslide that occurred off the steep slope of a fan-delta. The visible portion of the landslide measures 400 m by 60 m along the edge of a fan-delta surface. This visible face is the head scarp and upper slump block of a large landslide that extends down the steep face of the delta to depth in Troitsa Lake (Figure 2).

An estimated three million cubic meters of materials moved in the event. A displacement wave 1.5 m high hit the opposite side of the lake one kilometer away. Groups of large trees matted together were rafted by the wave up to one km across the lake. A backwash wave two m in height crashed back over the head scarp carrying debris up to 150 m inland over the delta surface. The north end of Troitsa Lake (10 km from the landslide) experienced an initial sharp swell about 60 cm in height; bays and shallows were then sucked empty. About 10 minutes later, a large return wave 1.5 to 2 m high crashed through the shallow bay, tearing sunken logs and debris from the bay floor and hurling the debris on to the beach and into the forest surrounding the bay. Boats and floating wharves were ripped from their moorings. A log jam at the head of Troitsa River was also dislodged and sent down the river.

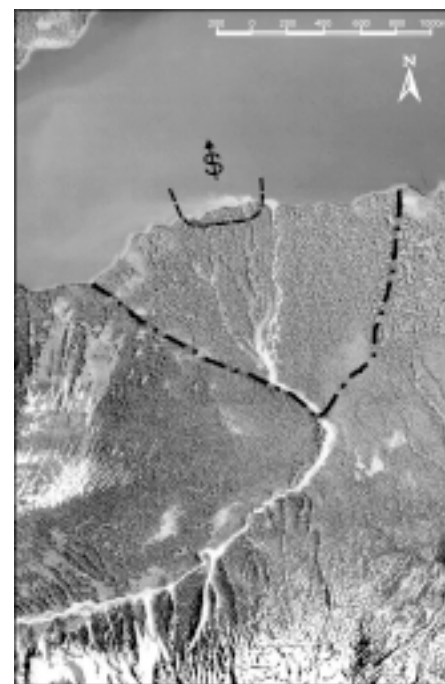
FIGURE 3. Troitsa Lake fan-delta with landslide location indicated.

The large fan-delta on Troitsa Lake where the failure occurred is forested with big spruce and subalpine fir. It covers an area of 100 ha and extends for a distance of 1,600 m along the water's edge (Figure 3). The most actively aggrading portion of the fan edge extends over a distance of 700 m. Sediment source for the fan-delta originates in a steep-gradient watershed (13.5 km²) containing recently exposed glacial materials. Glaciers ring the upper elevations of the valley. The fan-delta has a slope of 6 degrees from its apex to the lake shore. This fan has experienced many episodes of dynamic processes, as attested by the many distributary

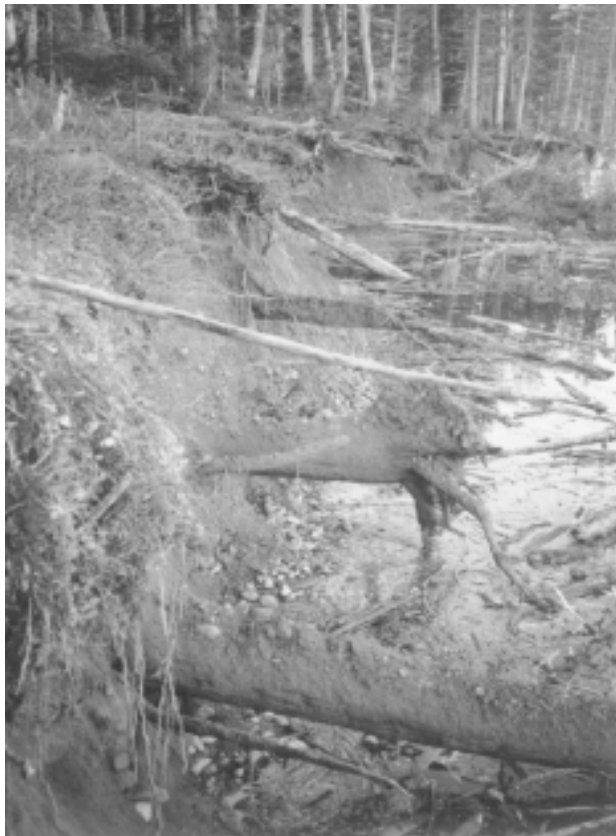
FIGURE 5. Trees imbedded in the landslide headscarp—evidence of a historic failure.

The Troitsa Lake fan-delta at first glance appears as a relatively flat, unassumingly stable landform—but evidence of a historic failure is exposed at the headscarp of the present landslide. Imbedded in the head scarp is a row of trees all protruding at the same level perpendicular to the scarp (Figure 5). New trees fallen in the water from the erosion created by the backwash are similarly placed, suggesting the imbedded trees are from a landslide-triggered tsunami. Radio carbon dating of one of the imbedded tree logs provided a date in the order of 650 years B.P. Possibly the time since the last landslide-triggered tsunami on Troitsa Lake.
