Prince Rupert Forest Region

Extension Note # 46
March, 2002

Catastrophic Rock Avalanche: Howson Range, Telkwa Pass

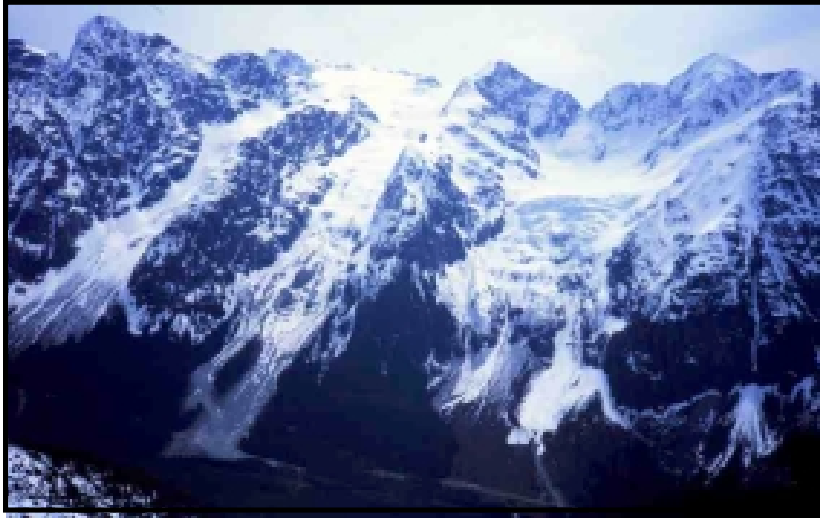
Figure 2. Ice valley glaciers, Howson Range-Telkwa Pass.

oversteepened valley walls (Figure 2). The ridges between the glaciers extend up to 300 meters in height and are composed of highly fractured and near vertically jointed granodiorite bedrock. Rockcliffs also rise up directly above Limonite valley in the Telkwa Pass area. Rockfalls in the vicinity can often be heard tumbling onto glacier ice or down slopes.

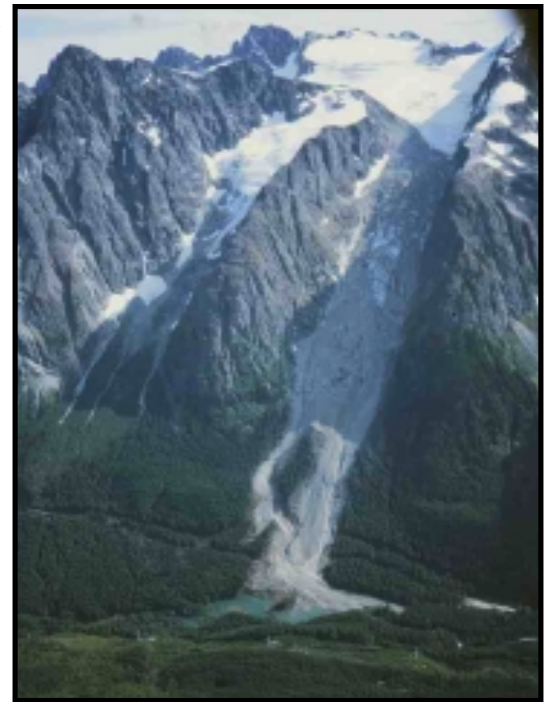
Figure 3. September 1999 rock avalanche. Note location of rock topple-slide, Ice valley glacier, rock avalanche path, deposition zone, and new lakes.

onto glacial ice, expanded to cover the ice-valley glacier to a width of 300-400 meters, continued down the ice valley then avalanched into the Limonite Creek valley (Figures 3, 4, and 5). The rock avalanche travelled a distance of 2.7 km, dropping 1,300 meters in elevation. The avalanche path through mature forest covered an area 1,200 meters long and up to 400 meters wide (Figure 6).

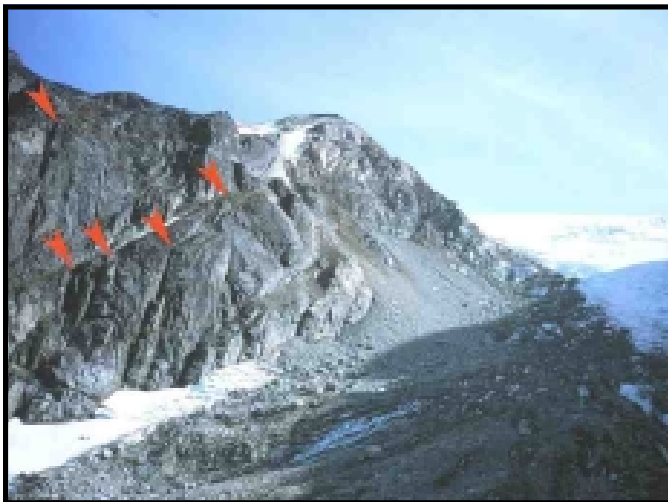
Figure 4. View up ice valley toward the headscarp. Note the headscarp, rock topple/slide on to glacial ice and near vertical joints in granodiorite bedrock (red arrows).

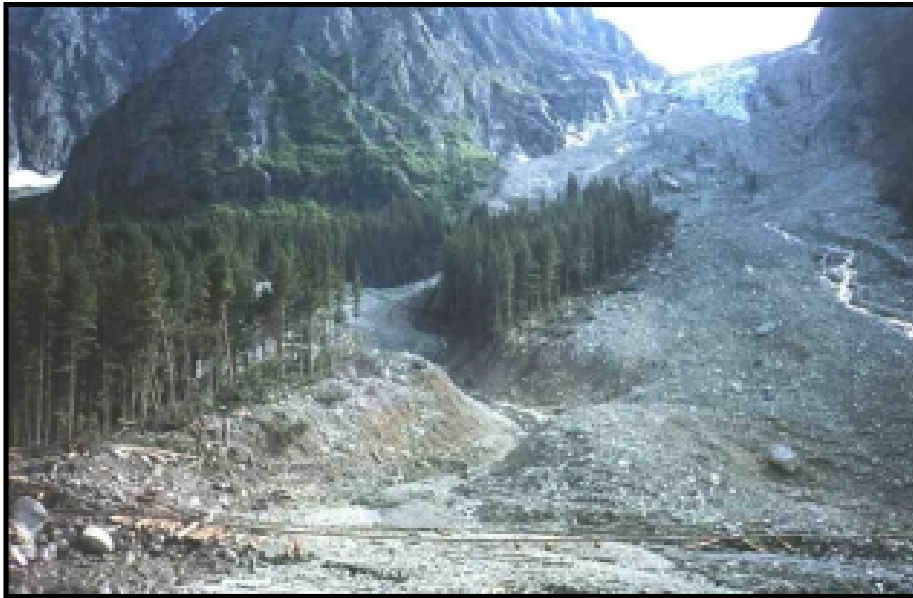
Figure 6. View toward the ice valley. Note rock avalanche width, forest removed, and gully on the left of photograph.

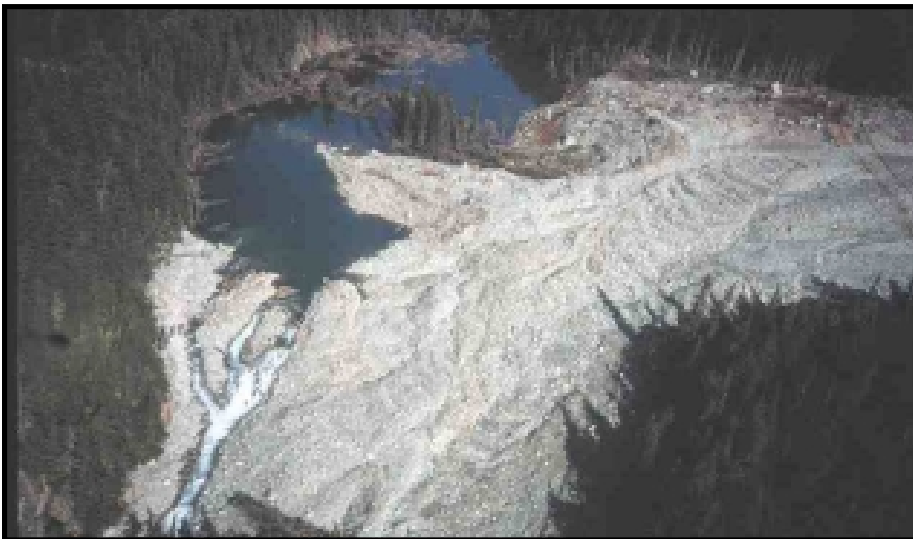
Figure 7. View up Limonite Creek. Note depth of valley in fill creating a dam, flow features from gully contained within landslide debris.

Scour along the avalanche path through the forest, incorporated colluvial and morainal material. Trees were blown over by the air blast along the sides and front margin. Mud was splattered on vegetation beyond the edge of the slide. Landslide debris dammed Limonite Creek, creating a lake that filled within a few days. The avalanche was contained along the west and east boundary, below the ice-valley glacier, by lateral moraines and a gully. Flow features appear in the depositional zone issuing from the gully along the east boundary of the avalanche—these flow features could indicate that a large debris flow, from the gully, occurred after the initial avalanche (Figure 7). The gully had probably been filled with landslide debris. Despite the large forest area contained in the avalanche path, few trees are visible in the landslide debris. Large boulders, some the size of a small house, are strewn along the landslide path (Figure 8). The avalanche incorporated and transported a total volume in the order of 2 to 5 M m³.

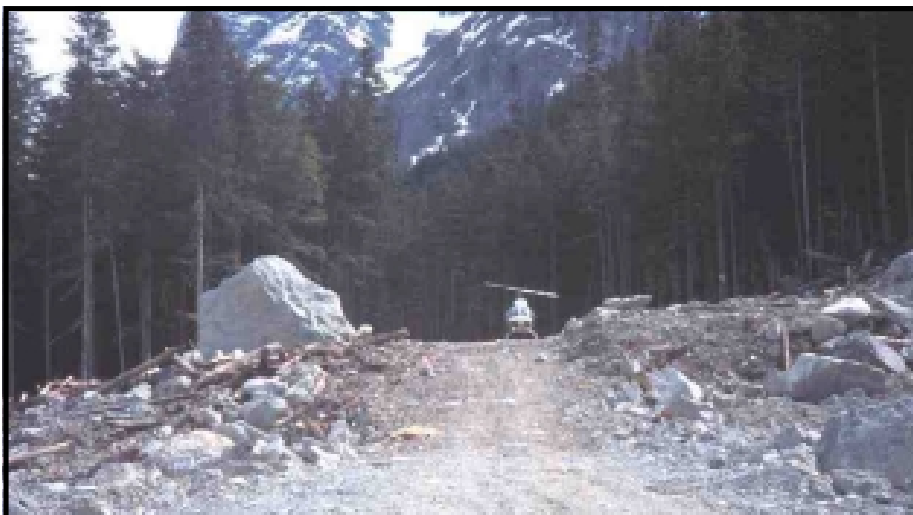
Figure 8. Helicopter situated next to a house-sized boulder carried down in the avalanche.

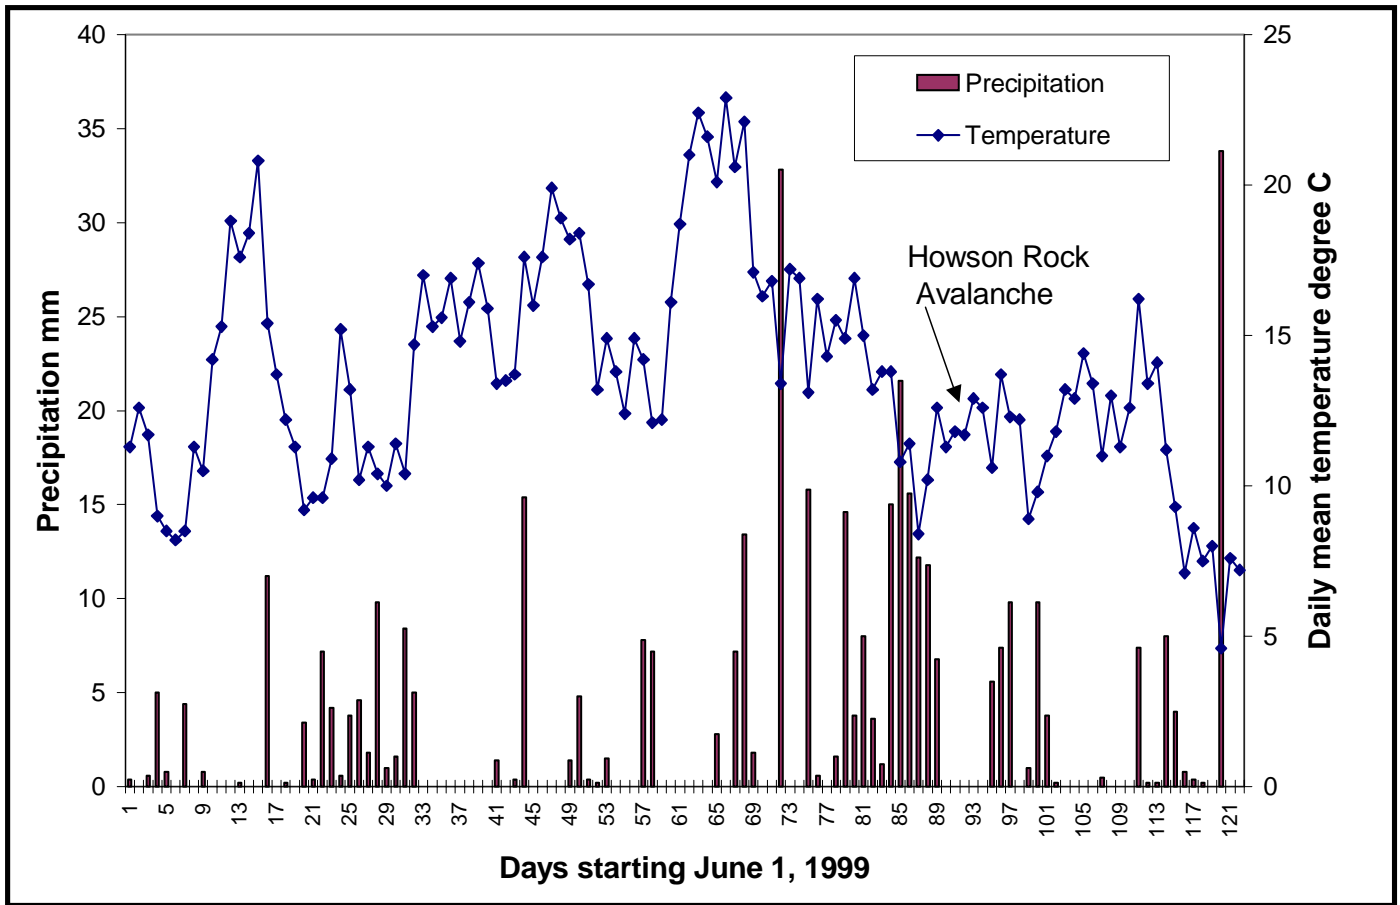
Figure 9. Precipitation and temperature June-September 1999, Terrace Airport.

A chart of precipitation and temperature for the Terrace airport is presented in Figure 9. Rainfall, during the months of May to August 1999 was reported at 2 times normal for the Terrace airport. Temperature for the summer of 1999 was below normal with conditions relatively clear and cool at the time of the event. However, daily mean temperatures for June, July and August 1998 were 3.2, 3.5 and 2.1 degrees above normal, respectively.
