Forest Research
Technical Report

TR-025 Geomorphology March 2003

Schmidt Creek Sediment Sources and the Johnstone Strait Killer Whale Rubbing Beach

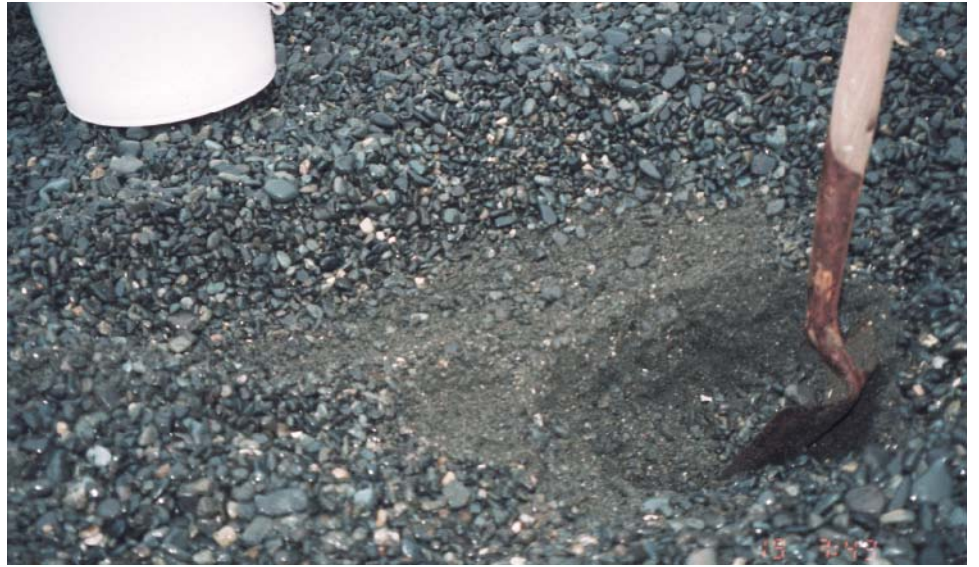
Photo 4. Sediment profile on Beach 5. Typical sediment profile on lower portion of Beach 5 (Sample locations 5-1, 5-2, and 5-3), where the well sorted pebble layer was 5 – 10 cm deep. Surface sample included only the well sorted pebble sediment and included the uppermost surface (0 – 2 cm). Sub-surface samples were from the sandy gravel layer.

about 40% of the sample, with the remaining 60% composed of gravel. Photo 4 shows the sediment profile near sample 5-1. Photo 5 shows Beach 1 sediment, and Photo 6 shows Beach 4 sediment. In contrast to the other samples, Sample 5-5 was the well-sorted pebble sediment characteristic of the whale rubbing beach. There was no sand in this sample, and the entire sample consisted of pebbles that ranged from 2 mm to 45 mm in size.
