The Application and Effectiveness of the Coastal Fisheries Forestry Guidelines in Selected Cut Blocks on Vancouver Island

D. Tripp
A. Nixon
R. Dunlop

D Tripp Biological Consultants Ltd.
Site T1, RR#1
Nanaimo, B.C.
V9R 5K1

April, 1992

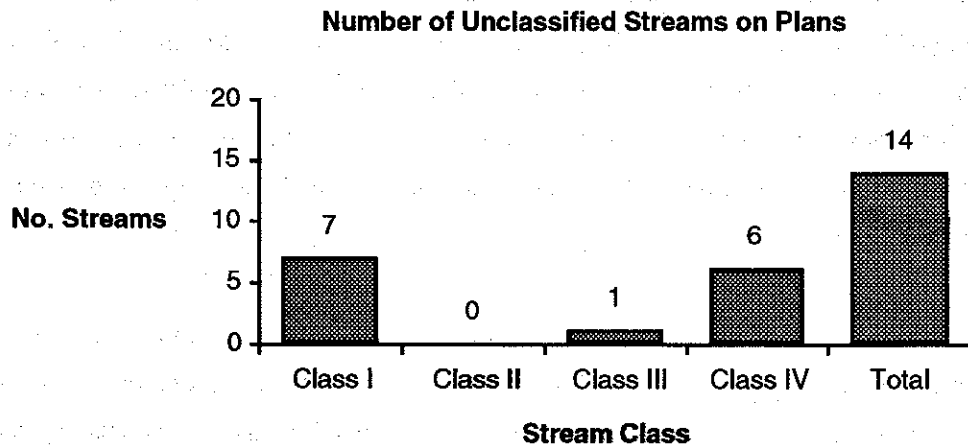
Figure 5. Number of streams not classified on the cutting plans.

streams (26.2% of the sample) were missed and thus left unclassified prior to harvesting (Fig. 5). All of these streams were first order streams that flowed into a third order stream within or close to the block. Seven of the streams were Class I waters, the rest were Class III and IV waters. All appear to have been treated as if they were Class IV waters.

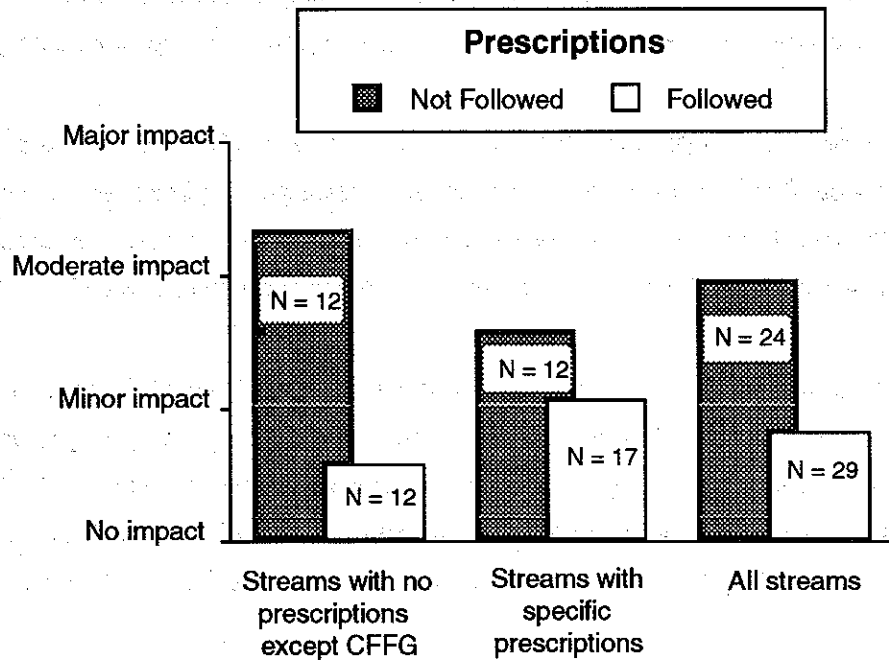
Figure 6. Effectiveness of the Coastal Fisheries Forestry Guidelines and other site specific prescriptions in reducing stream impacts in recent cut blocks on Vancouver Island.

The average impact recorded in streams where the CFFG or site specific prescriptions were followed were further compared with the impacts in streams where prescriptions or guidelines were not followed (Fig. 6). As before, impacts were scored as 0 (no impacts), 1 (minor impact), 2 (moderate impact), or 3 (major impact). Major, moderate and minor impacts are as defined earlier in Section 4.1.

Results indicate that, by themselves, the Coastal Fisheries Forestry Guidelines were effective in reducing the severity of logging impacts from an average score of 2.33 (major/moderate impacts, N = 12) to 0.58 (minor/no impacts, N = 12). The differences were significant at $P < 0.005$ (Mann-Whitney U test). The overall reduction recorded in the severity recorded in all streams with or without site specific prescriptions was also significant ($P < 0.005$), dropping from an average score of 1.96 (approximately a moderate impact) to 0.83 (less than a minor impact).
