Fish Passage Culvert Replacement 33.5 km Underdown Road, TFL 35 (Inkaneep block), Wabash Creek, Southern Interior Forest Region

Replacement of two circular culverts with one arch culvert to restore upstream rainbow trout passage on Wabash Creek (an S3 stream not within a community watershed).

SOTFL154662, 4662001, 2006/07.

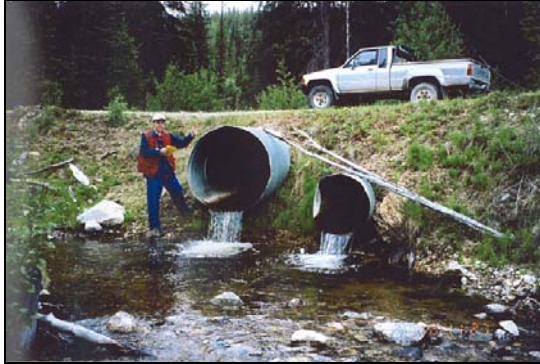
Photo 1. Before: outlet of perched culverts that were undersized for Q100.

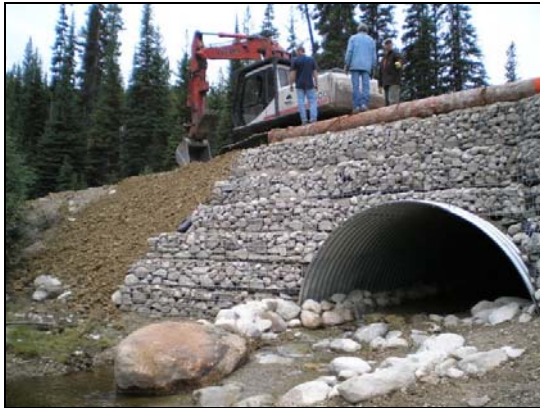
Photo 2. Looking upstream from outlet showing layers of reinforced soil constrained by geotextile inside of wire baskets. The stone facing protects underlying geotextile from UV damage. Several stone lines were constructed inside of culvert to mimic natural stream structure.

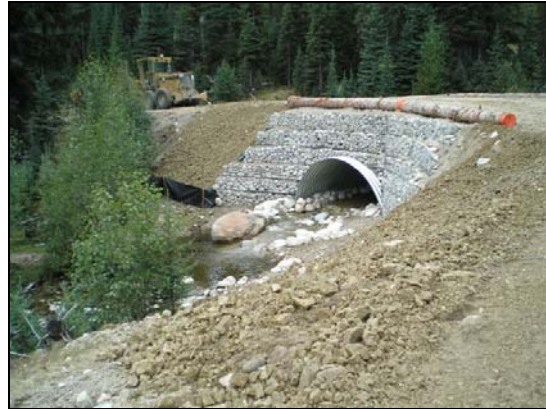
Photo 3. Looking at outlet of finished product.
