# Assessment of the Tumbler Ridge Drinking Water Supply: Source Wa- ter Characteristics

James Jacklin, March 2004<sup>1</sup>

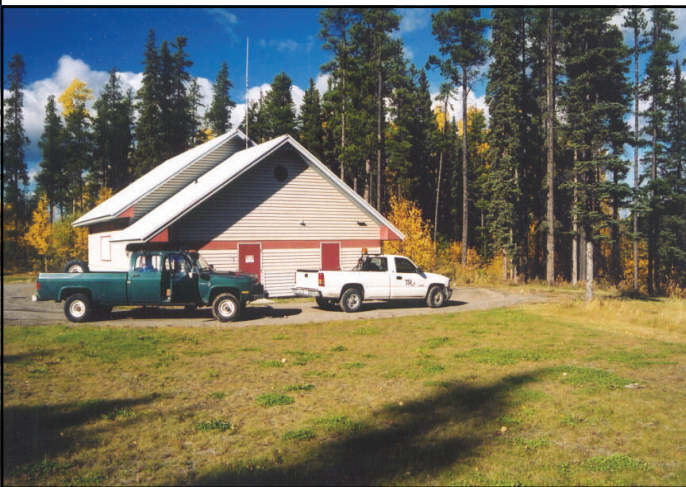
Plate 1. A view of the Tumbler Ridge water treatment plant. The raw water samples were collected from an inside tap.
