Assessment of the Valemount Drinking Water Supply: Source Water Characteristics

James Jacklin, March 2004¹

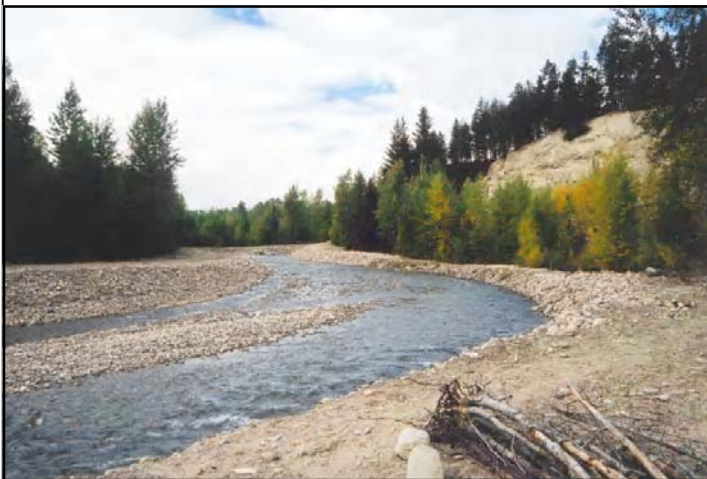
Plate 1. An upstream view of the Swift Creek sampling location, just above the Valemount pump house.

This brief report will summarise water quality data collected from the Village of Valemount's raw potable water source, Swift Creek (Plate 1). The data are compared to current provincial drinking water quality guidelines meant to protect finished water if no treatment other than disinfection is present. This comparison should identify parameters with concentrations that represent a risk to human health. It is intended that this program will lead to the identification of human activities responsible for unacceptable source water quality, and that it will assist water managers to develop measures to improve raw water quality where needed.

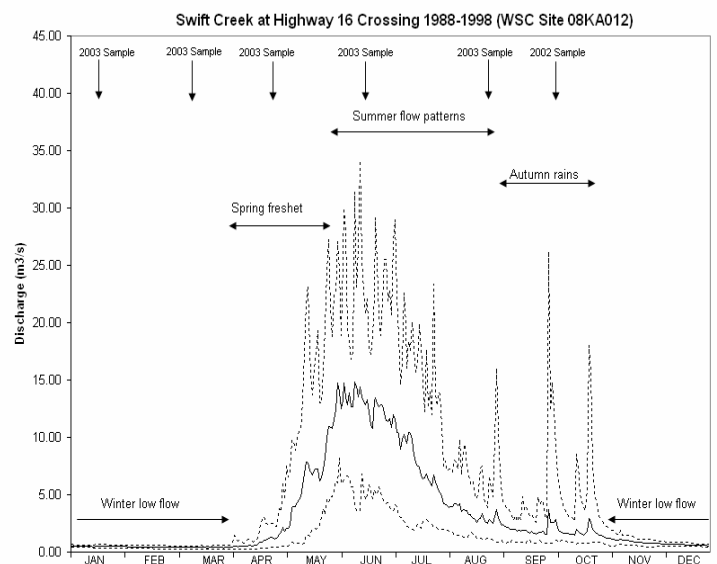
Figure 2. Lowest (bottom line), average (middle line) and maximum (upper line) daily flows observed in Swift Creek over the period 1988-1998.

Flows in Swift Creek are lowest during the winter months (December through March) and highest during spring melt and mid-summer (generally May-July) (Figure 2). To ensure that sufficient water is available to support the Village of Valemount and associated water users during low-flow periods, storage capacity has been increased by the installation of a cross-channel weir (Plate 2; Murray Capstick, Village of Valemount, pers. comm.). The 1988 to 1998 hydrograph suggests that much of the water that enters the channel during the spring does so via overland flow, which causes direct channel response (Capstick, p.c.). Given the low winter flows and the likelihood that overland flow inputs to the channel are more significant than groundwater inputs, water quality in Swift Creek is particularly sensitive to landscape-level activities. Thus, in terms of hydrologic processes, particular care should be taken when managing land-use activities and water withdrawal rates in the Swift Creek watershed and riparian habitats.

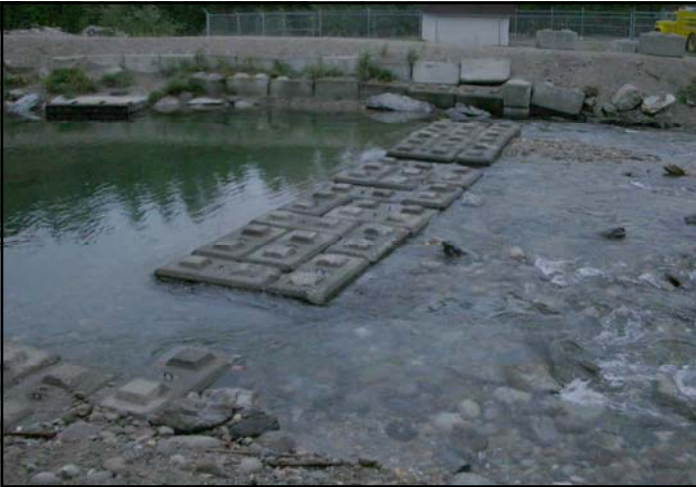
Plate 2. A cross-section view of the weir in Swift Creek. This weir has helped to increase water storage capacity in Swift Creek.

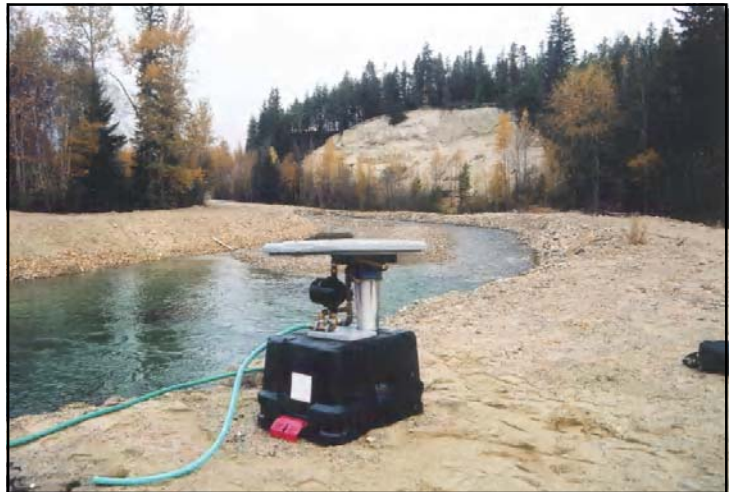
Plate 3. The parasite filtration kit on the bank of Swift Creek beside the water pump house.
