- CANADIAN HYDROLOGY SYMPOSIUM: 82
- ASSOCIATE COMMITTEE ON HYDROLOGY
- NATIONAL RESEARCH COUNCIL OF CANADA
- JUNE 14-15, 1982
- FREDERICTON, NEW BRUNSWICK

SOIL MASS MOVEMENTS IN THE RENNELL SOUND AREA,
 QUEEN CHARLOTTE ISLANDS, BRITISH COLUMBIA

D.J. Wilford and J.W. Schwab¹

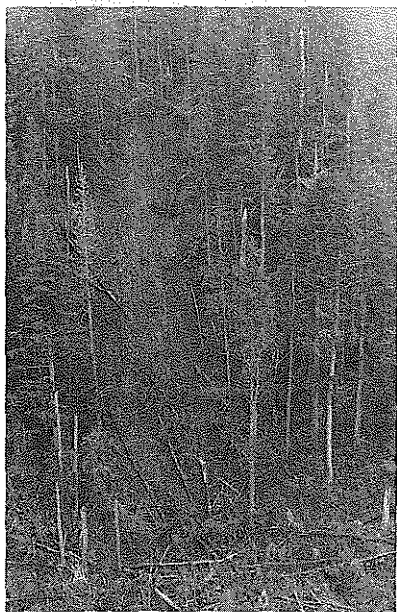
Figure 3. Mass movements constitute a dominant geomorphic process in Rennell Sound.

Debris avalanches in natural forests appear to be initiated by three day storms with a 2 to 5 year return period (approximately 200-250 mm) (Figure 3).

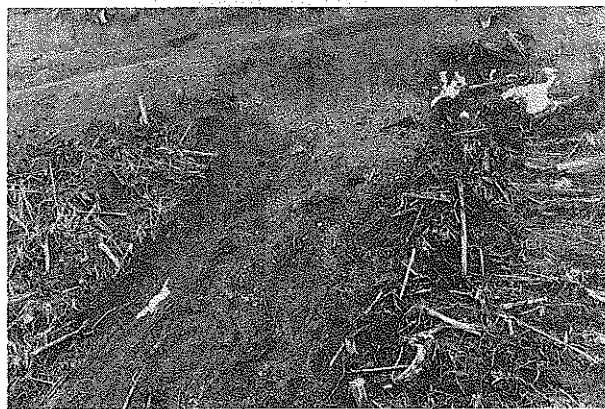
Figure 5. Debris avalanches occur on roads as a result of excess sidecast piling waste material on the outside of a road edge, and inadequate road drainage.

Debris avalanches associated with forest roads characteristically occur on receiving sites or depressional sites with slopes between 25 and 36 degrees. They are a result of slope overloading and the saturation of fill and sidecast material. Failures are initiated by: 1) sidecasting large amounts of waste material into receiving or depressional sites; 2) piling large amounts of waste material on the outside of a road edge which is built over a depressional or receiving site; 3) inadequate road drainage, and poor ditch and culvert maintenance (Figure 5).

The occurrence of debris avalanches initiated by roads can be reduced by: 1) constructing full bench roads; 2) endhauling waste material from

sites where stability is questionable; 3) excavate material to bedrock when crossing receiving and depressional sites, using coarse shot rock as a road bed to allow subsurface water movement through the fill; 4) not sidecasting waste material into depressional and receiving sites; 5) not piling large amounts of waste material from road construction and maintenance, on the outside edge of a road in a depressional or receiving site, and 6) building roads to the engineered specifications for drainage, and carrying out the necessary culvert and ditch maintenance.
