Forest Research Extension Note

EN-004 Hydrology March 2001

Roberts Creek Study Forest: the effects of shelterwood harvesting and blowdown on sediment production in a small zero-order creek

by Robert O. Hudson and Brian D'Anjou

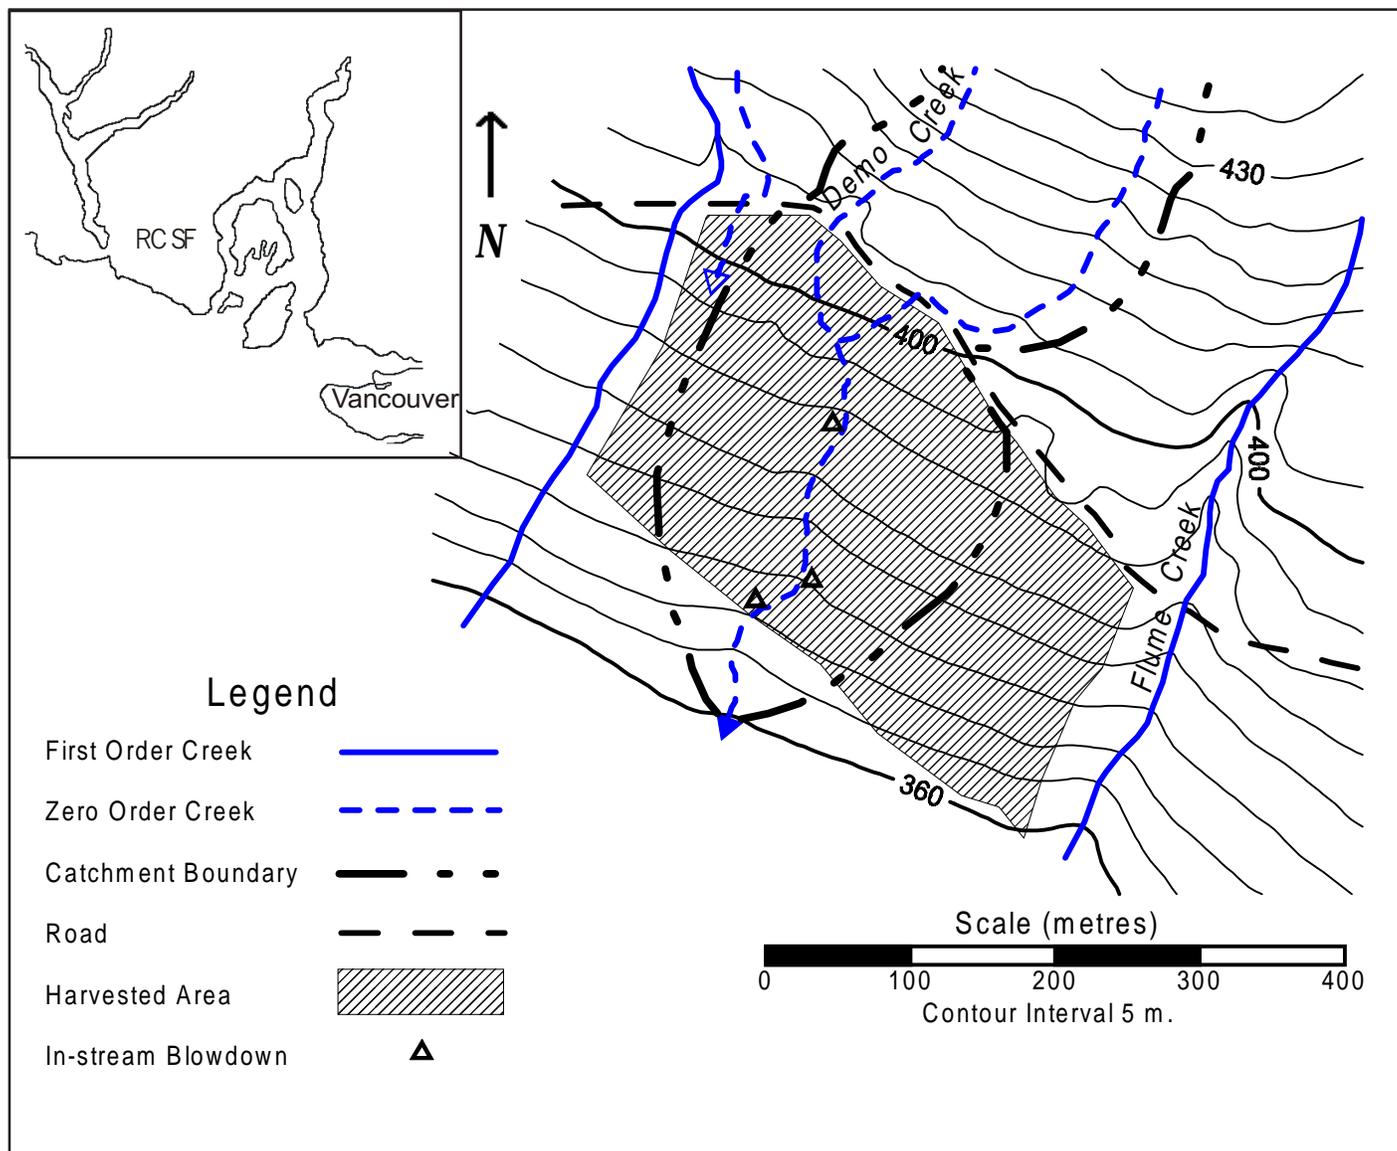
Figure 1: The “Demo Block” study area: Flume Creek, Roberts Creek Study Forest.

The Roberts Creek Study Forest (RCSF) is located on the southwestern flank of Mount Elphinstone on the Sunshine Coast, approximately 40 kilometres northwest of Vancouver, BC (Figure 1). The RCSF is a collection of

Demo Creek, a zero-order S6 stream, flows through the block (Figure 1). Soils are classified as Humo-Ferric Podzol; humus is thin (<5 cm), and there is an impermeable, root-restricting layer between 75 and 80 cm. Across the middle of the block, a bench with hardpan near the surface causes groundwater seepage under wet conditions, resulting in shallow-rooted trees.

shallow-rooted. Three of the Douglas-fir trees that blew down within the block were rooted in the creek channel (Figure 1). This blowdown caused loosening of channel sediments and bank disturbance that resulted in creation of erodible sediment sources in the channel.

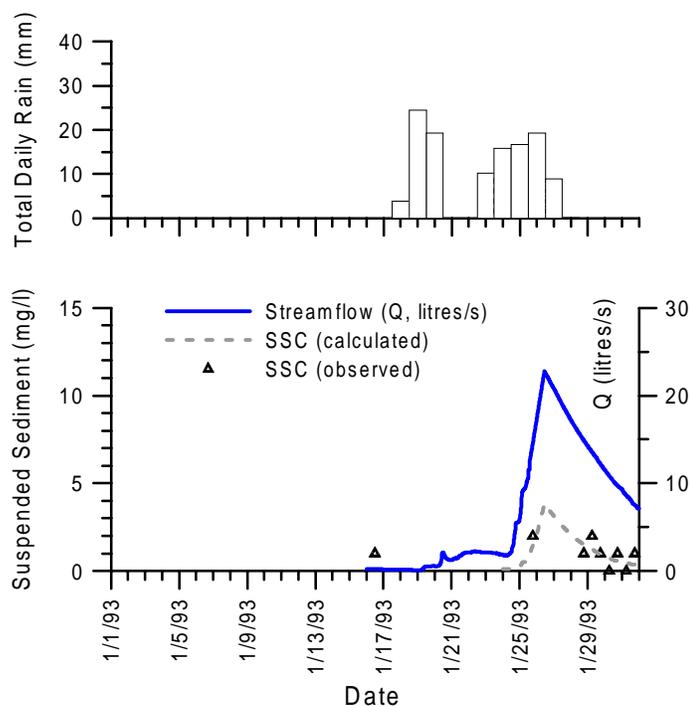
Figure 2: Rainfall, Streamflow (Q) and Suspended Sediment Concentration (SSC) at Demo Creek, January 1993

In the 1992-93 pre-treatment season, peak flows reached about 27 litres/second. Maximum total daily rainfall for the season was 35 mm, occurring on 23 March. The largest peak flows occurred on 24-28 January due to rain-on-snow (Figure 2). Some of the flows during the January event had to be estimated from manual measurements (collected by current metering) because the weir was overtopped. Following that event, the weir was built up using sandbags to channel all flows into the structure. The event of 21-23 February was due to rainfall; thus, although the rainfall volume and intensity was greater than for the January event, the peak flow reached only 18.8 litres/second (Figure 3). Suspended sediment concentrations among samples collected during the pre-treatment season were all between 0 and 4 mg/l at

Demo Creek, and also on adjacent creeks (Figures 2, 3).

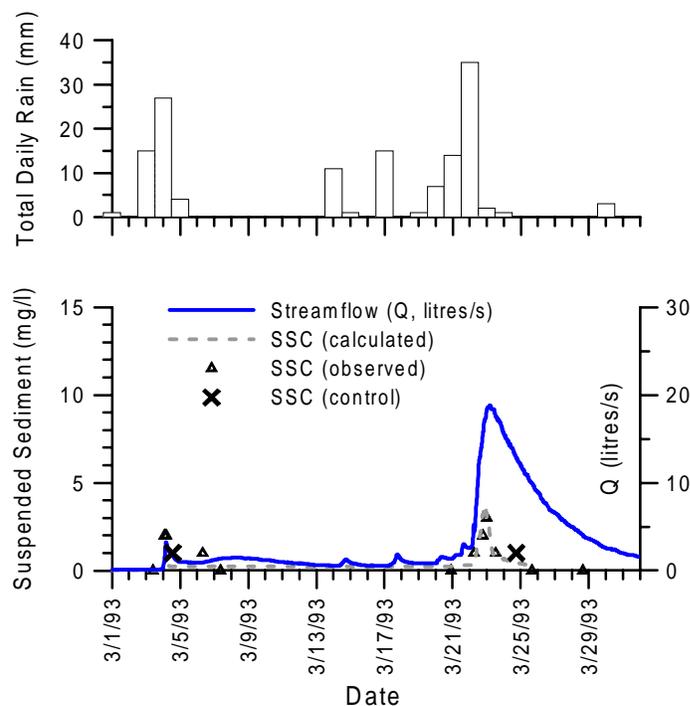
Figure 3: Rainfall, Streamflow (Q) and Suspended Sediment Concentration (SSC) at Demo Creek, March 1993

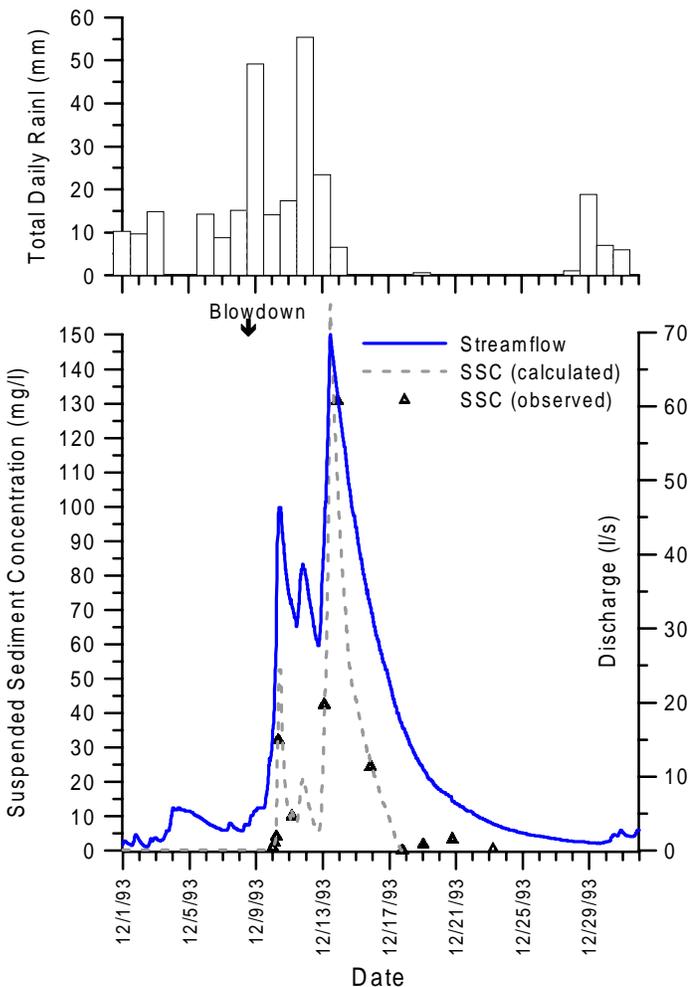
Figure 4: Rainfall, Streamflow (Q) and Suspended Sediment Concentration (SSC) at Demo Creek, December 1993

In contrast to the pre-treatment season, the 1993-94 post-treatment season saw higher peak flows. On 14 December, the weir was overtopped and the range of the water level probe was exceeded by the flow; it is estimated that peak flows reached about 70 litres/second in response to 55 mm of rain that fell the previous day (Figure 4). Three separate runoff peaks occurred from 9-13 December. The blowdown that occurred in the stream resulted in an initial pulse of approximately 53 mg/l of suspended sediment on the rising limb of the runoff hydrograph on 10 December, and a larger pulse of 159 mg/l of suspended sediment early in the morning of 13 December.

This is typical of sediment production during runoff events, in that sediment pulses occurred on the rising limb of the hydrograph, and the sediment concentration was proportional to the peak flow of each event. These pulses were most likely

the result of channel and bank scour of the sediment sources created by the three windthrown trees.

Although current field assessment procedures (Form FS 712-2) suggest moderate windthrow hazard due to topographic exposure and soil factors within the study area, forest stand attributes including uniform structure, tall trees (exceeding 30 meters) and height/diameter ratio (exceeding 90) point to high hazard. Three of the Douglas-fir trees that blew down were adjacent to the channel, with roots that extended under the channel bed. In spite of the lack of real control data, it is clear that the main water quality effect on Demo Creek associated with the uniform shelterwood harvesting was an intense but short-lived sediment production event, the result of blowdown in the channel of only three trees. Peak sediment concentrations during this event reached roughly 10 times the expected level for that creek under non-harvest conditions, based on data obtained from the pre-treatment period, from post-blowdown storms on Demo Creek, and from the adjacent "control" creeks. If those trees had been marked for removal rather than retention, the observed sediment pulses shown in Figure 4 would not have occurred.

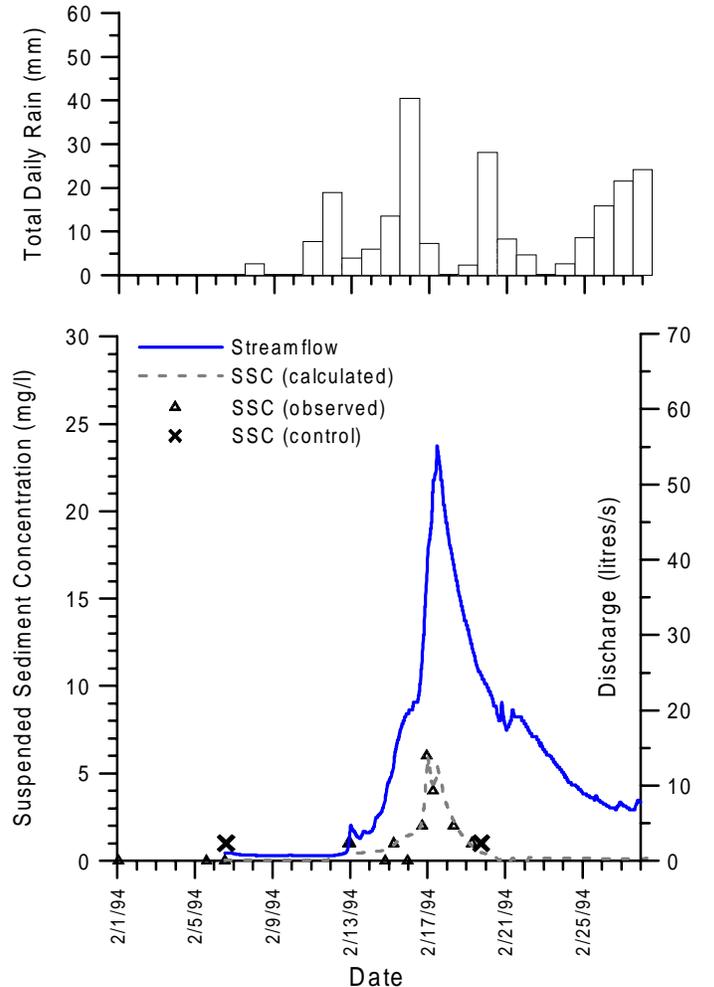
Figure 5: Rainfall, Streamflow (Q) and Suspended Sediment Concentration (SSC) at Demo Creek, February 1994

Immediately following the December storms with their associated blowdown and resultant sediment production events, suspended sediment concentrations in Demo Creek returned to levels that were comparable to those of the pre-treatment period, and to those at the control sites. The second biggest storm of the season, occurring on 15-17 February 1994, resulted in a peak flow of about 52 litres/second and produced an instantaneous peak in suspended sediment concentration of only 6 mg/l (Figure 5). Thus, blowdown had an immediate but short-lived effect on water quality.
